ADVANCED MASTERS IN STRUCTURAL ANALYSIS
OF MONUMENTS AND HISTORICAL CONSTRUCTIONS

Master's Thesis

Historical Case Study: The Frari's Basilica in Venice

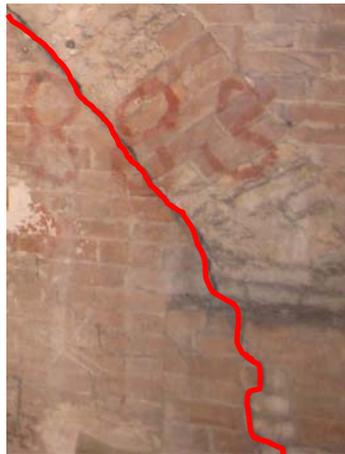
Figure 3-4: Final part of the relieving arch and crack pattern

1. the deep severe cracks on the transept wall of the bell tower denote that the tower was still detaching from the church and settling towards the South-East direction;
2. the ashlar of the arch that divide the left aisle from the transept were suffering the splitting of the tower and with a tendency to detach;
3. tower wall and perimeter wall of the Basilica (orthogonal to each other), cause of the previous statement, tended to separate;
4. the relieving arch, which constitutes a preferential thrust line, was of difficult interpretation and it may have contributed to the widening of nearby cracks (Figure 3-4).
5. the need to understand the load that affected the provisional tie rod in order to acquire knowledge on the entity of the loads the bell tower transmitted to the Basilica.

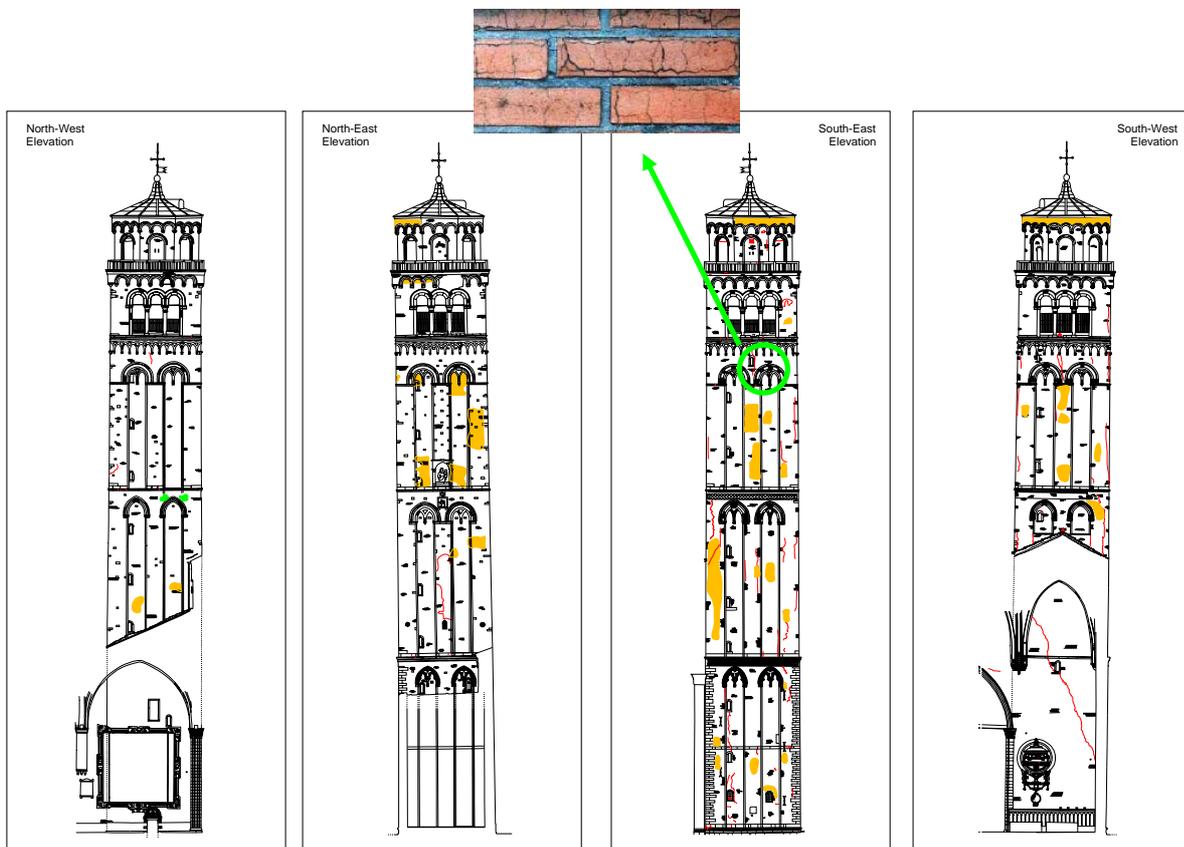
Figure 3-15: Crack pattern on bell tower elevations

In the bell tower, most of the cracks inferred from the damage survey presented a vertical trend with limited extension; a concentration of cracks close to the corners of the tower could be seen, possibly due to local concentrations of loading. Closer hair cracks could be seen at the belfry, most likely related to the later substitution of the old belfry with a new electrical one (Figure 3-15).

Especially on the South-East and South-West elevation, the zones where typical phenomenon of *spalling* are highlighted (which is the detachment of one layer of a material higher than 3 mm thickness).

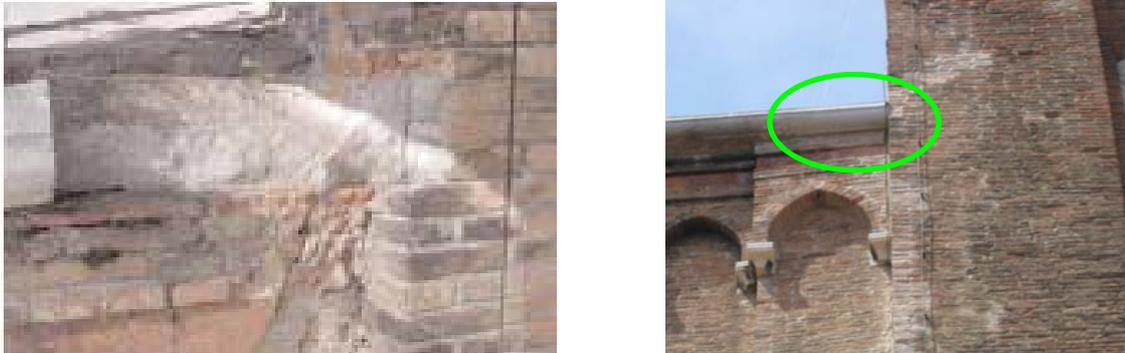
Figure 3-16: Rock stringcourse before and after intervention

Further cracks cannot be seen from outside, as in recent years major works of local rebuilding were performed. Nevertheless these interventions left a visible mark on the masonry and a virtually clear interpretation on whether the masonry had been replaced or not. In Figure 3-16 a clear example of the damage which occurred to the interface layer of the two structures is shown: the rock stringcourse on top of the Basilica (green spot) was buried in the wall of the tower. After the

different settlements occurred over the past centuries and after a small redistribution of stresses among itself (rock is a weak material, not good working in tension) it literally exploded causing potential hazards to people walking by.

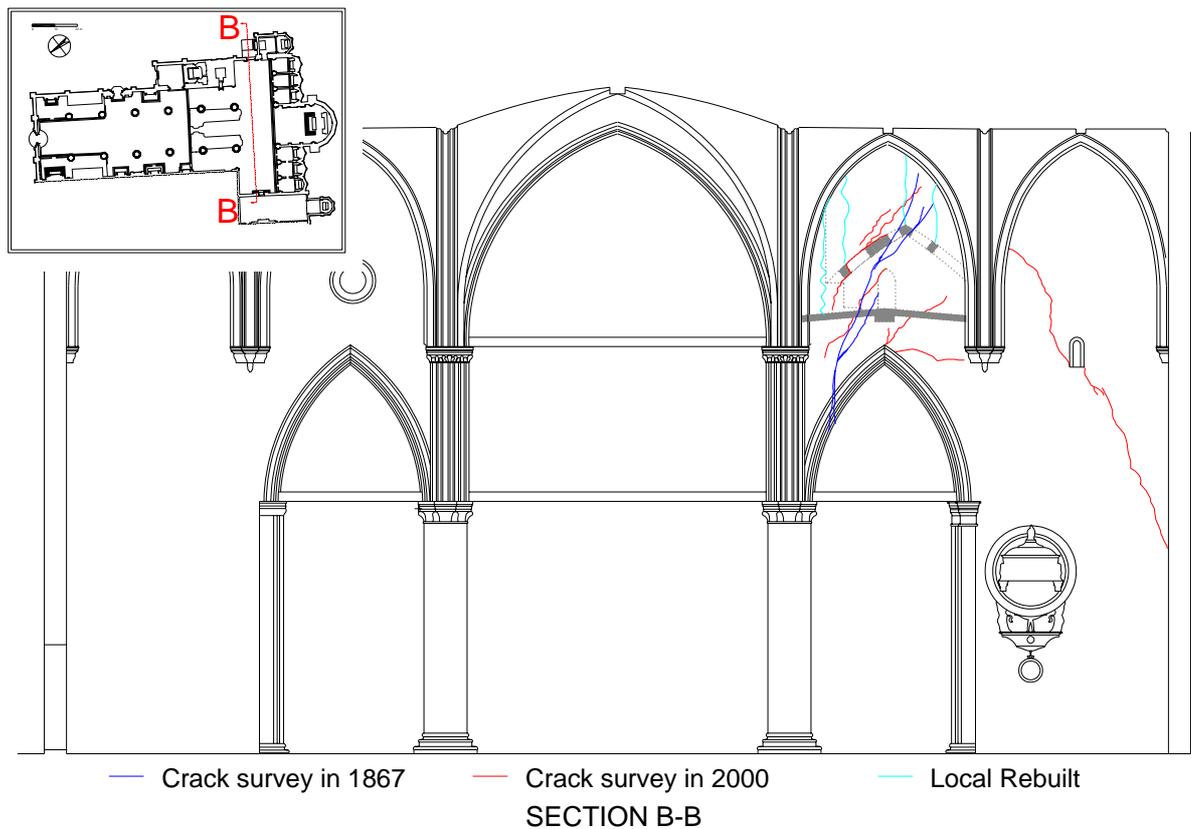
Figure 3-17: Section of the transept

The more concerning situation is that depicted inside the Basilica. Most likely cause of the interventions of the beginning of XX century, the changing in behavior of the structure produced the crack pattern depicted in Figure 3-17.

While during second part of the nineteenth century the crack pattern was due to the differential settlement and the out of plumb towards "outside" of the bell tower, after the intervention of the beginning of the past century the new crack pattern suffered from reversal behavior; while the widen of the foundation towards "Campo dei Frari" seemed to have stop the tilting of the tower, during the following decades, and thanks to the geometrical survey, a reversal of trend had been noticed.

The red 45° crack that arises on the bell tower wall towards the transept (Figure 3-17) is clear evidence of the actual trend.

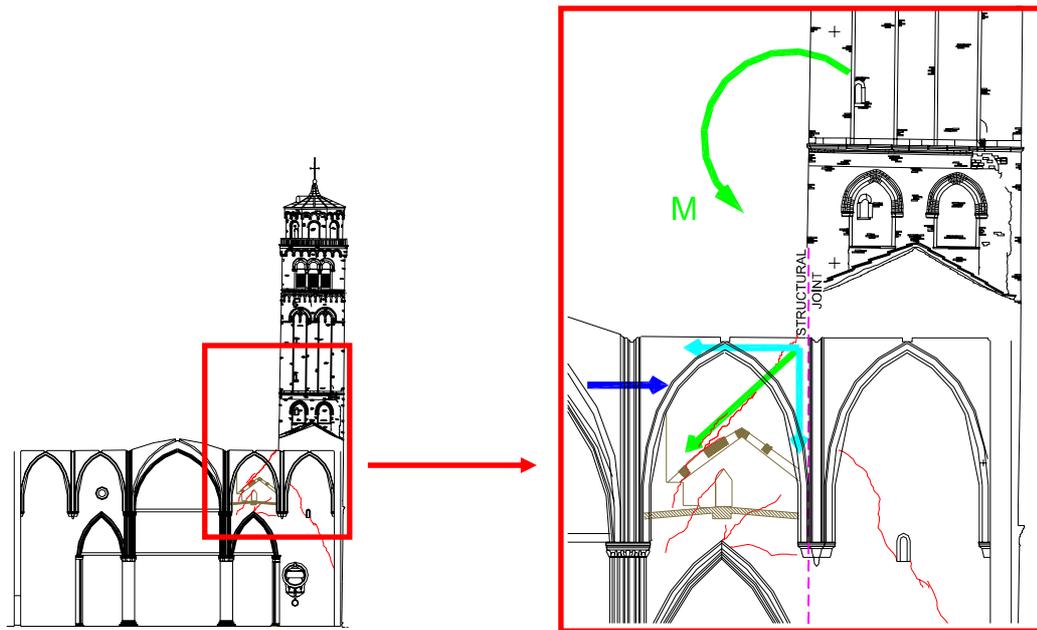
Figure 3-21: Loads exchange pattern

These cracks, which follow the trend of the tensile isostatics in the part of the wall that connects the bell tower to the Basilica, explain the formation of inclined struts (between the main cracks) capable of transmitting relevant components of vertical and horizontal forces from tower to church and vice versa. Even if the amount of forces enrolled in the exchange between the structures is difficult to define (cause of high non linear components) their pattern is undoubtedly clear, as depicted in Figure 3-21.

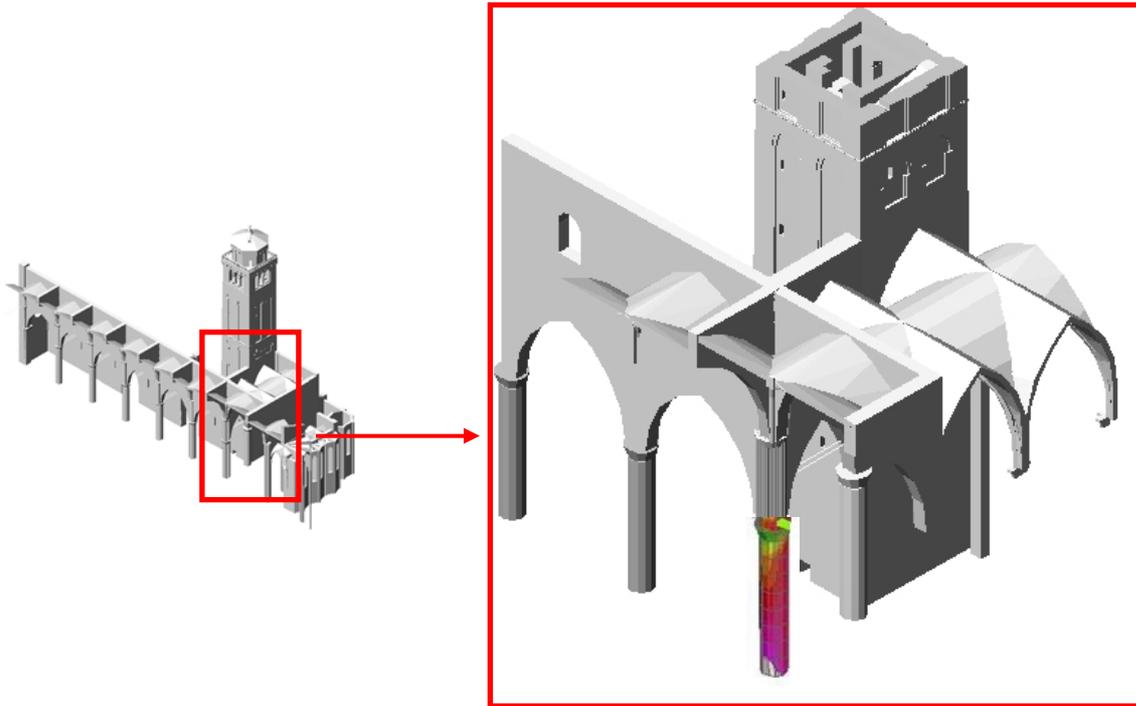
Figure 3-22: Actual behavior of the column

An increase of the compression state of the column and therefore an arising flexural moment on top of it, are the consequence of both eccentric vertical load (increased) and horizontal load. Thus the pillar is highly subject to a strong deformation which is clearly demonstrable with the values of the flat jack test performed on different locations of the pillar. In fact the column is highly compressed at its base towards inside the Basilica (white –Figure 3-22) and a relatively high tensile state in the opposite side of the base cross section (purple). The formation of the cracks induced a redistribution of the stresses among the structure, thus an increase of vertical force in the column induced a reduction of vertical force in the tower. But such exchange of forces had far worse effects in the column than in the tower (due to reasonable matter of cross sectional area).

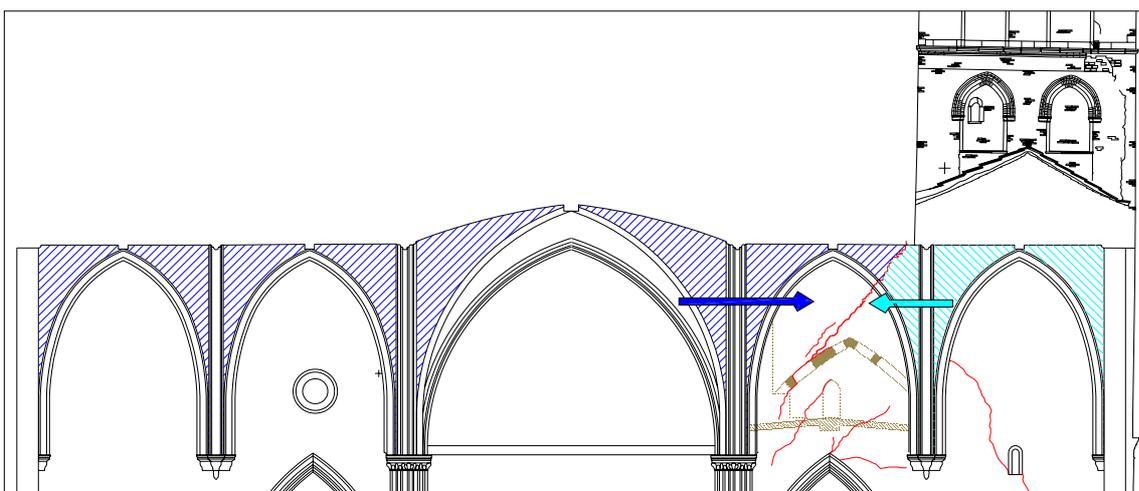
Figure 3-23: Possible explanation of the cracks in the upper part of the transept wall

Moreover the stronger stiffness of the left hand side of the transept wall (blue, Figure 3-23), compared to the remaining part on which the horizontal force of the tower acts (cyan, Figure 3-23), let the weaker part of the masonry wall, already fractured, become even more seriously compressed. This phenomenon induces a state of *bulging*, which is namely a deformation of a wall consisting in a deviation from its original form, which the shape of deviation is roughly a curve, as can be noticed in Figure 3-24.

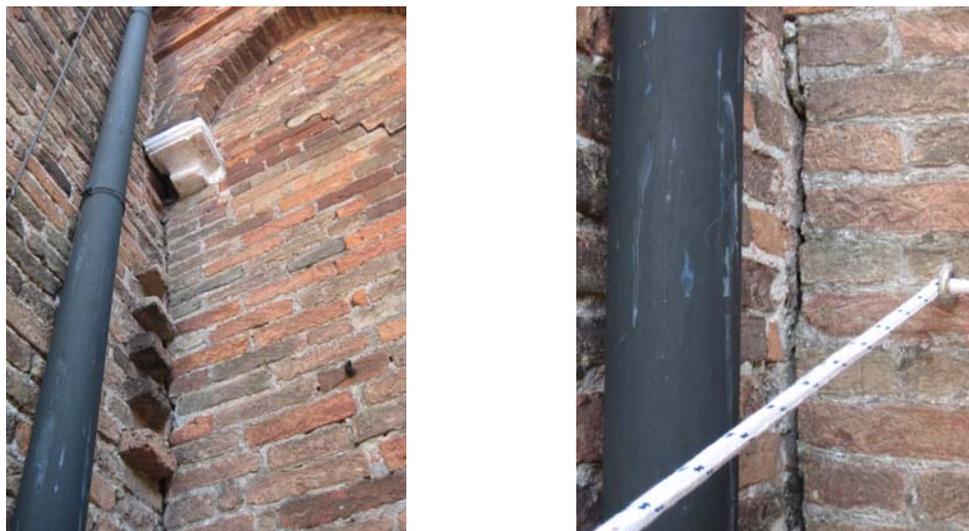
Figure 3-25: Scarf masonry bricks and original structural joint

In the same position again a primitive joint can be noticed between the two structures and the attempt to scarf them together (Figure 3-25). This surely is a late effort as the local rebuilt (on the other side of the wall depicted in the Figure 3-19) does not allow a wooden rule meter to go through the joint but it stops after about 40 cm in confirmation of the subsequent execution of repair works.

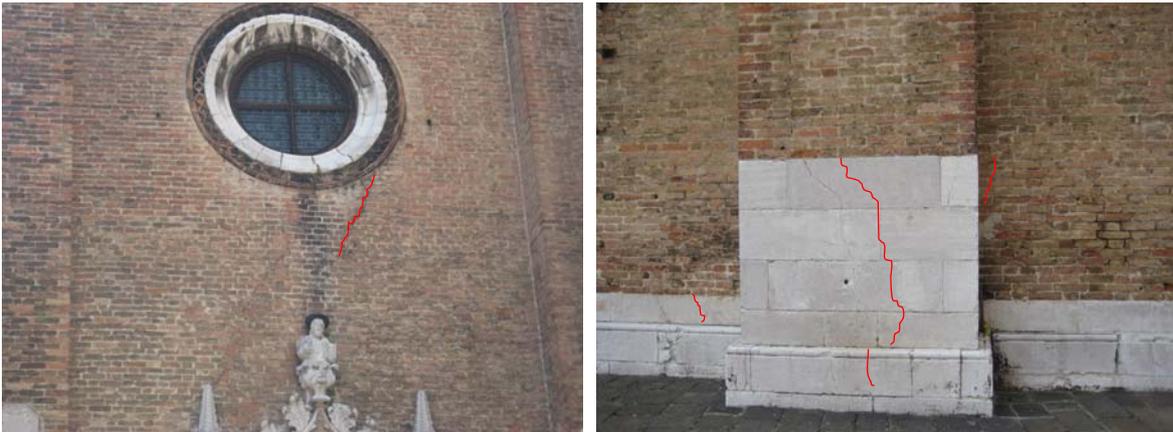
Figure 3-26: Minor cracks on the front façade

As the topographical survey confirmed, the major settlements were concentrated in the localized zone of the tower, St. Peter chapel and the intersection between the tower and the transept. However some other cracks, of minor importance, can also be seen in the main façade, below the main rose window and at the base of some pilaster (Figure 3-26).

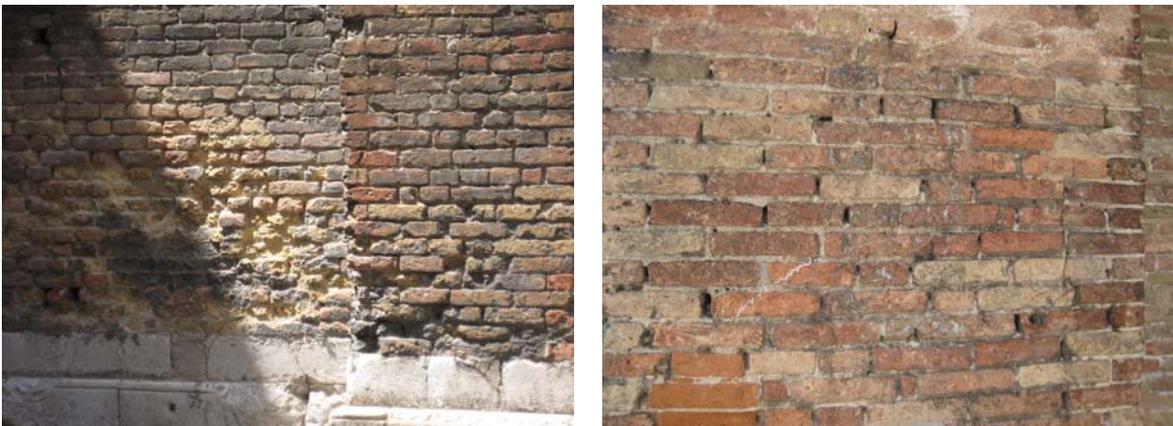
Figure 3-27: Creep associated with chipping and sanding

A more interesting phenomenon that could be noteworthy is the so called *creep* that appears thus causing vertical parallel (sometimes thin) cracks which eventually leads to collapse. In this case, this phenomenon is joined by the occurrence of *chipping* which consists in one or more fragments that tend to separate and be broken from the edge of individual bricks or natural stone blocks (Figure 3-27). A closer look at this kind of trend highlights the chance of an increase in the phenomenon of *sanding* that can be seen in the same Figure 3-27 and occurs when the binder gets less cohesion.

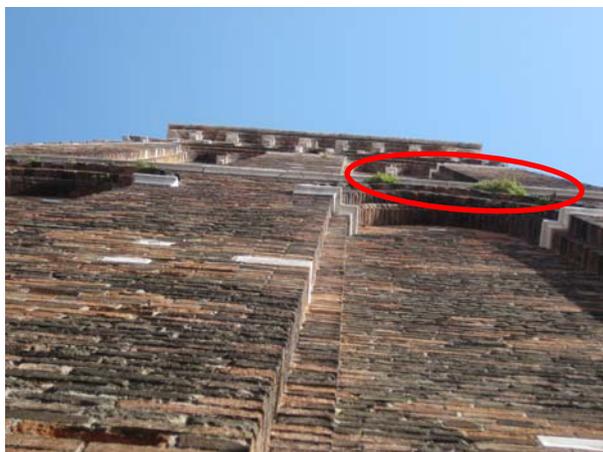
Figure 3-29: Vegetation growth

Due to the high concentration of moisture in the Venice environment, this phenomenon could have been more relevant in the Frari's Basilica. In fact there is no evidence of vegetation growth in the opening joints of the Basilica. The only vegetation spot encountered during the visual inspection is in the North-West wall of the bell tower (the one facing the Basilica) and in a pretty high location thus its removal is difficult. Nevertheless it can hardly be seen from people walking by (Figure 3-29).

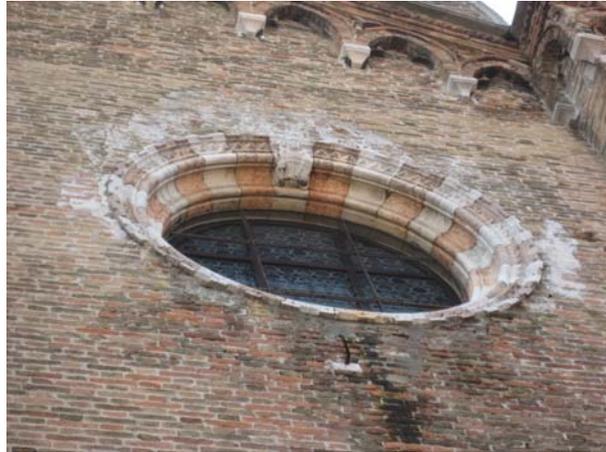
Figure 3-30: Possible chemical reaction

The presence of the excrement of pigeons may have become cause of the deterioration of masonry elements, in that it can affect the composition of the clay bricks and trigger chemical reaction within its components (Figure 3-30).

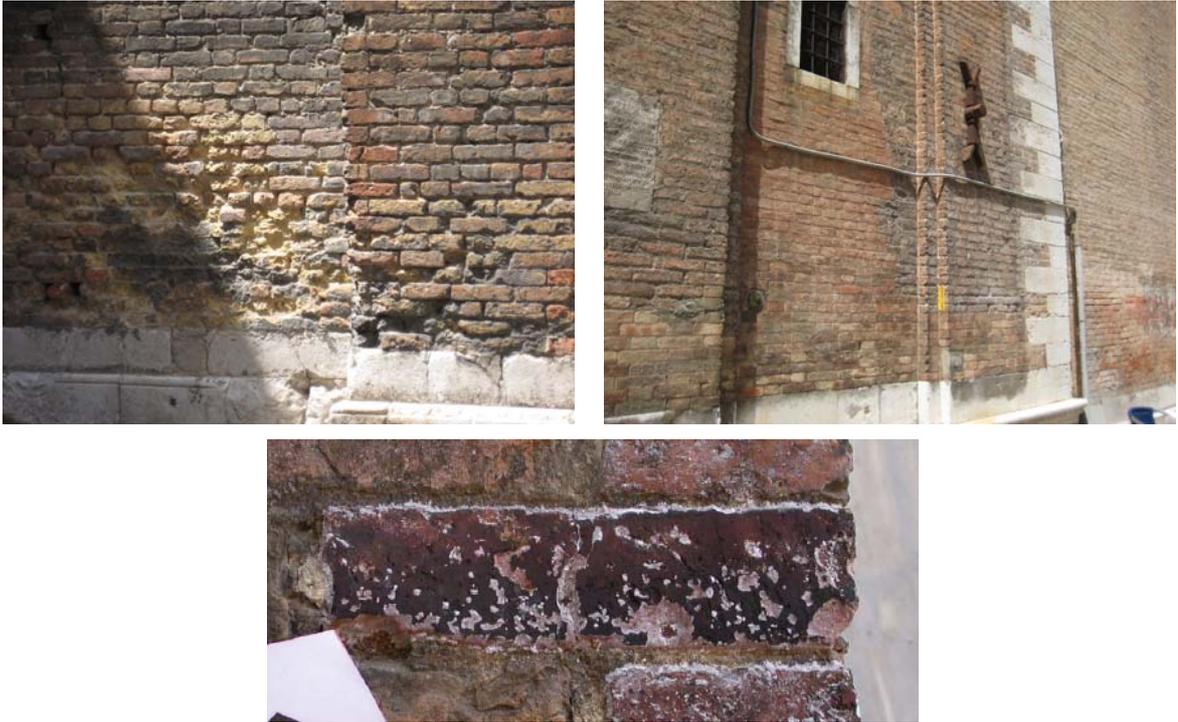
Figure 3-31: Moist spot and salt efflorescence

Rising damp, another dangerous mechanism in Venice, has been wisely avoided by interposing a thick layer of Istrian stone (less permeable) between the soil and the masonry superstructure. However salt crystallization can be noticed in various areas of the external walls of the structure (Figure 3-31).

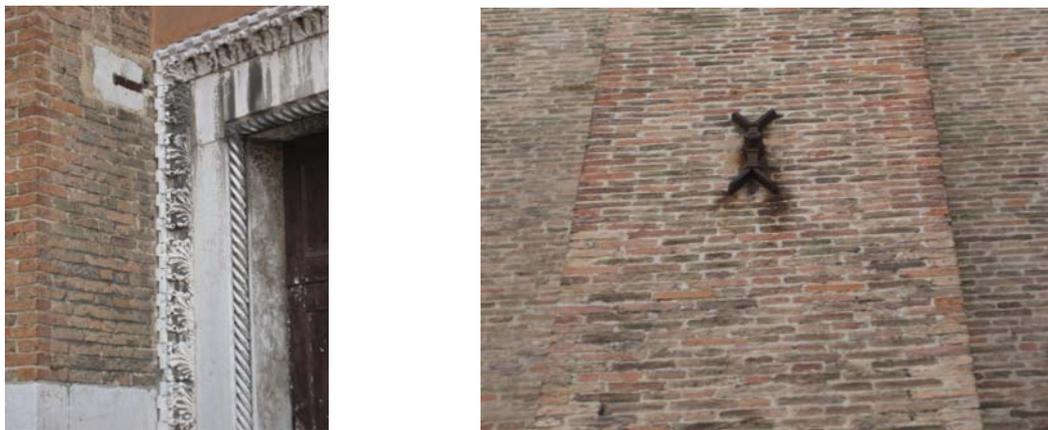
Figure 3-32: Oxidised steel elements

Moisture related problems affect steel elements as well. A certain amount of steel pieces can be observed all around the structure and all of them, as a result of the aggressive environment, present a dangerous state of oxidation (rusty brown colour). As known, oxidised metal can increase their volume up to 7 times the original and induce unexpected stress in the masonry around (Figure 3-32).

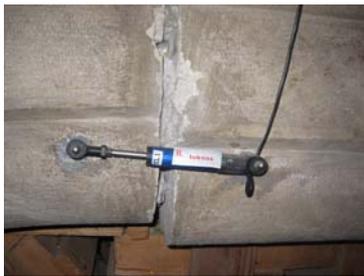
Figure 4-19: Gauge EL1

Gauge EL1 (Figure 4-19) recorded a rapid increase of the opening of the crack of about 0.4 mm from November 2004 to mid February 2005 (Figure 4-20, yellow) with deformation speed of approximately 1.17 mm per month.
