ADVANCED MASTERS IN STRUCTURAL ANALYSIS
OF MONUMENTS AND HISTORICAL CONSTRUCTIONS

Master's Thesis

THE GUARDIAN OF THE
PONTIFICAL STATE -
Structural Assessment of a
Damaged Coastal
Watchtower in South Lazio.

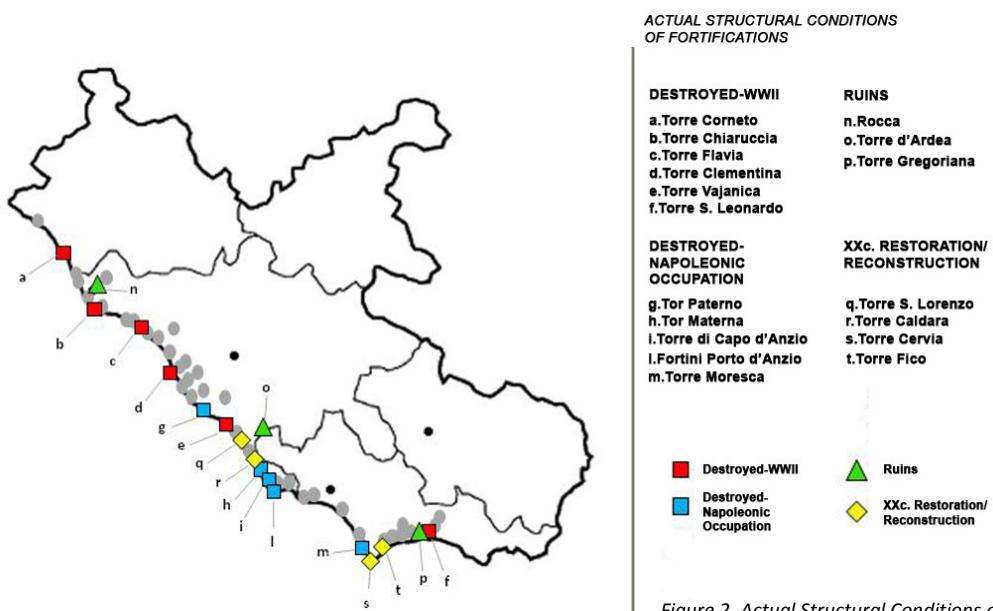
Figure 2. Actual Structural Conditions of Fortifications

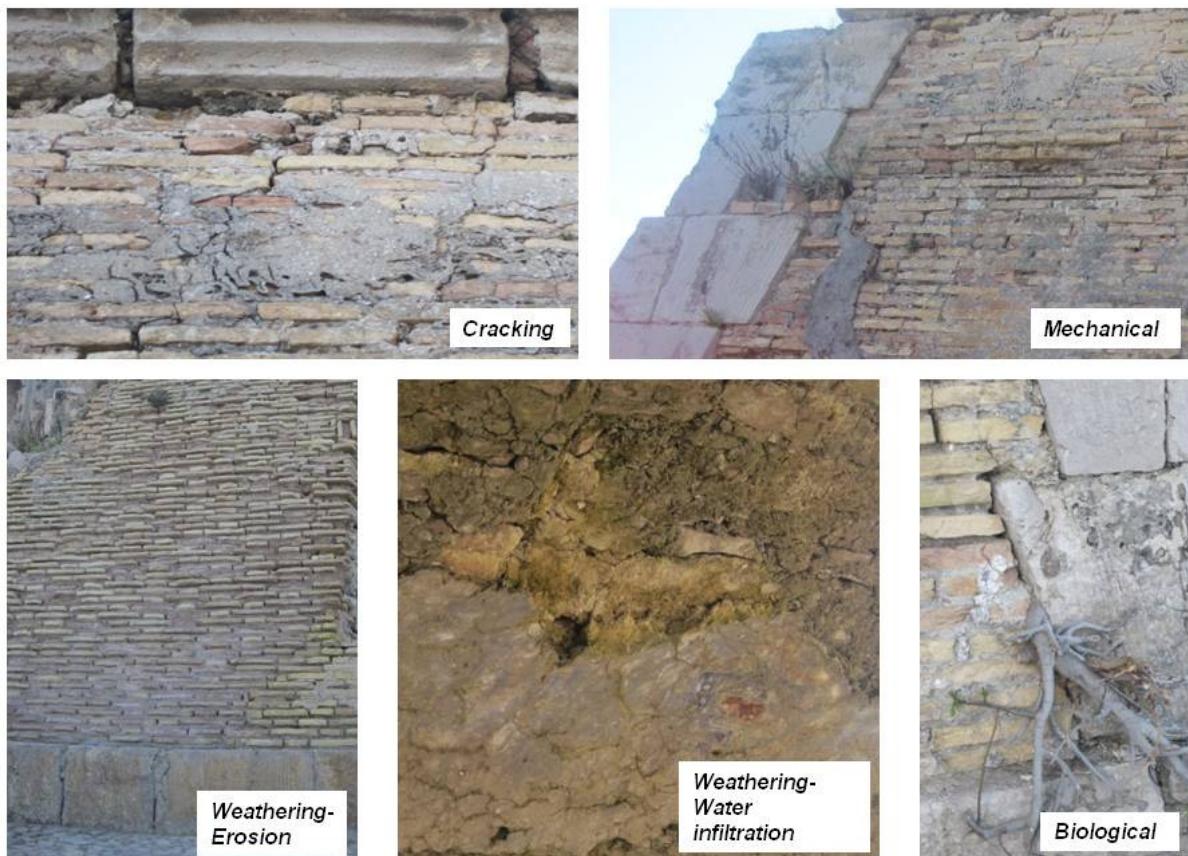
The actual conditions of Torre Gregoriana are affected by a prolonged period of abandonment and negligence following the WWII. The visual inspection carried out concentrates on the different types of damage that, interacting between each other, result in a rapid decay of the structural fabric. The survey points out the magnitude of such decay, providing a classification of adverse actions which might result threatening to the structural stability and material integrity of the watchtower. The typologies of damage include cracking, mechanical decay, weathering and biological attack(*Figure 20*).

Figure 20. Damage Typologies

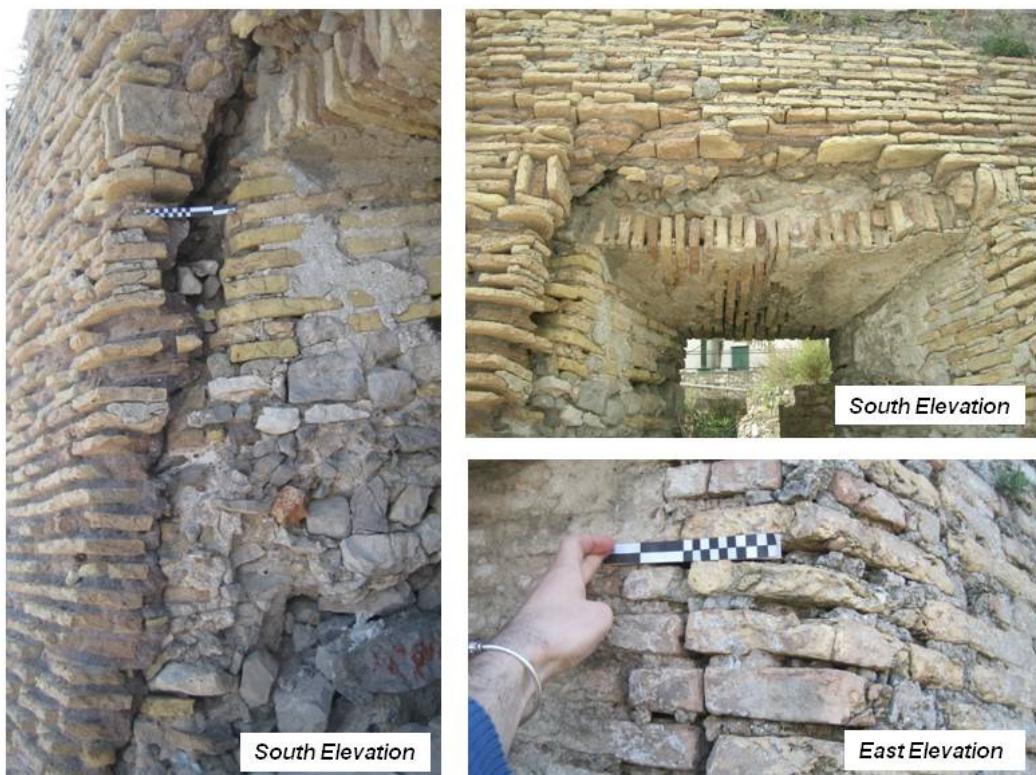
Another threatening damage which has not been discussed so far regards the detachment of the external leaf of the tower walls (*Figure 21*).

Figure 21. External Leaf Detachment
