ADVANCED MASTERS IN STRUCTURAL ANALYSIS
OF MONUMENTS AND HISTORICAL CONSTRUCTIONS

Master's Thesis

Moisture Problems in Irish
Tower Houses: Application to
Barryscourt Castle

Portugal | 2011

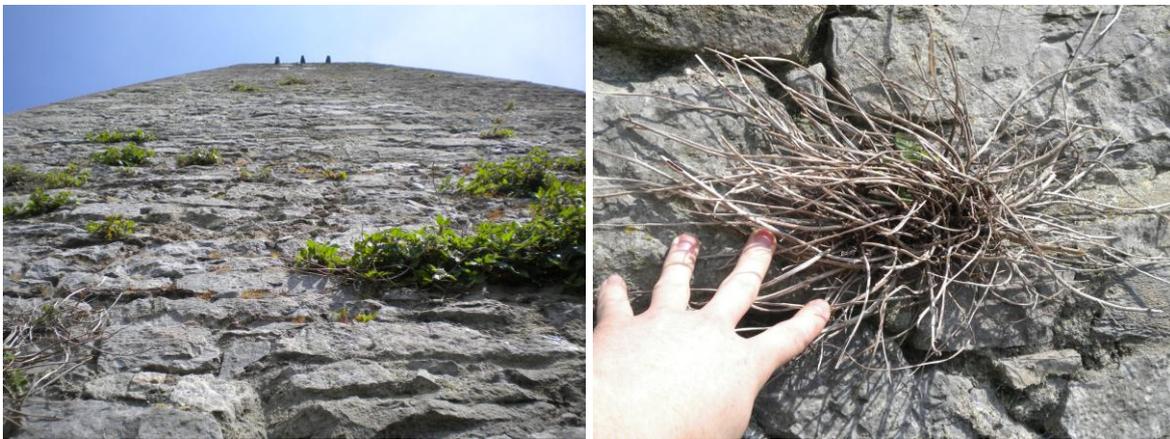
Externally, overall the building appears to be in very good condition indeed, wholly intact with no collapsed sections, ruptured masonry and unharmed ramparts. However, upon closer inspection, the building has minor problems such as continued pockets of lodged vegetation which is rooting in cracks in the joint mortar and between the mortar itself and the surrounding stones. These plants are causing clumps of mortar to detach from the joints and when these plants are removed they leave gaping holes to allow more water to be driven further into the masonry (Figure 23).

Figure 23: (a) Vegetation on external castle wall (b) Associated mortar deterioration

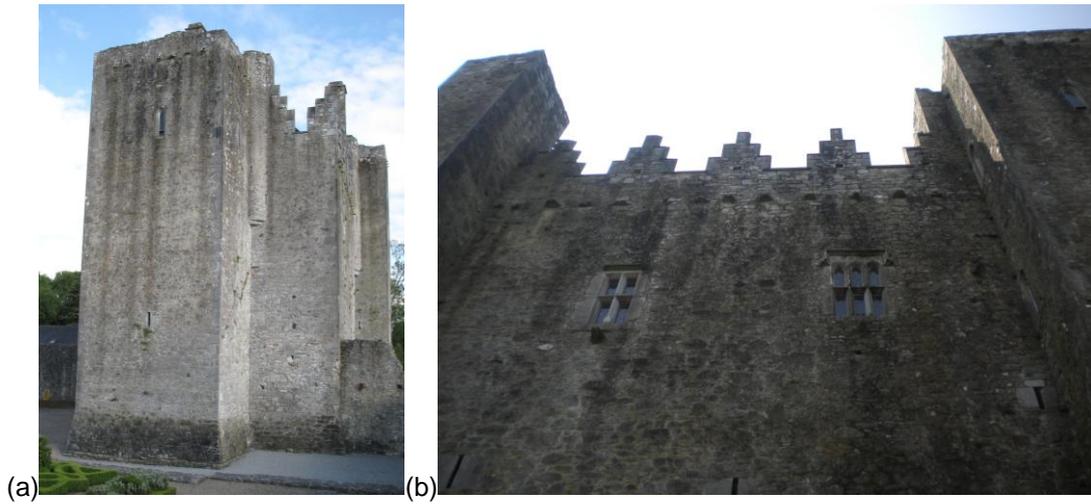
The overhanging dripstones which act as overflow spouts for the rooftop rainwater seem to be working for their original intended purpose however noticeable staining occurs down the castle façade from the trailing drained water. This staining is quite prominent on all facades below the dripstones but also on the batter section of the wall (Figure 24). This black staining seems to be due to mould and lichen formation, named the lichen *Placynthium nigrum* (Seawright, 2009). This lichen is widespread throughout Ireland, developing on slow-drying calcareous rocks and old mortar such as found at Barryscourt. Similarly, some patches of white lichens can be found near the black lichens, and seem to be of the *Verrucariaceae* lichen species, perhaps, *Verrucaria hochstetteri*. This lichen also commonly occurs on Irish limestone throughout the country and can cause damage such as pock marks if left for long periods of time.

Figure 24: Black staining under dripstones and on batter – (a) North face (b) East face

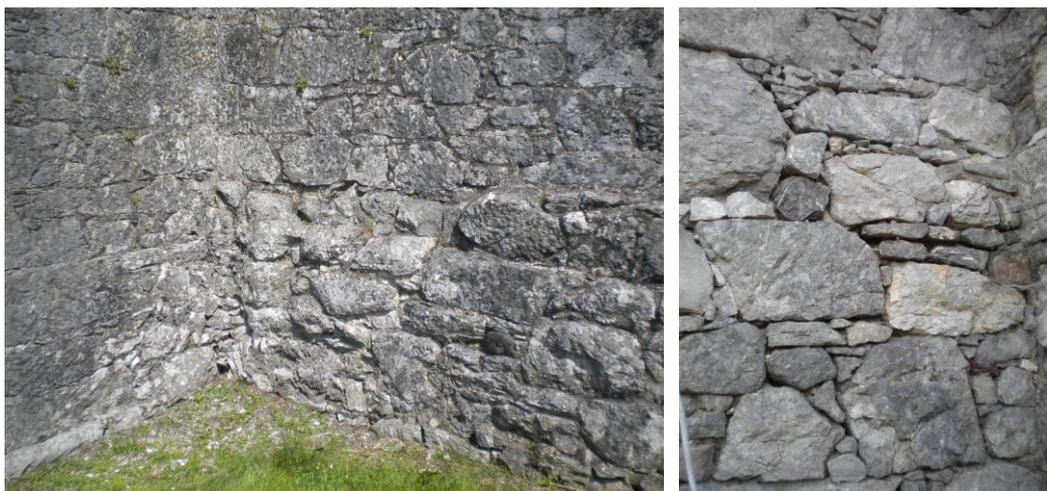
The mortar loss situation is not associated solely where vegetation has gained hold but also occurs on the lower section of the wall; especially on the batter (the widened base section of the defensive external wall – widened for stability and to deter undermining and also to deflect objects dropped from the ramparts onto attackers). Significant sections of the mortar have fallen away from between the stones, leaving large openings vulnerable to moisture and plant life. The most affected region is on the western batter wall which also receives the majority of wind and rain due to the prevailing wind direction being from this side (see Figure 11). It was quite sandy to the touch and detached in pieces when rubbed with ones fingers indicating the poor binding strength of the mortar itself. The more exposed the joint had been made to the elements from exfoliation and spalling, the worse the mortar condition (Figure 25).

Figure 25: Stone and mortar deterioration on lower sections of wall (batter) - West façade

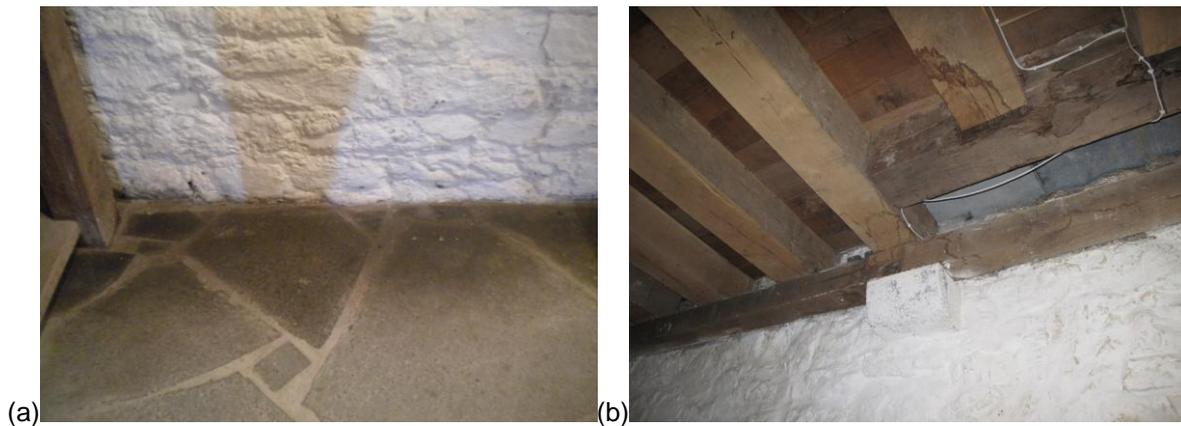
Figure 26: (a) Ground floor dampness and staining on flagstones; (b) Overhead timber flooring

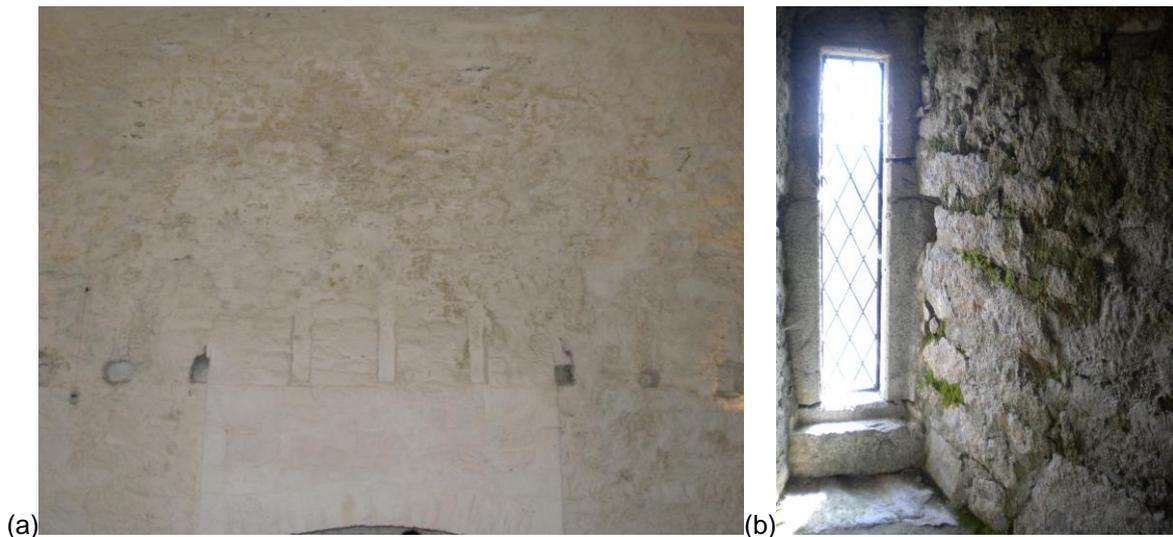
Figure 27: (a) Extensive cream/yellow staining near the chimney in the first floor; (b) Poor mortar condition/biological activity in the first floor room of the southeast turret

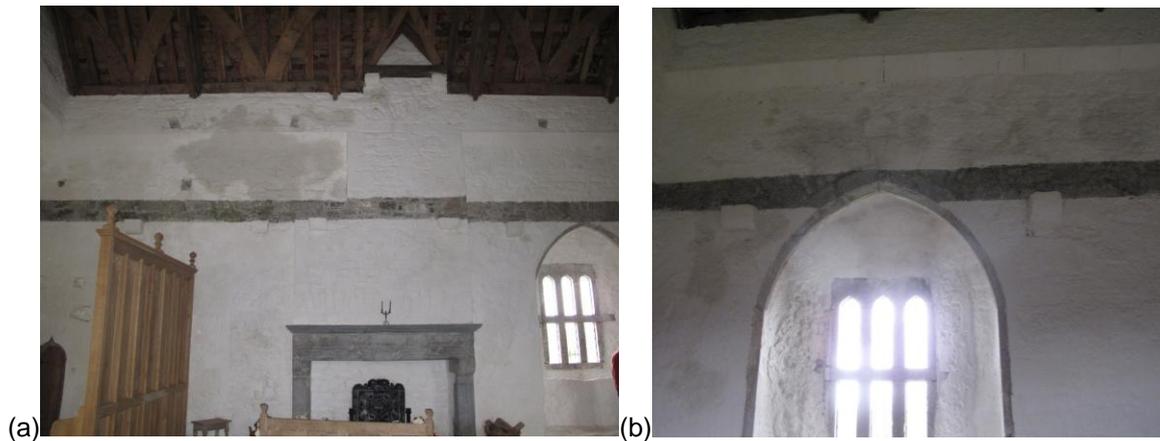
Figure 28: Moisture staining on Great Chamber walls – (a) West wall (b) East wall

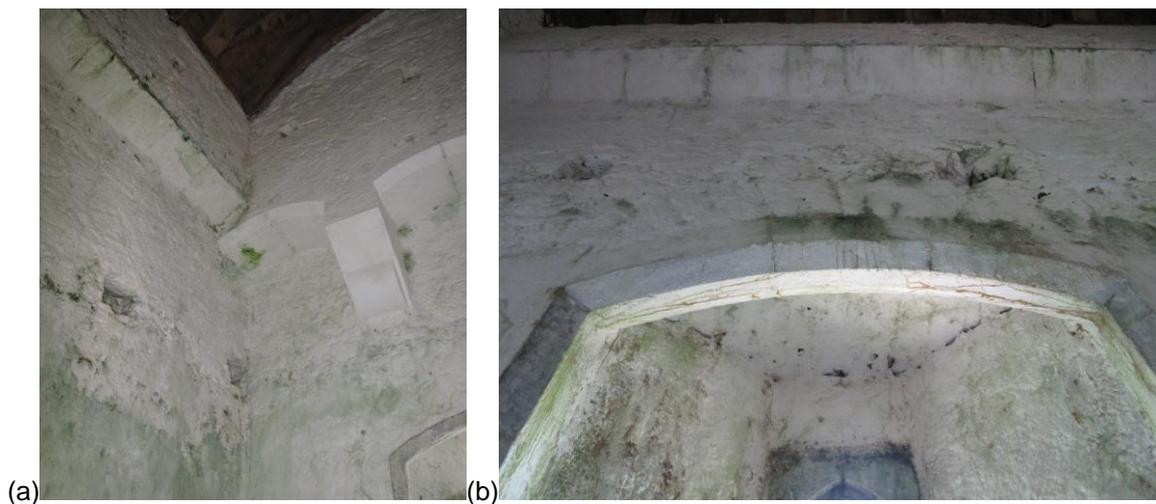
Figure 30: Thriving biological activity in the Master Bedchamber on all walls and window surroundings

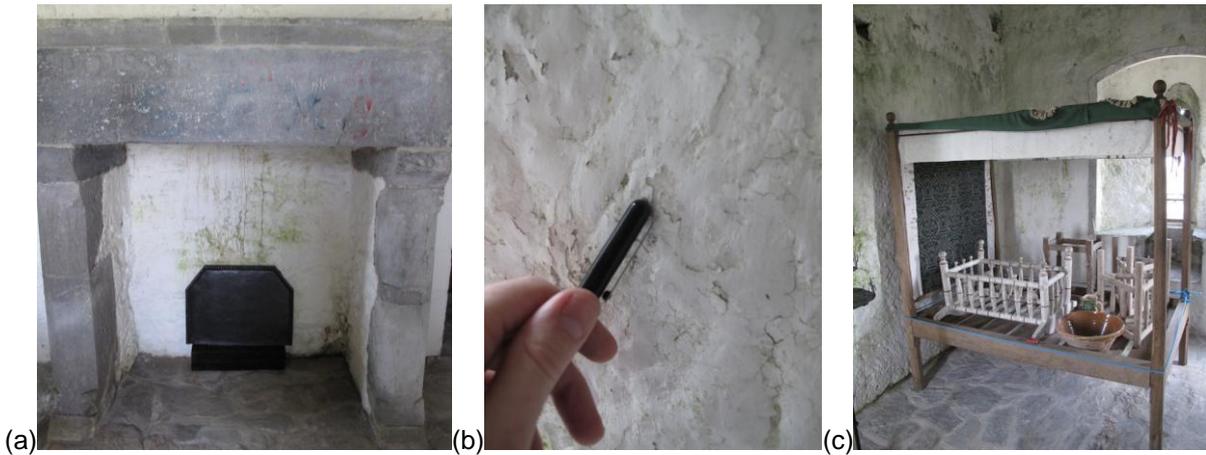
Figure 31: (a) Moisture staining from interior of bedroom chimney; (b) Surface exfoliation and (c) Textile removal due to damaging environment

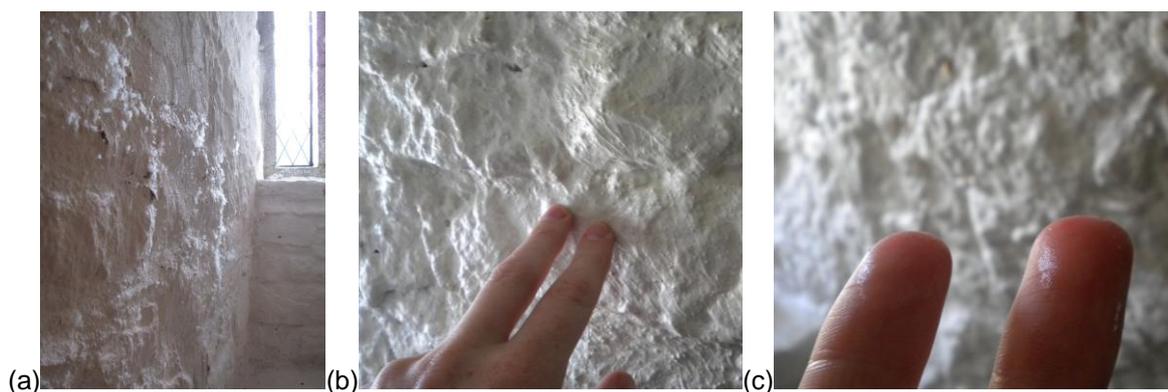
Figure 33: (a) Salt crystals appearing as white “fur” which were clearly visible upon the secondary site inspection whereas (b) & (c) Photos during primary site inspection of identical window with condensation on walls

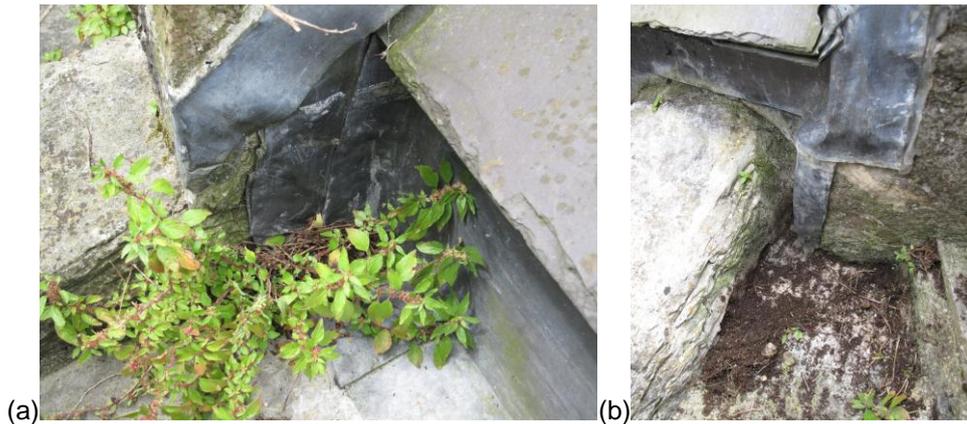
Figure 43: (a) Vegetation rooted in corners; (b) Mortar damage and openings due to vegetation growth

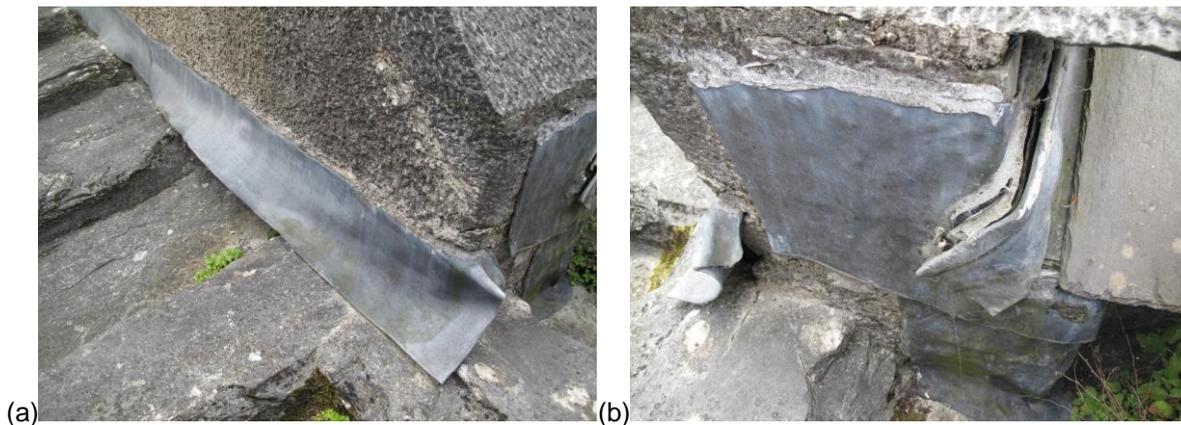
Figure 44: (a) Lead runoff "curtain" at gable ends; (b) Inadequate flashing seals with large openings

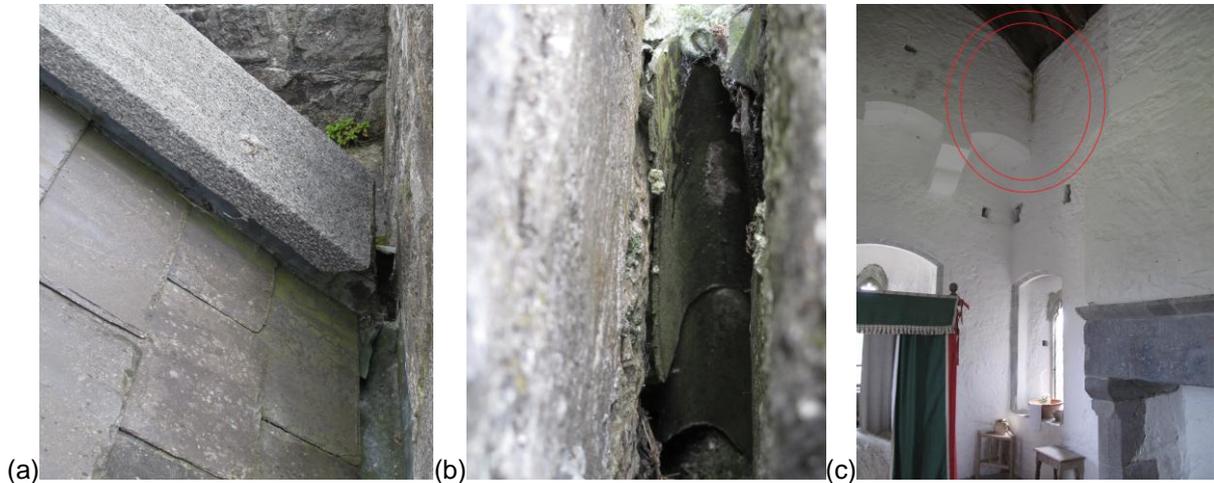
bedchamber, at the south-eastern corner which exhibited staining and moisture from the thermography analysis.

Figure 45: (a) South-eastern corner of north-eastern tower; (b) Hole in covering; (c) The corresponding infiltration in the bedchamber

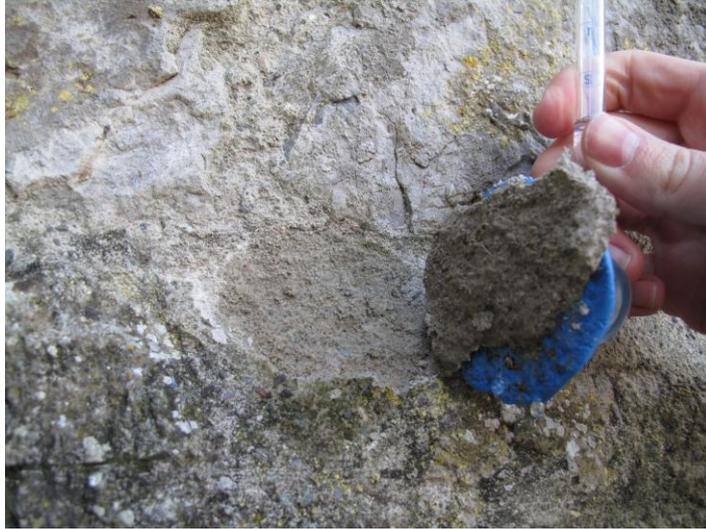
Figure 50: Easy detachment due to poor mortar quality

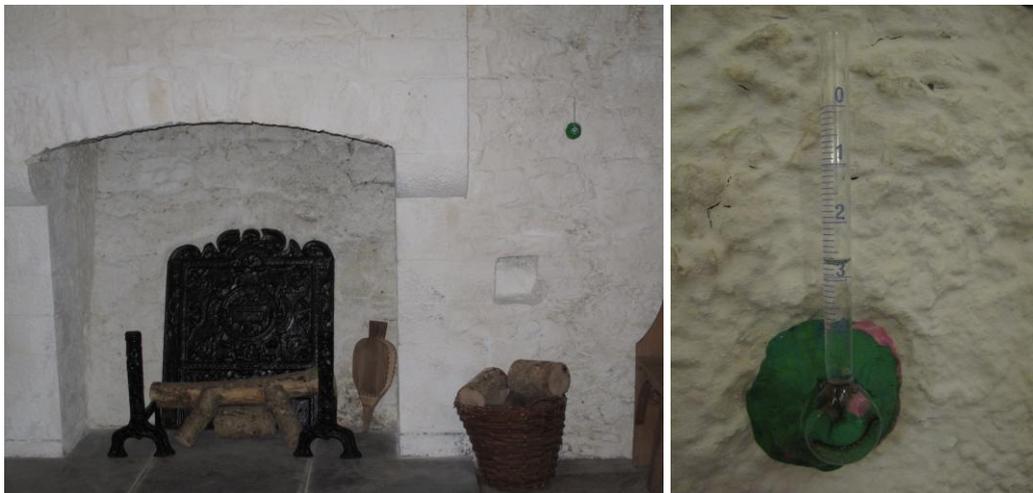
Figure 51: RILEM testing next to fireplace on first floor hall & water being absorbed into surrounding material (limewashed mortar)

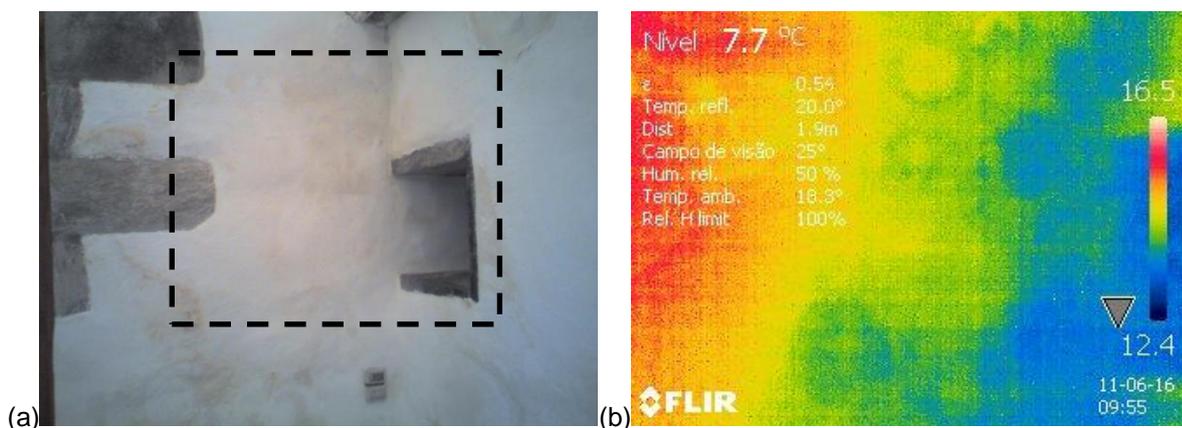
Figure 56: Extensive presence of moisture in the ground floor room

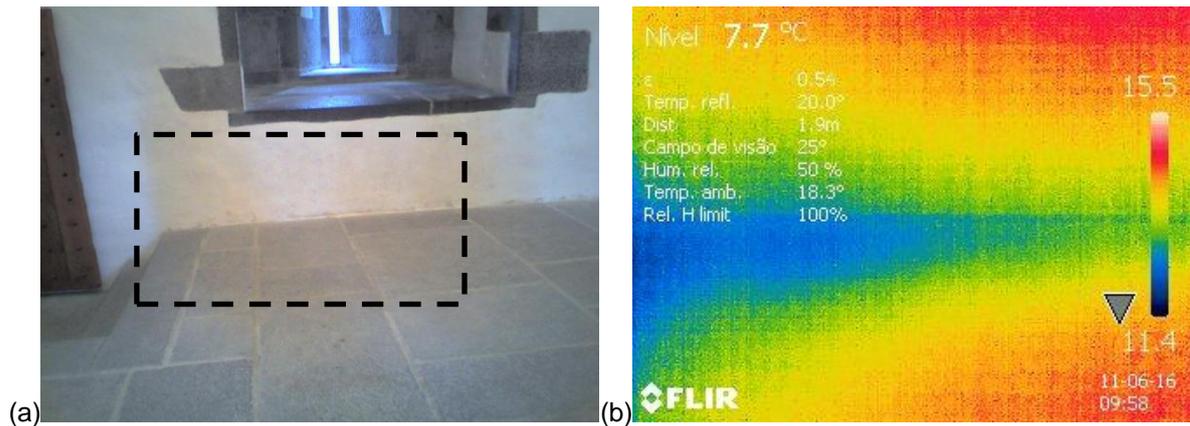
Figure 57: Significant moisture around the floor edges of the ground floor

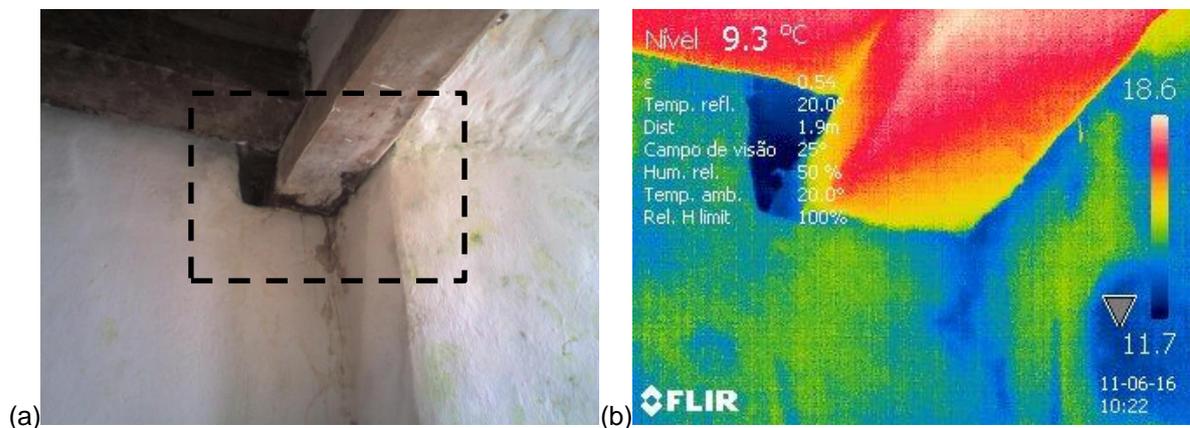
Figure 58: Moisture surrounding timber structural supports with serious dampness in the wall pocket

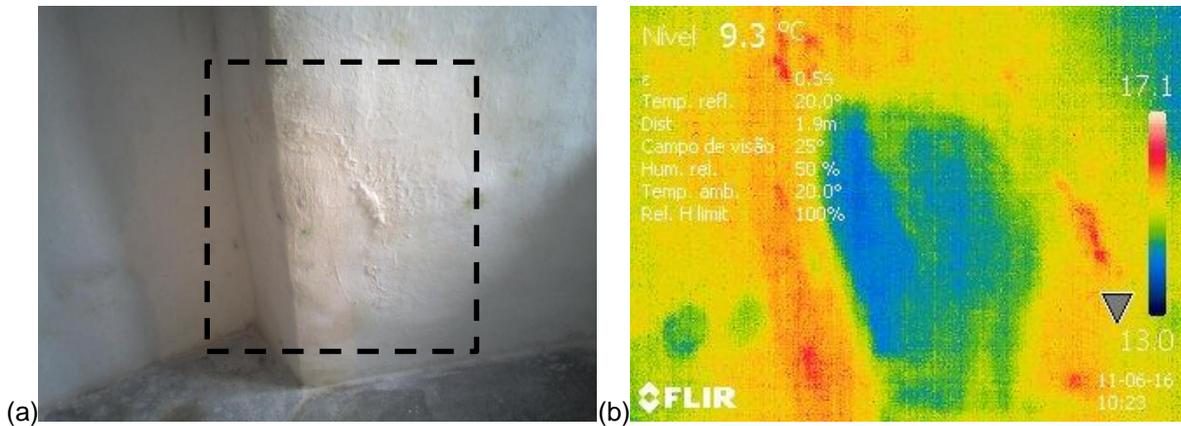
Figure 59: Thermography image of wall region with salt presence

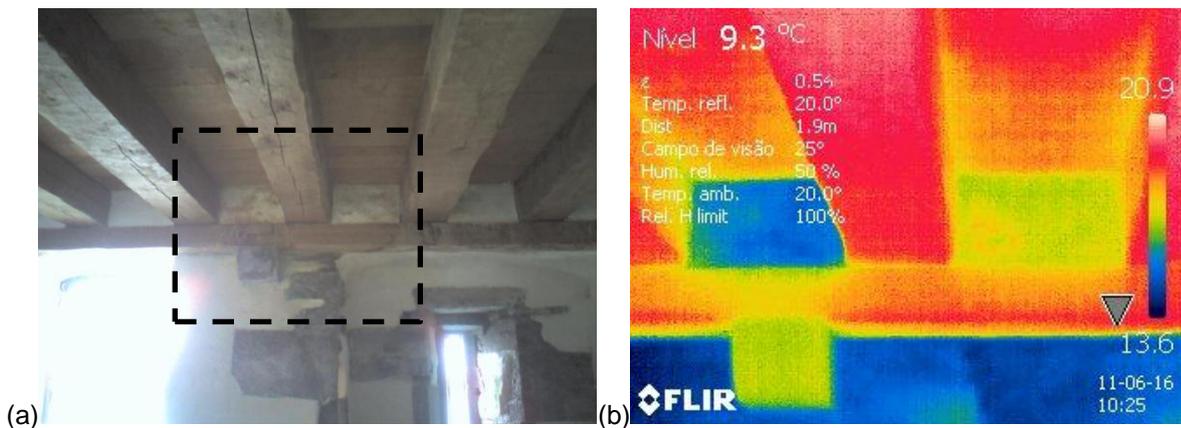
Figure 60: Further moisture around timber supports, especially near windows

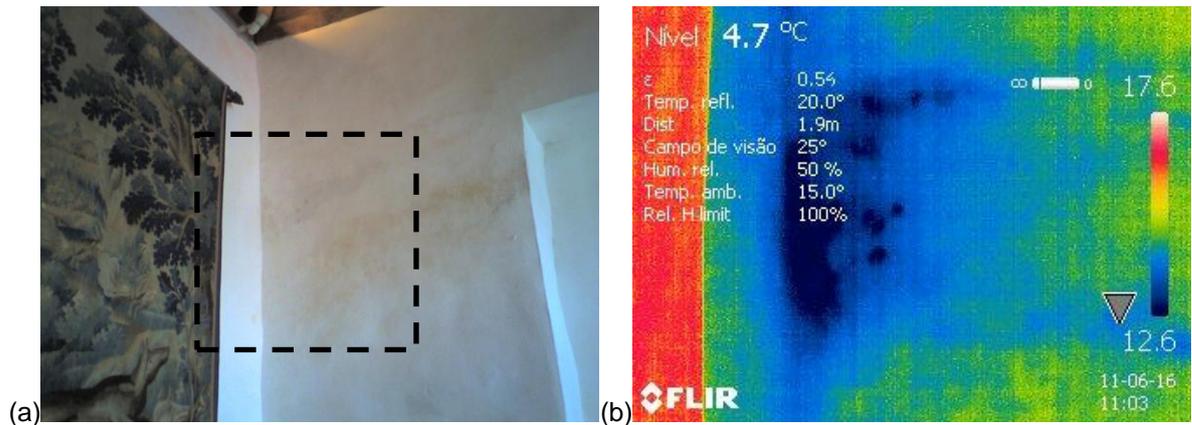
Figure 61: Moisture detectable especially at room edges

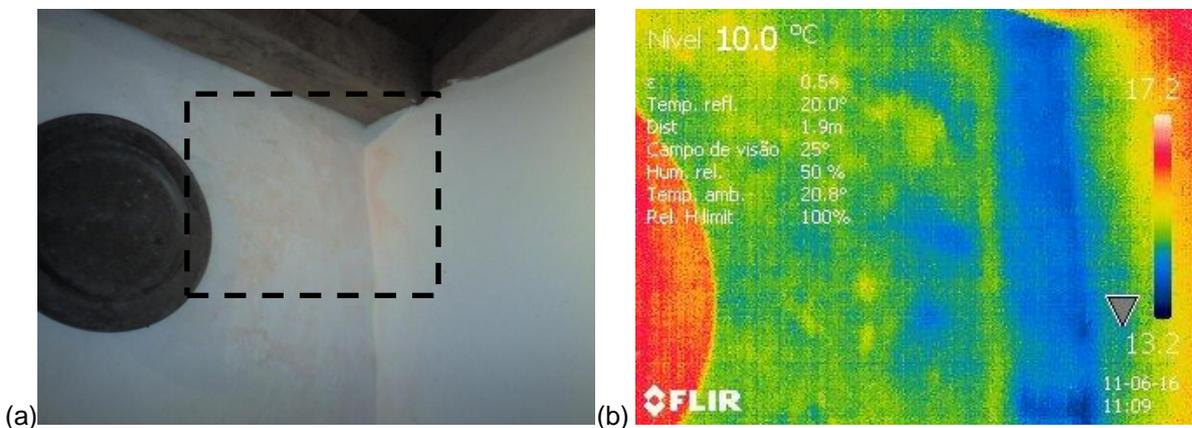
Figure 62: Further moisture at corners & wall joints from top to bottom

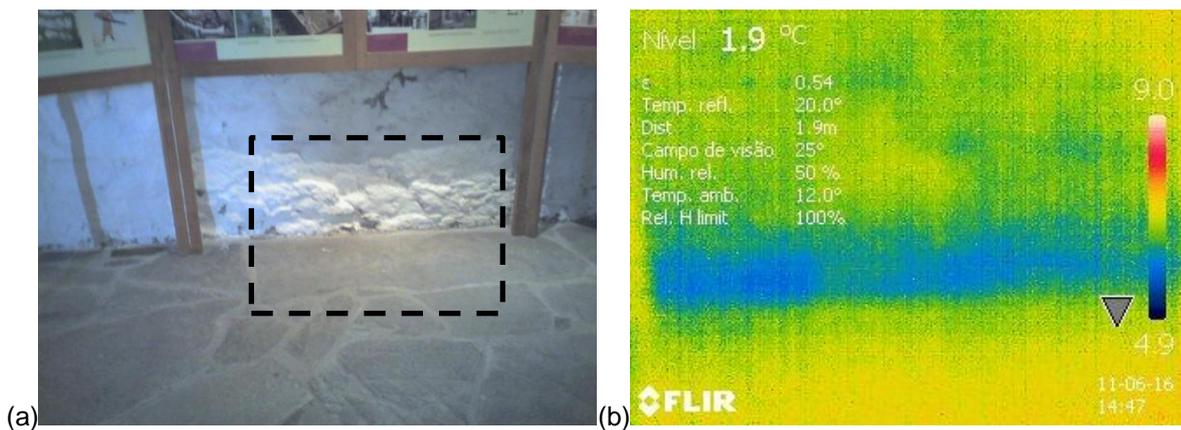
Figure 63: Moisture detected at edges of ground floor

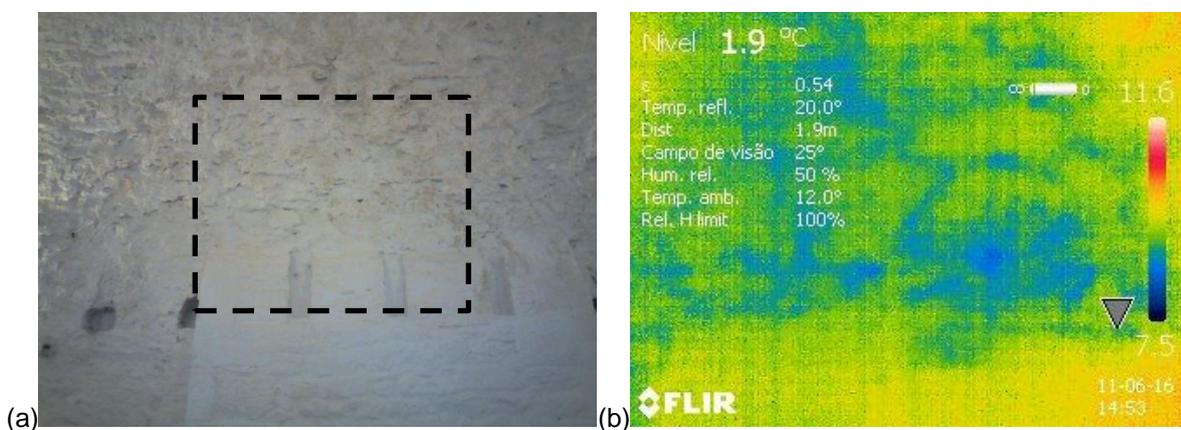
Figure 64: Staining near first floor chimney shown to have moisture presence

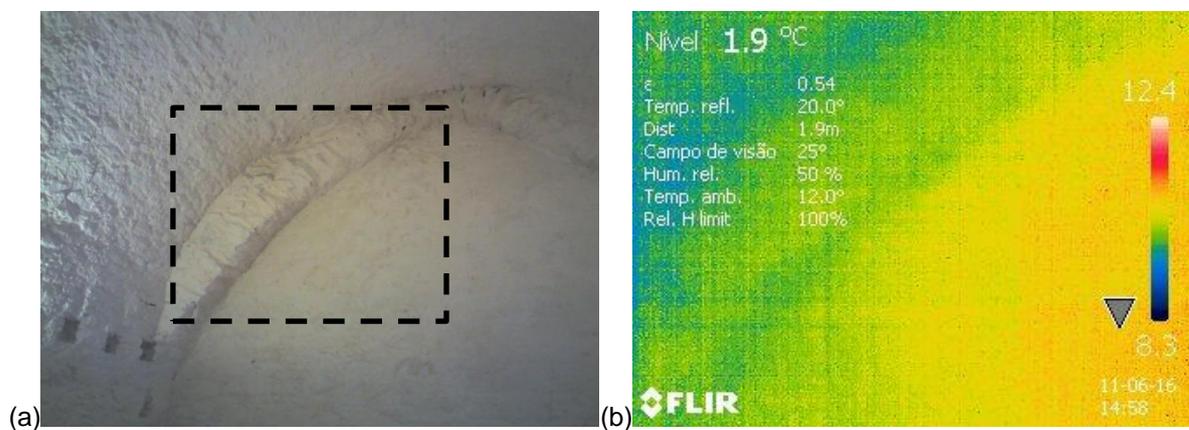
Figure 65: Moisture on first floor where barrel arched ceiling meets gable walls

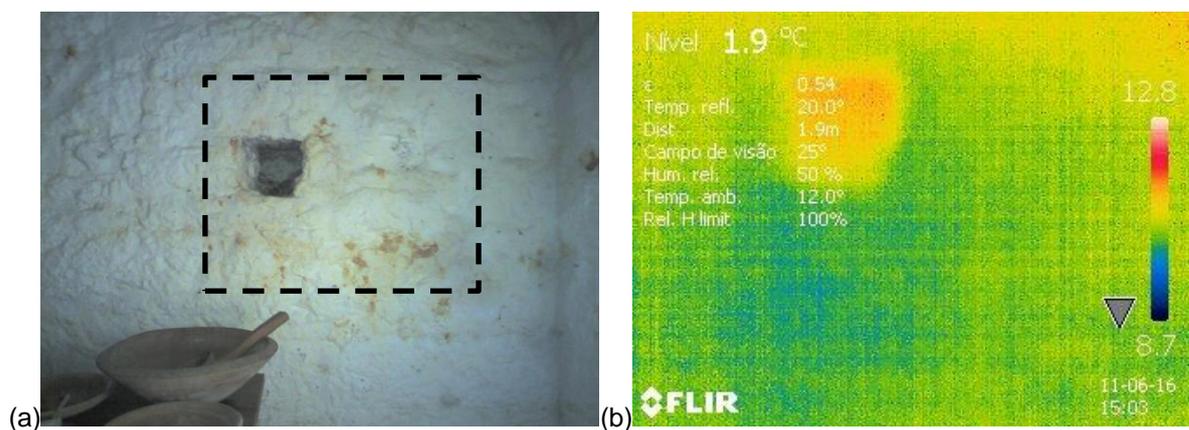
Figure 66: Slight moisture detected in walls of kitchen with wall socket showing up warmer due to thinner wall in this region

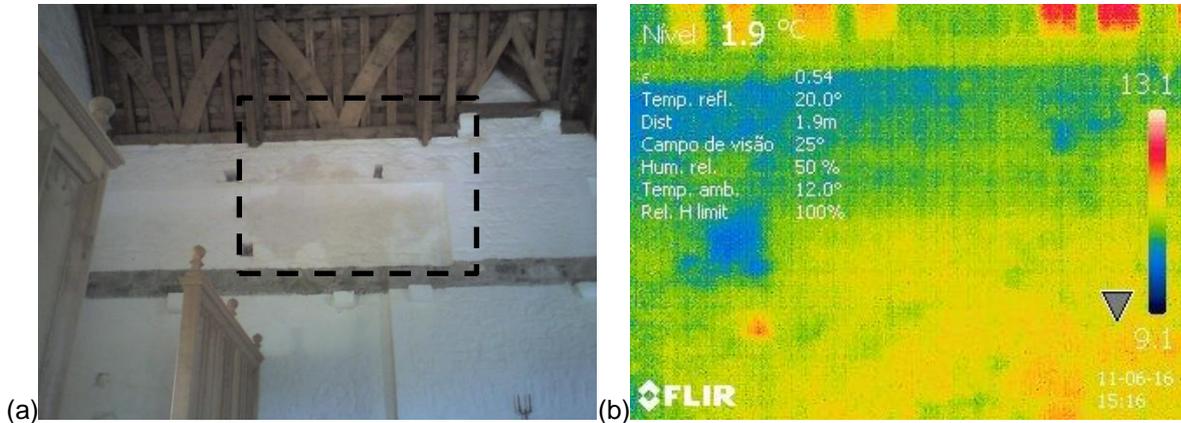
Figure 67: Moisture behind staining on west wall of the Great Chamber

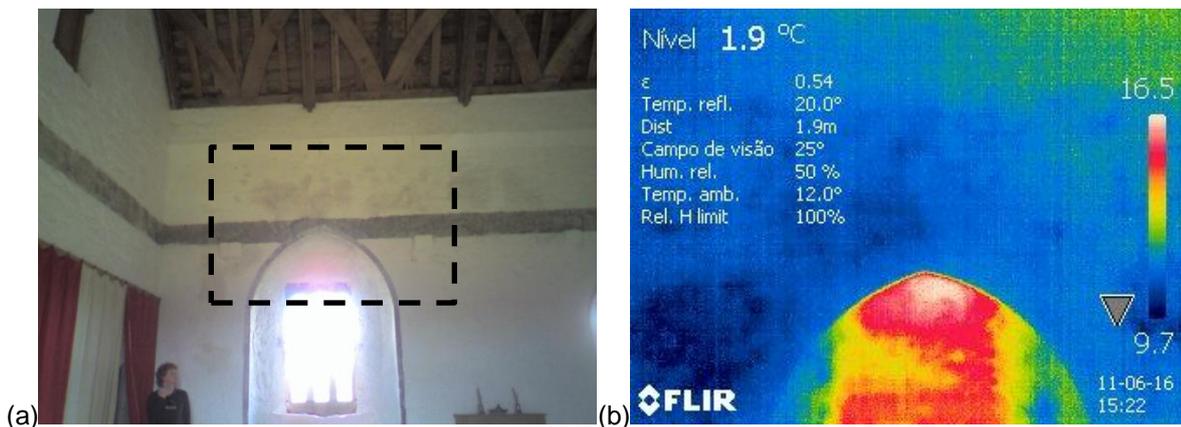
Figure 68: Moisture behind staining above northern window on east wall of Great Chamber

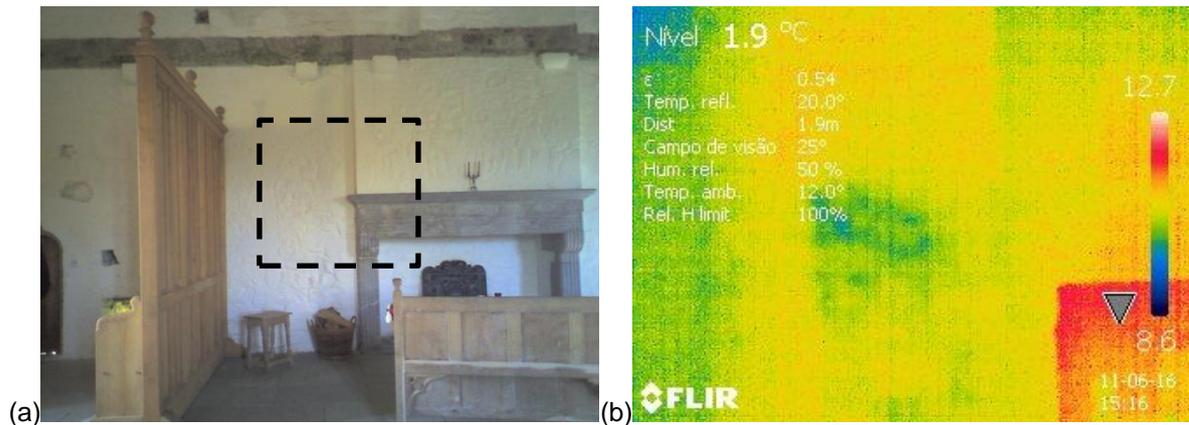
Figure 69: Thermography image showed pocket of differential temperature on south side of the main fireplace in the Great Chamber

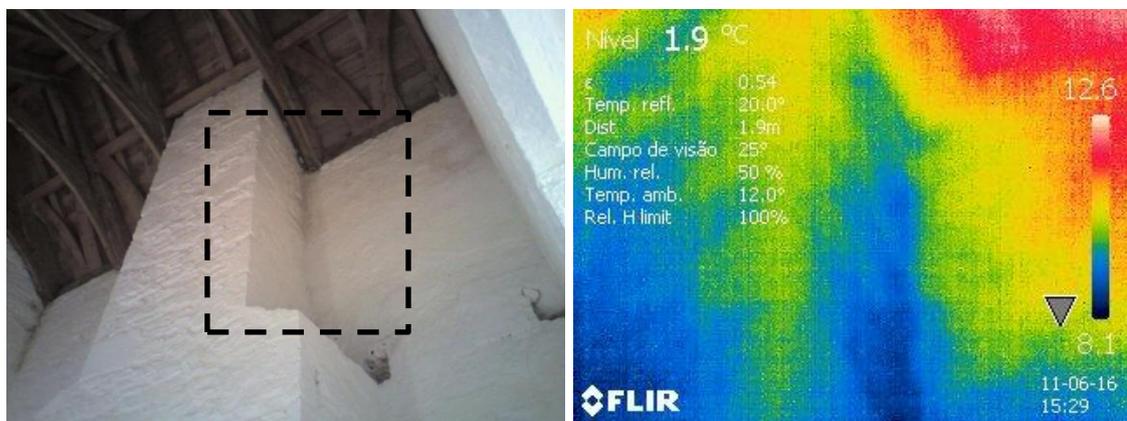
Figure 70: Moisture detected by thermography testing surrounding western corners where chimney meets the walls in Master Bedchamber

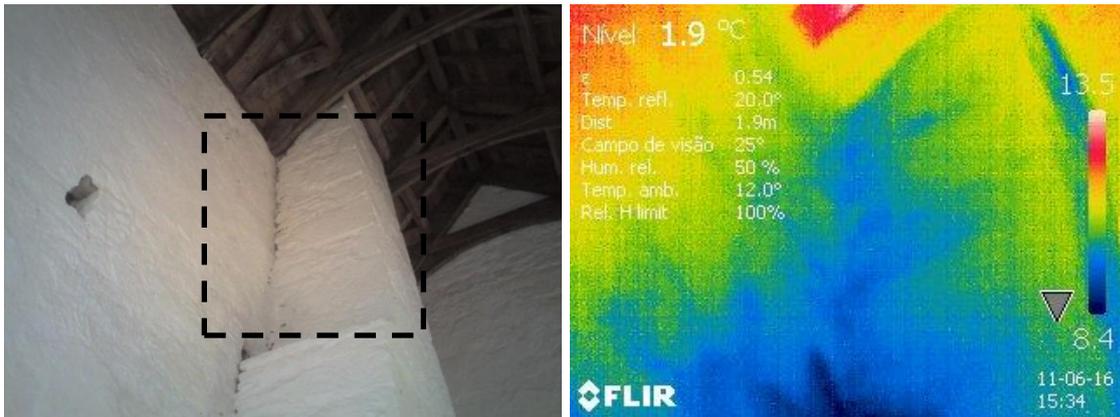
Figure 71: Moisture detected on east side of chimney

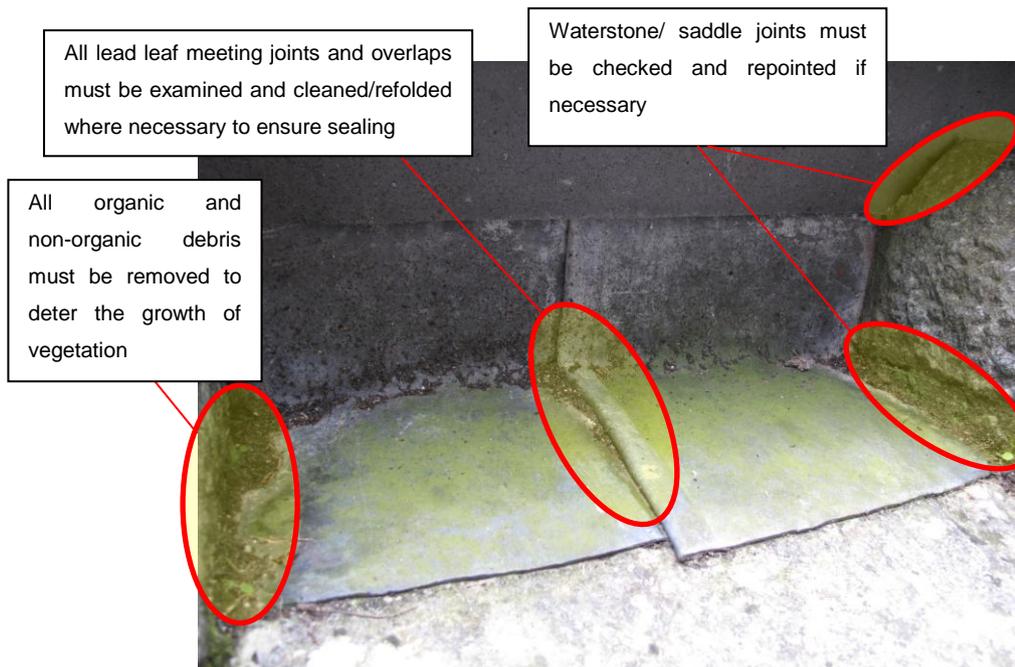
Figure 80: Lead flashing and open mortar joints which require attention

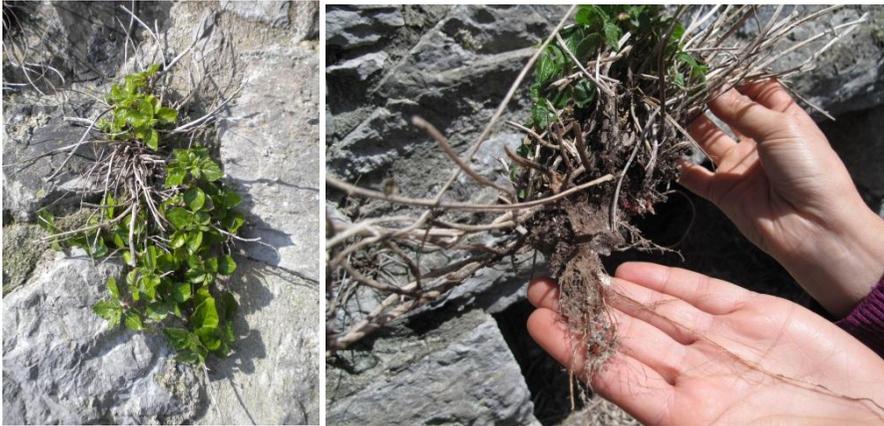
Barryscourt Tower House - Exterior		BIO_02
DAMAGE	Biological activity; Vegetation growth	Grading: Severe
LOCATION	Wall walks and roof sections where waterstones and saddles are situated. Gutters and downpipes also affected	
CAUSES	Ideal conditions for vegetation growth where water is remaining stationary on the roof surfaces. Small cracks in sealing mortar already present provide shelter and moisture encouraging mosses, fungi and more concerning plants, which in turn are rooting and allowing extra moisture in to underlying walls. Ample shelter and moisture under eaves and earthen debris ideal for growth. No maintenance of wall walk regions is in place.	
MAIN MECHANISM	Small size plants and mosses thrive in the cracks between stone and mortar. This growth causes further damage as roots weave into mortar and stone cracks expanding and forcing cracks to widen, allowing moisture into underlying walls

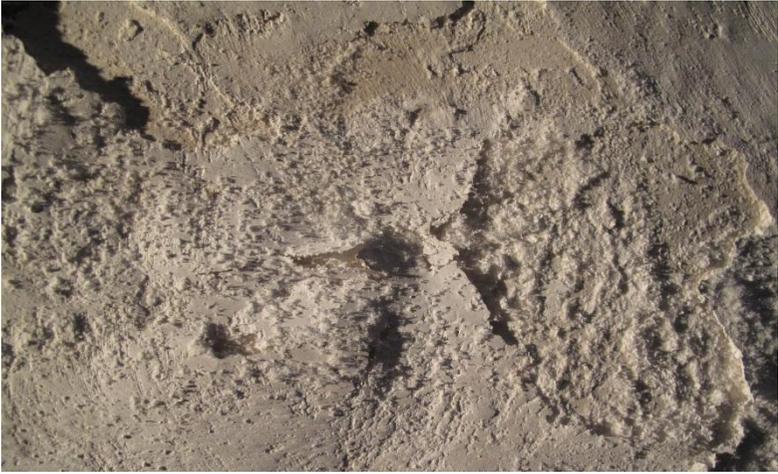
Barryscourt Tower House - Interior		BIO_04
DAMAGE	Biological Activity - Moulds/Fungi	Grading: Moderate
LOCATION	Master bedchamber most affected with large scale mould patterns and wall fungi on all walls, also surrounding chimney interior in bedroom and main chimney of Great Hall. Windows surrounds in all towers also exhibit activity. Chapel also badly affected but examination not conducted due to restricted access during ultra violet treatment.	
CAUSES	Abundant presence of moisture in the sheltered environment provides ideal conditions of biological activity, feeding from limewash organic content.	
MAIN MECHANISM	During the thermography analysis of the bedchamber, the roof was shown to be leaking in the corners of the room, especially where the bedroom chimney meets the roof. Water ingress is occurring and percolating through wall to provide necessary moisture for the moulds and fungi to flourish. Fungi spores attach to surface and multiply rapidly under correct conditions.

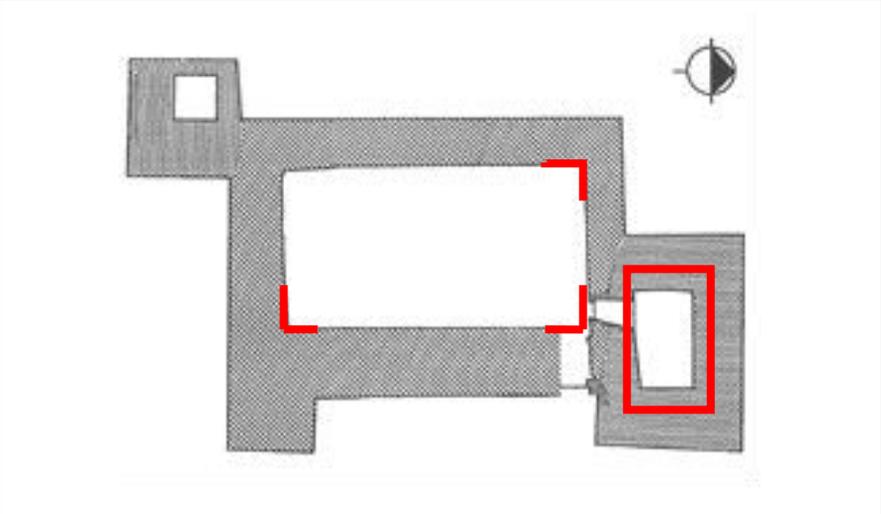
Barryscourt Tower House - Interior		PH_03
DAMAGE	Moisture induced staining and surface deterioration	Grading: Moderate
LOCATION	Global problem occurring on most interior walls of the tower house, especially noticeable in first floor hall, Great Chamber hall walls, northeast tower rooms exhibit many staining patches.	
CAUSES	Moisture causing staining - Number of contribution factors including faulty roof sealing joints, inadequate drainage. However, the moisture staining patches also occur in the middle of walls signifying porous masonry which is facilitating the ingress of moisture in times of rain and accelerating when accompanied by driving wind.	
MAIN MECHANISM	Water works through wall by differential pressure force and infiltrates to interior facades where it stays, causing staining of materials, namely lime wash and mortar joints, stone facing and timber. Constant moisture causes limewash to discolour to cream/yellow. Water combines with tannins in timber and stains walls when dripping or pouring. Water leaves staining lines and watermarks on naked stone.
