ADVANCED MASTERS IN STRUCTURAL ANALYSIS
OF MONUMENTS AND HISTORICAL CONSTRUCTIONS

Master's Thesis

Investigation of the Use of
Iron in Construction from
Antiquity to the Technical
Revolution.

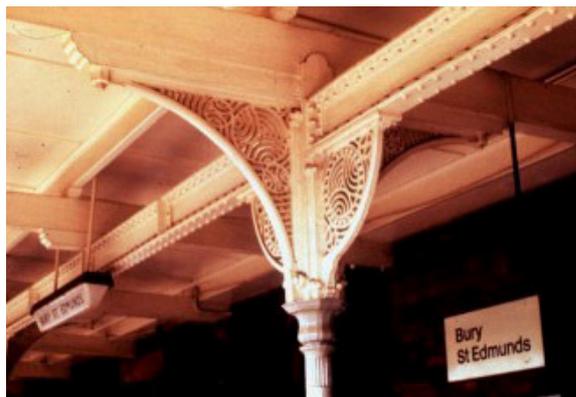
Figure 2.11: Timber roof purlin (depth increased in the support), wrought iron riveted edge beam and cast iron decorative brackets and column.

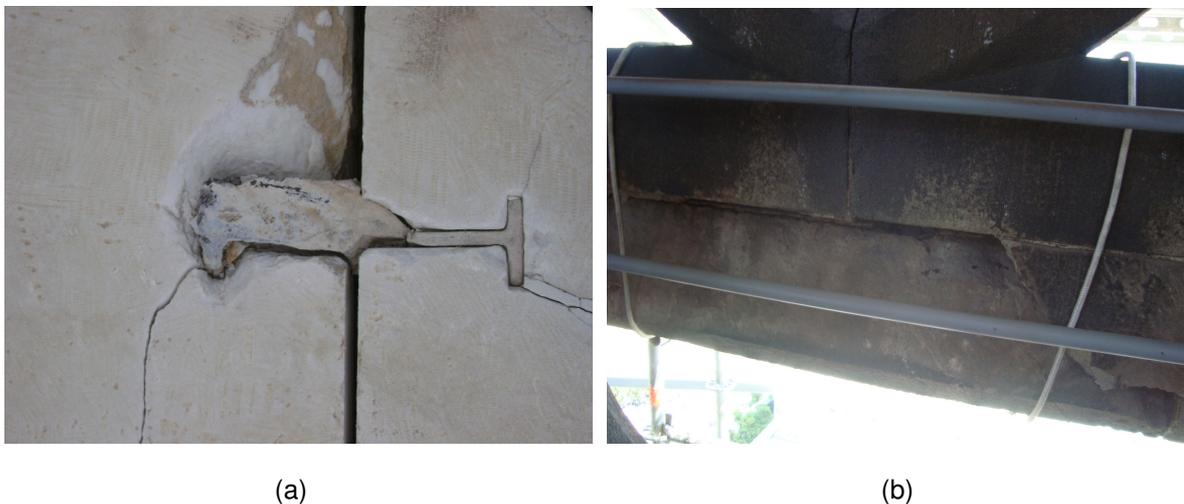
Figure 2.15: Damages due to iron use in monument restoration (a) Parthenon, (b) Barcelona Cathedral (photos A. Drougas).

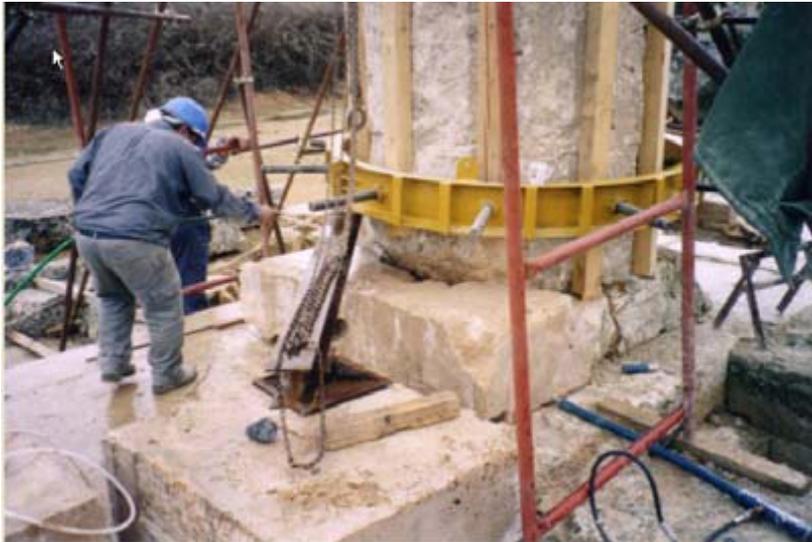
Figure 2.16: Temporary propping of drum column at the temple of Zeus at Nemea with steel members [65].

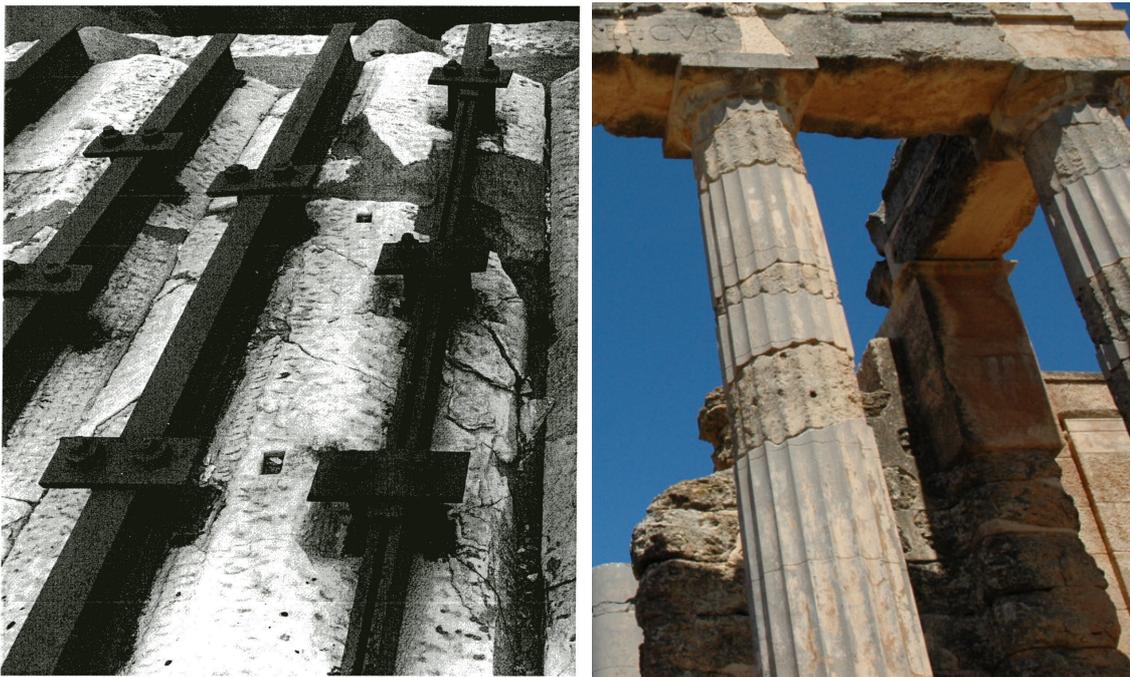
Figure 3.13: Steel frame (Erechtheum) and reinforced concrete (Zeus at Cyrene) in ancient monument restorations.

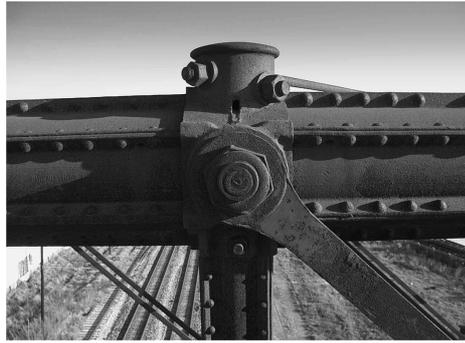
Figure 5.1: Upper chord pin-and-eyebars connection in an 1881 Whipple Phoenix Truss. The eyebars and compression sections are wrought iron, the joint blocks are gray cast iron, and the pins are wrought iron on the upper chord and steel on the lower chord [46].

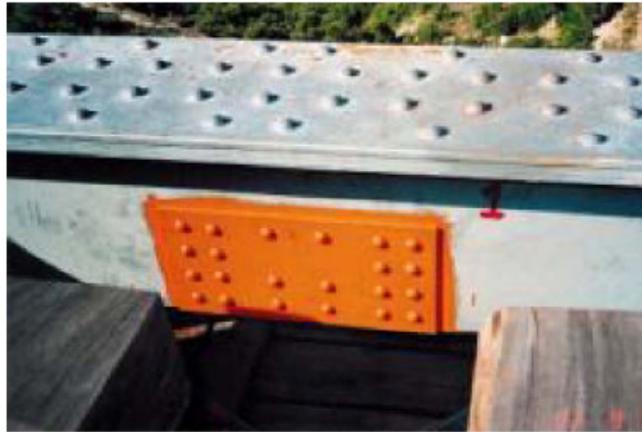
Figure 8.1: Cold repair of sampled bridge beam web with riveted plate [70].

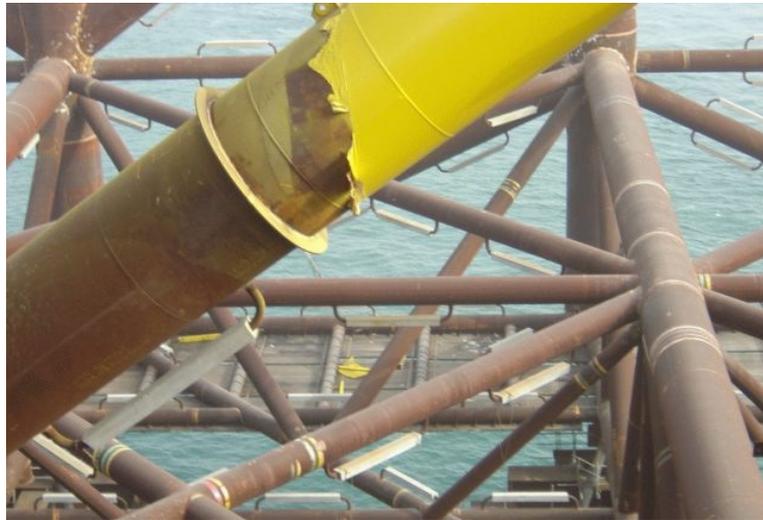
Figure 8.2: Aluminum anode on steel member.

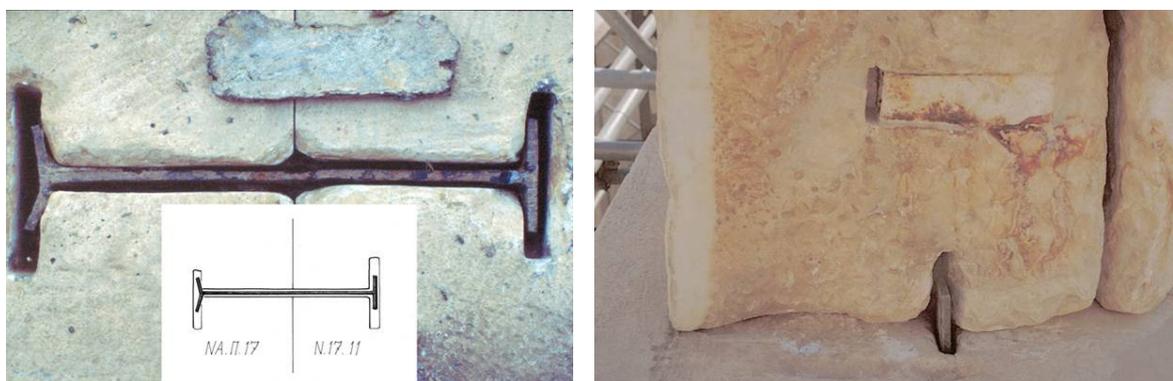
Figure 9.1: Clamp and dowel [57].

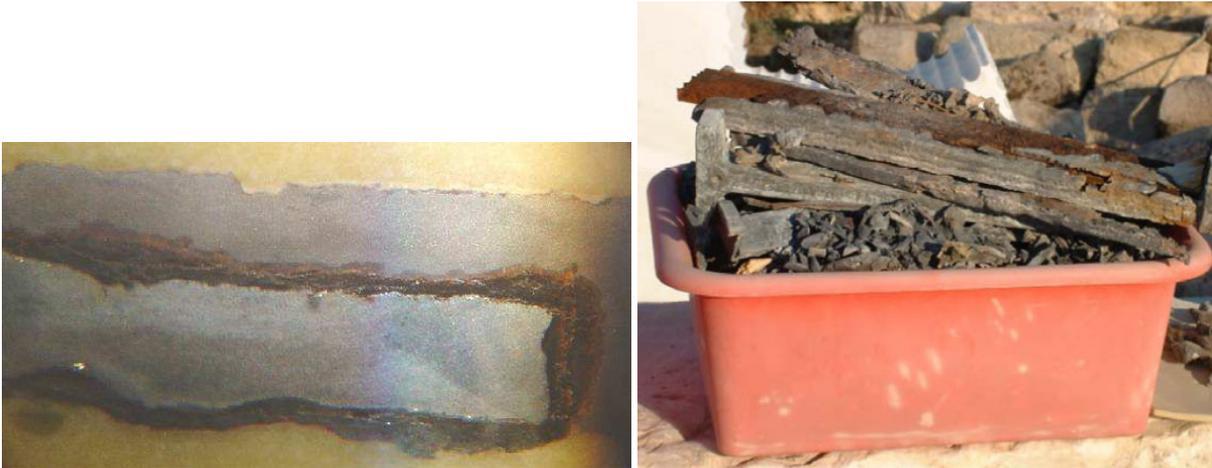
Figure 9.7: Superficial corrosion of ancient iron clamp [58] and extensive corrosion of recent restoration iron clamps.

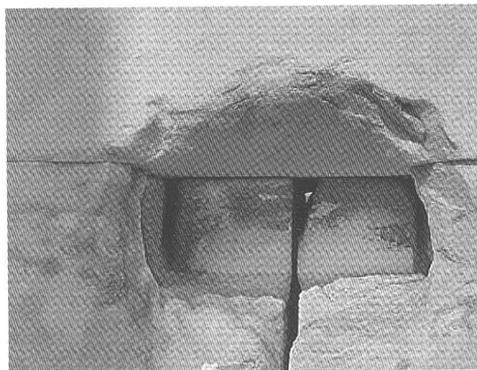
Figure 9.8: Carved dowel mortise for extraction of iron and lead.

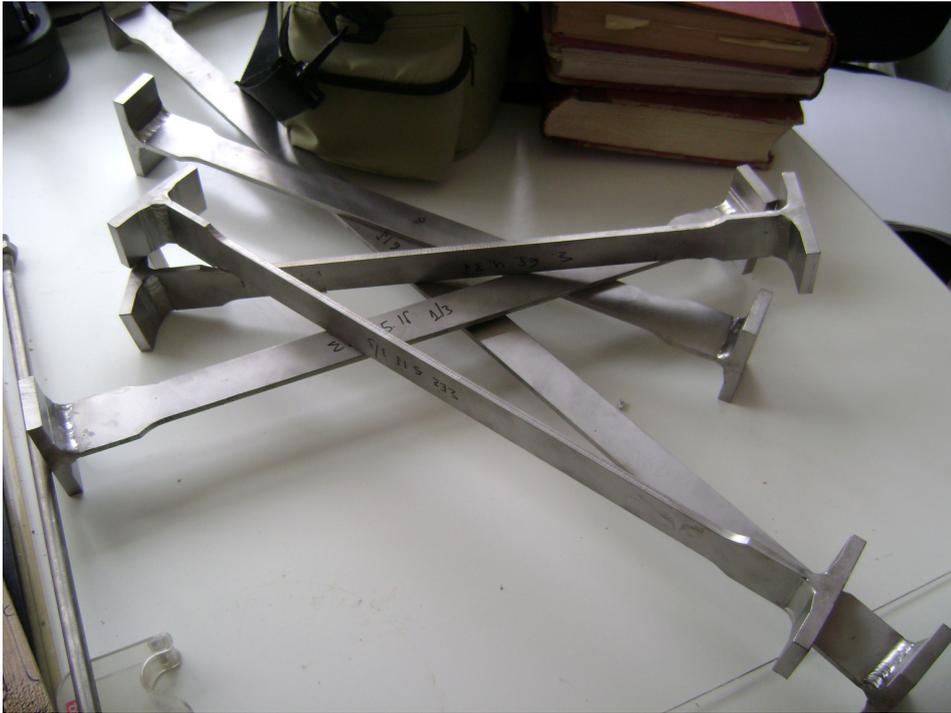
Figure 9.10: Titanium restoration clamps (photo A. Drougas).

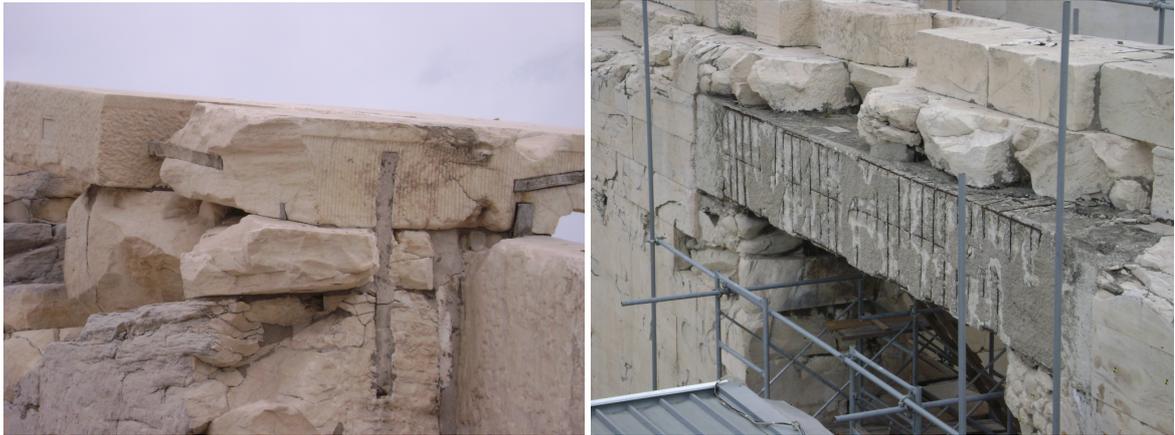
Figure 9.11: Recent restorations with external clamps and reinforced concrete (photos A. Drougas).
