Name: Justin Hettinga  
Email: justin.hettinga@gmail.com  
Title of the Msc Dissertation: Structural analysis of the roof of St Anne's Church  
Supervisor(s): Professor Pavel Kuklik  
Year: 2008 - 2009

Buildings in Prague with an original Gothic roof structure are the focus of this thesis. An overview of buildings from the Gothic period (13<sup>th</sup> to 16<sup>th</sup> c.) and relevant architects is given. As the history of Prague, Bohemia, and the Holy Roman Empire is relevant to the construction of Gothic structures in Prague, it is discussed briefly. The majority of the Gothic buildings in Prague suffered considerable damage from wars, invasions, or fires, and few still have their original roof trusses. St Anne's Church, Old New Synagogue, Pinkas Synagogue, and Church of St Wenceslas in Zderaz all have original gothic roof structures. Access to St Anne's Church was granted, so it was studied for this thesis.

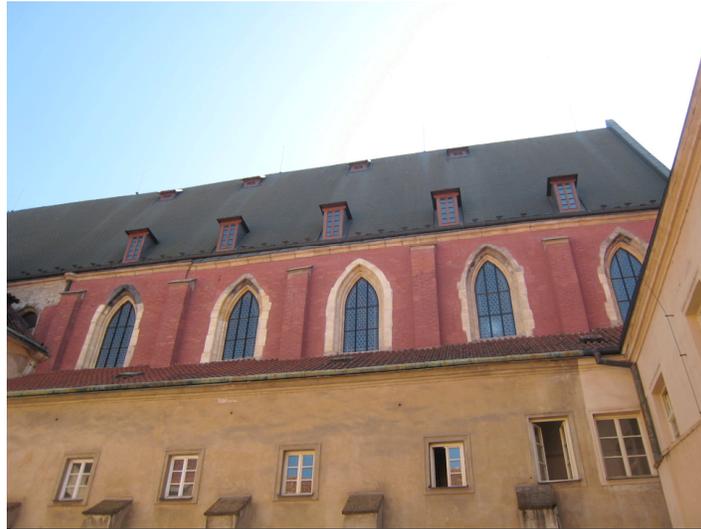
The roof of St Anne's Church is very steep, at  $64^\circ$  (see Figure 2). One end of the roof is a masonry wall, while the other has 10 timber beams joining at the peak of the roof, forming the shape of half of an inverted hexagon (see Figure 3).

**Figure 2** External view of the south side of St Anne's Church

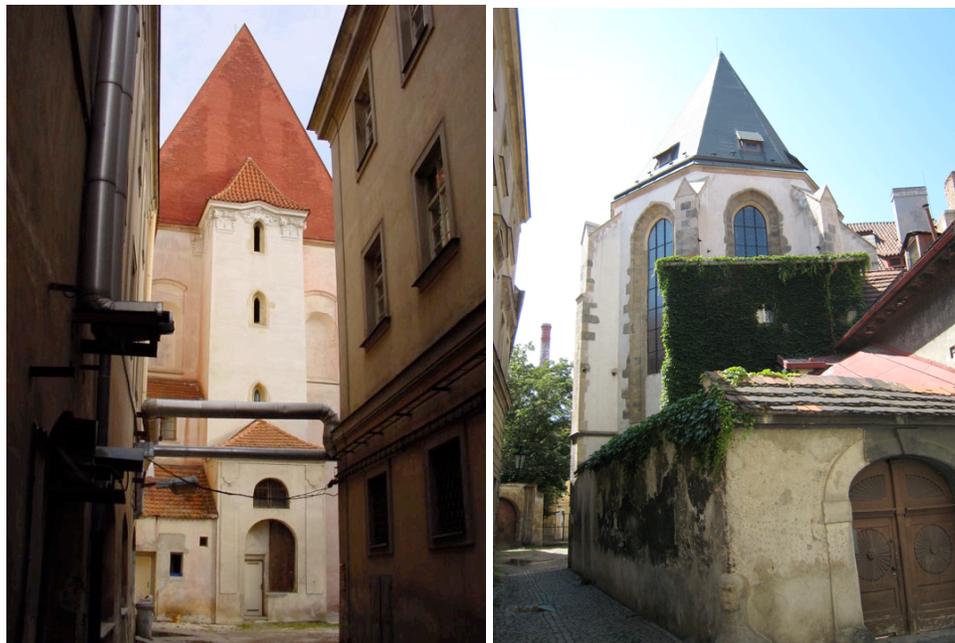
**Figure 3** View of the west and east sides of the church

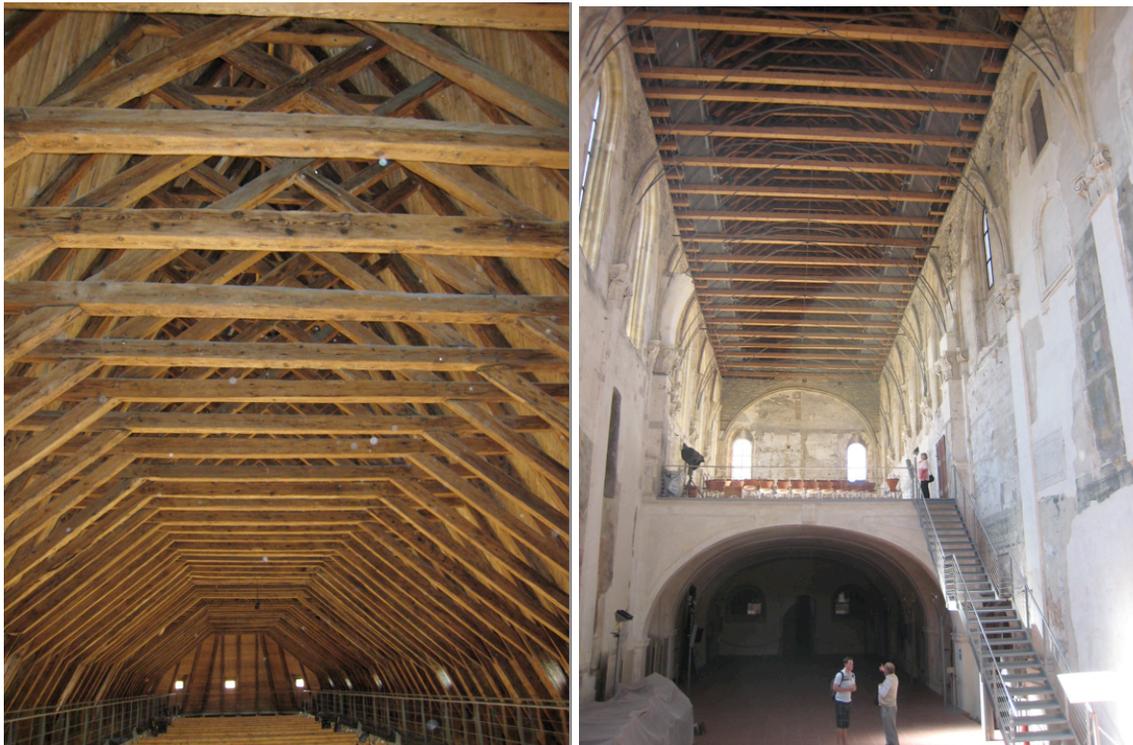
The roof covering consists of two layers of 20 mm thick boards, which are nailed directly onto the main diagonal chords of the truss. These two layers are orientated at a 45° angle from the horizontal, and perpendicular to each other. This is a very stiff configuration; as each board is long enough to be attached to multiple trusses, the average board spans three trusses. Because they are on an angle, stiff triangular elements are produced.

**Figure 4** Views of the roof structure of St Anne's Church, the first looking to the south, the second to the north

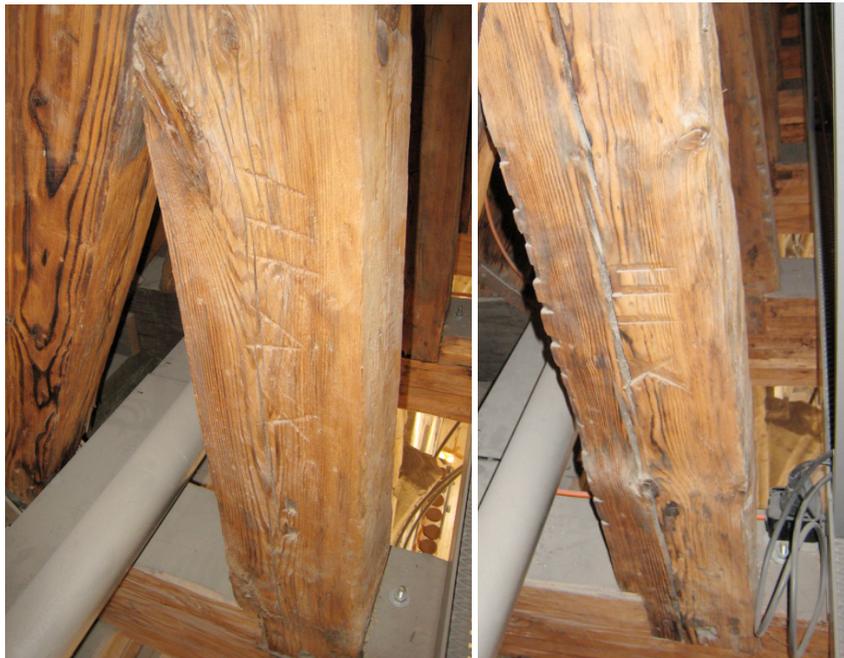
On each truss, roman numerals can be seen on at least two members. The numbering starts at the west side of the church (the side with the masonry wall). The trusses were intentionally placed in a specific order. Two members marked with roman numerals are shown in Figure 5.

**Figure 5** Roman numerals on the members done by the carpenter

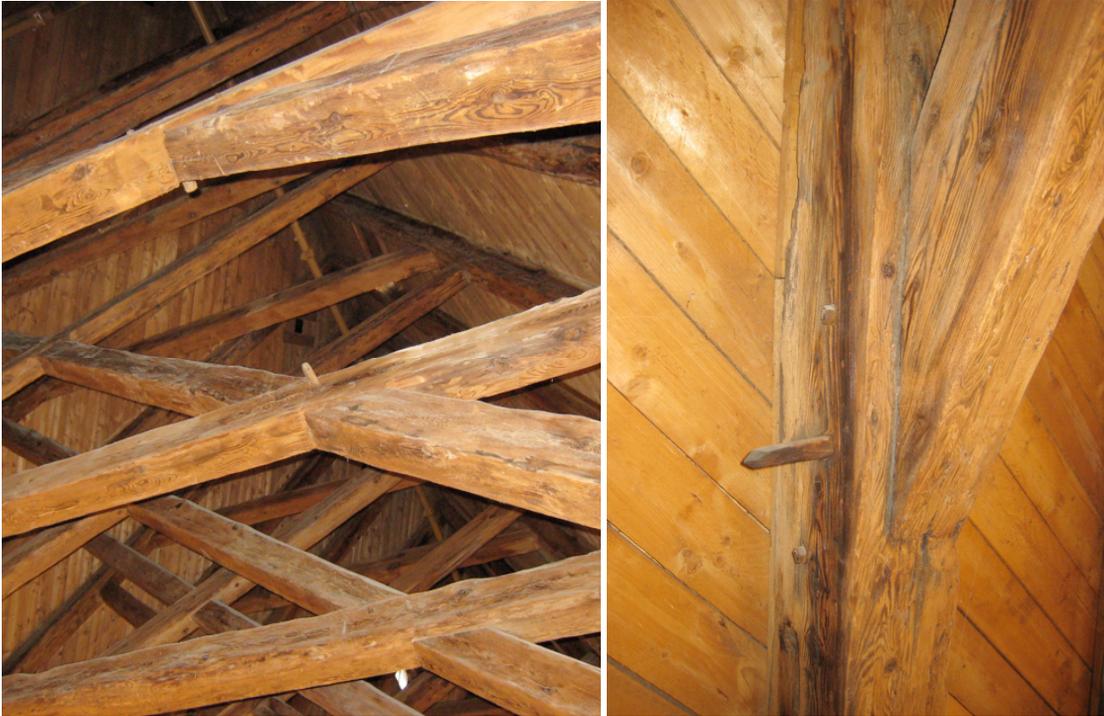
The joints were constructed using square wooden dowels with a cross section of 2 cm by 2 cm. The members at all joints are cut so that approximately half of each member is removed. At interior joints of the truss, both members are continuous past the joint, which is made possible by cutting back the member. The joints, in addition to the original wooden dowels, have had two steel bolts of diameter 12 mm added (see Figure 6).

**Figure 6** Joint with the members cut back and continuing past each other (left picture), and wooden dowels visible (both pictures)

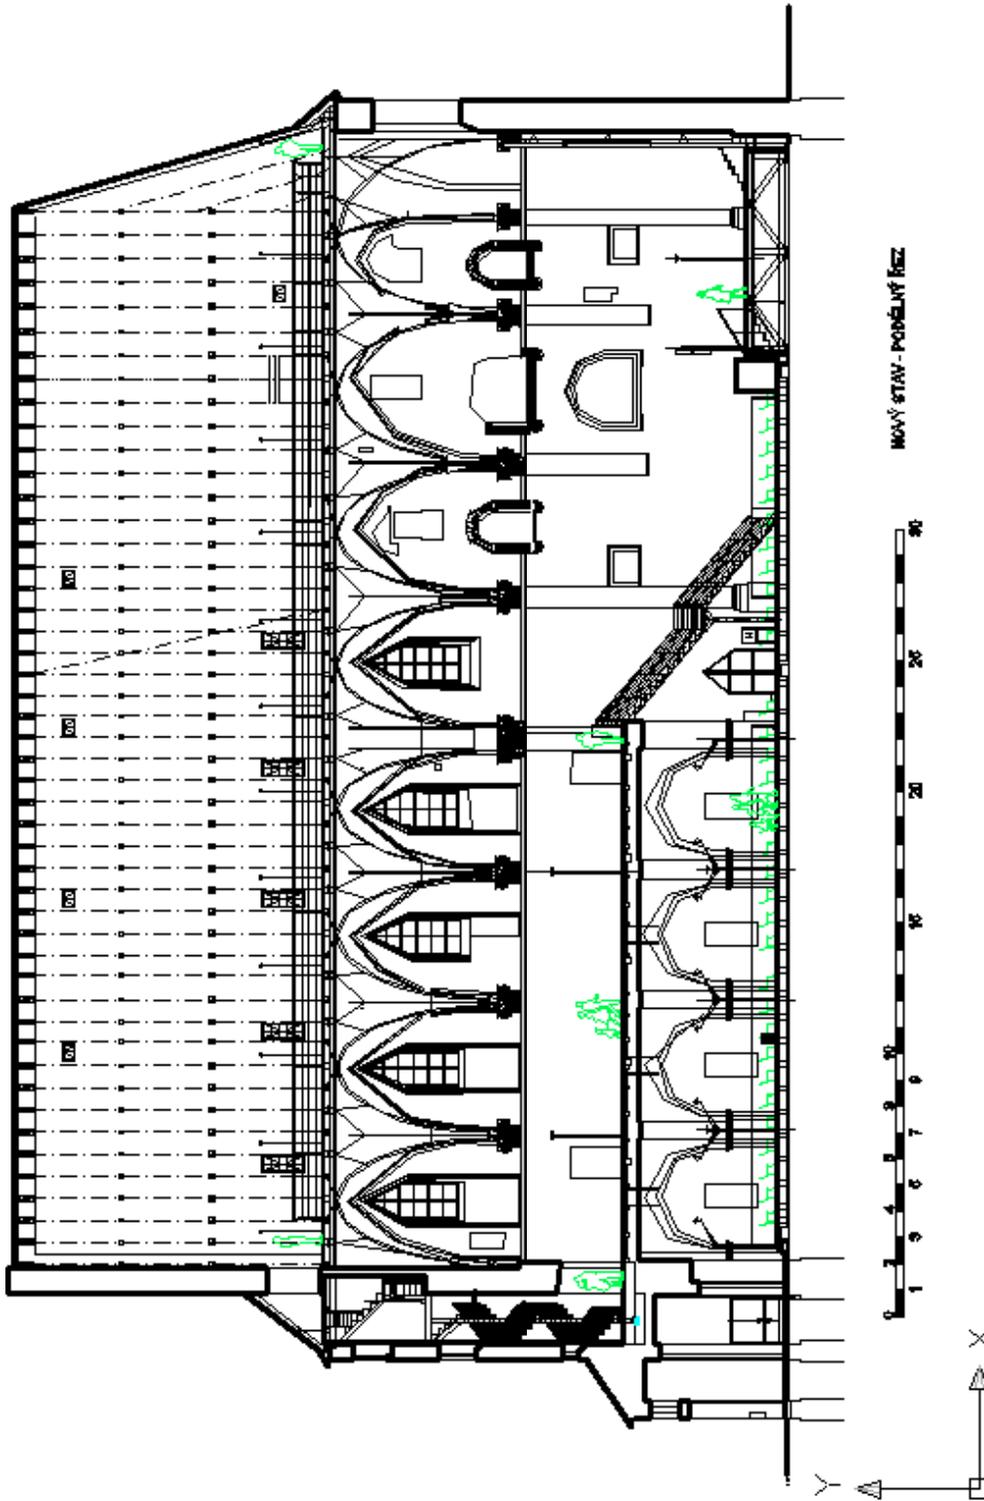
Figure 7 Elevation view of the south side of St Anne's Church

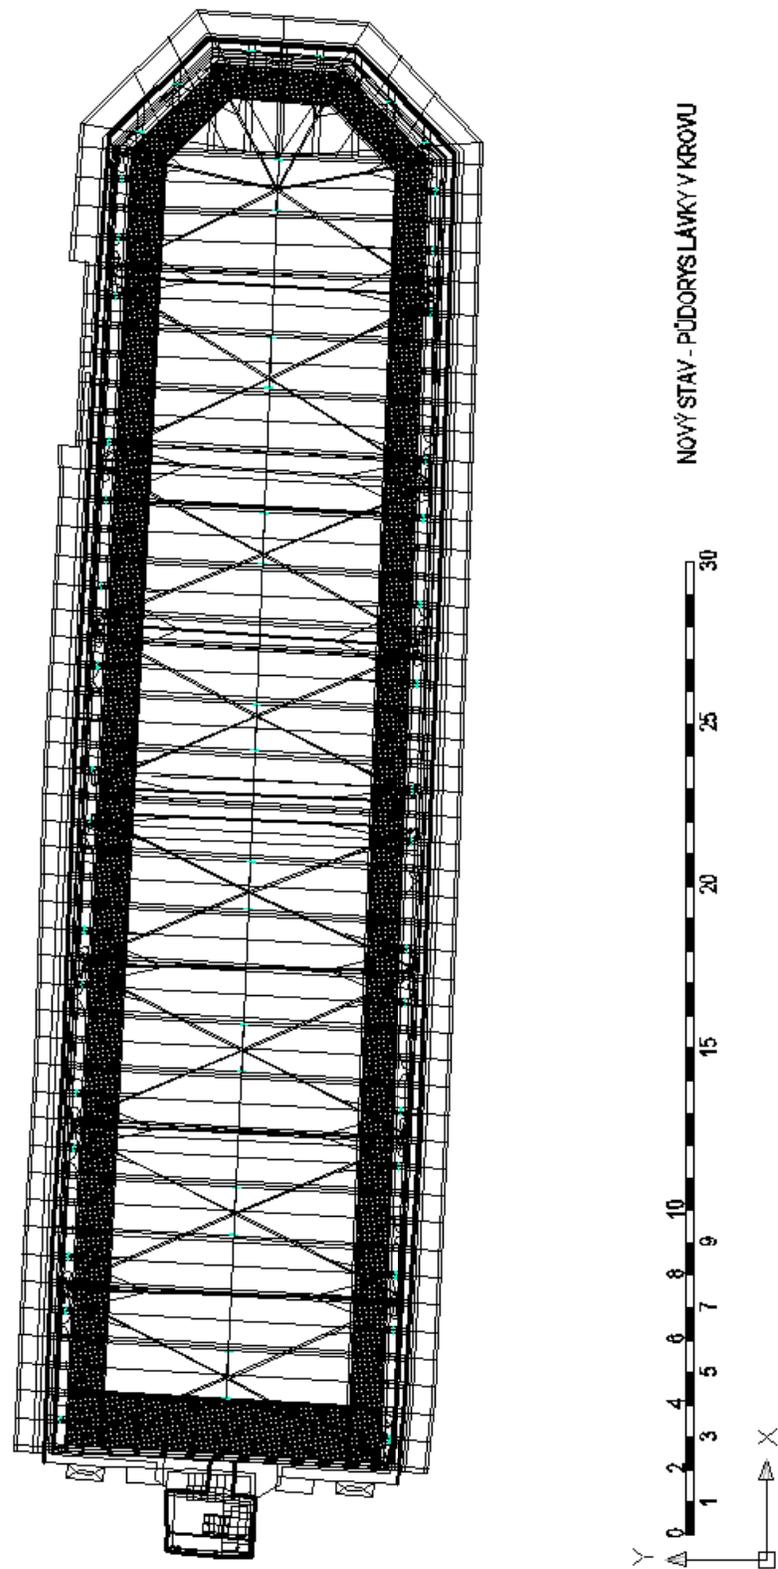
**Figure 8** Plan view of St Anne's Church, the x-axis points east

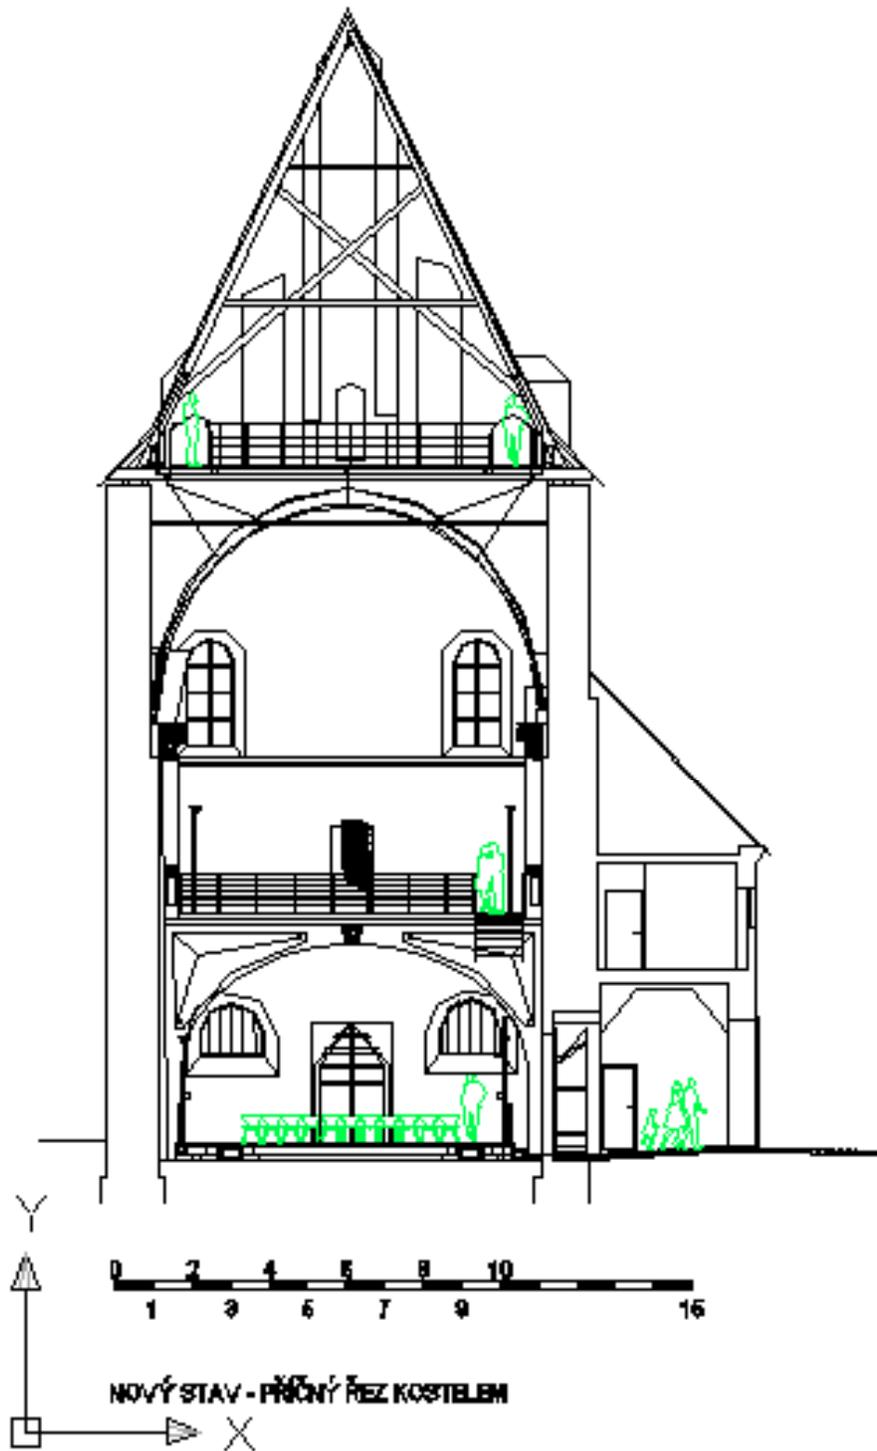
Figure 9 Cross-section of St Anne's Church, the x-axis points north

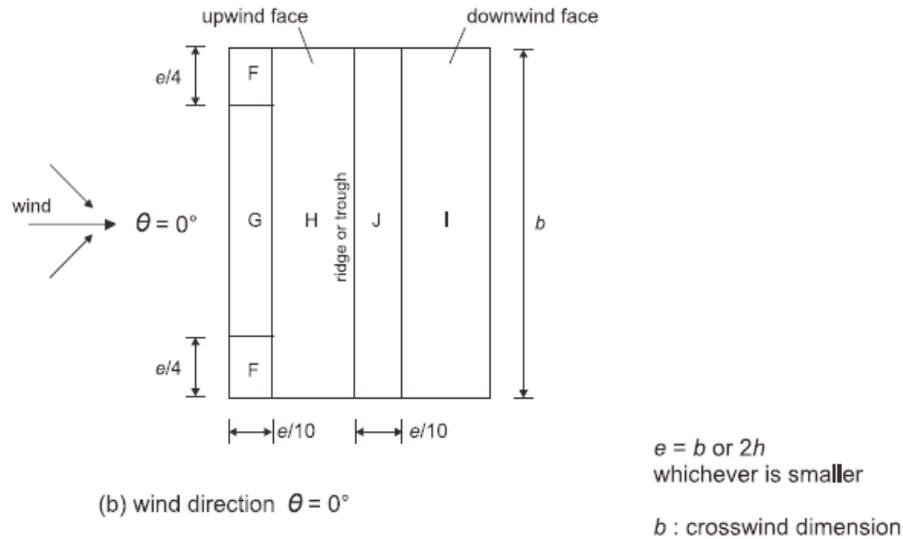
Two cases are considered, where the wind direction is perpendicular to a longitudinal wall, then to an end wall.

**Figure 10**  $W_e$  for a 1/500 return period at wind direction  $\theta = 0^\circ$  (Pitch angle =  $64^\circ$ ), coefficient  $e = \{\text{smaller of } 2h = 60, \text{ or } b = 44\text{m}\} = 44\text{m}$

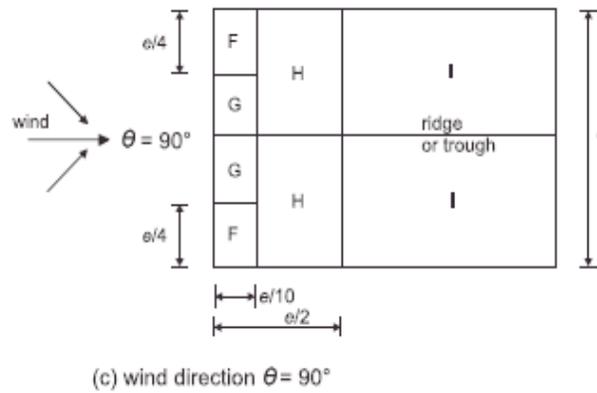
Similarly, for the other wind load case, the zones and corresponding pressures are shown in Figure 11 and Table 3.

**Figure 11**  $W_e$  for a 1/500 return period at wind direction  $\theta = 90^\circ$  (Pitch angle =  $64^\circ$ ), coefficient  $e = \{\text{smaller of } 2h = 60, \text{ or } b = 12.6\} = 12.6 \text{ m}$

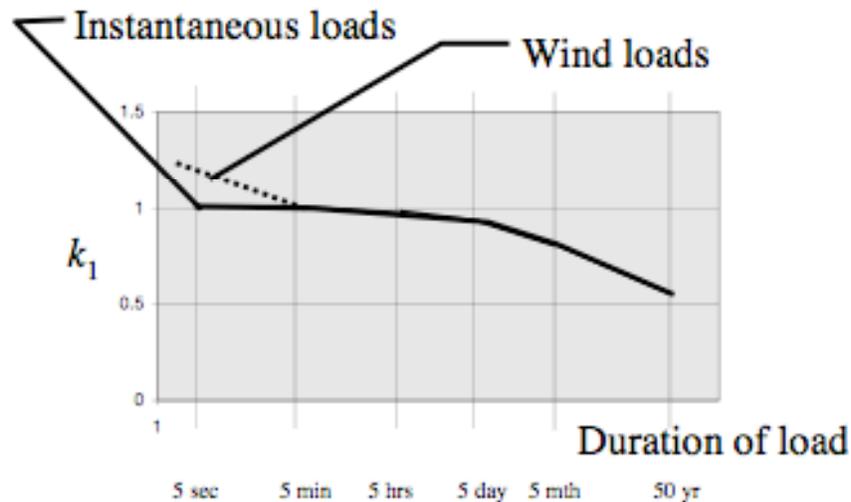
**Figure 12** The effect of load duration on strength, which is multiplied by factor  $k_1$  [8]

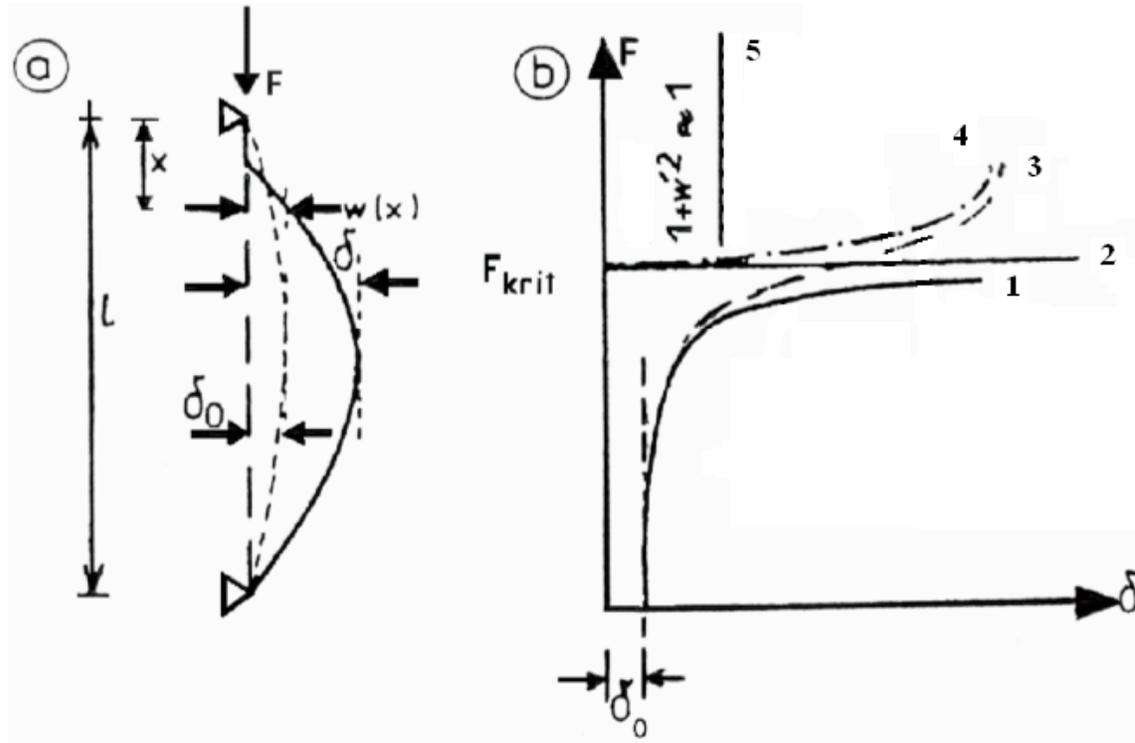
Figure 13 below illustrates the force deflection relationship for different initial conditions and curvature equations.

**Figure 13:** Stability and critical loading for different curvature equations and initial deflections [10]

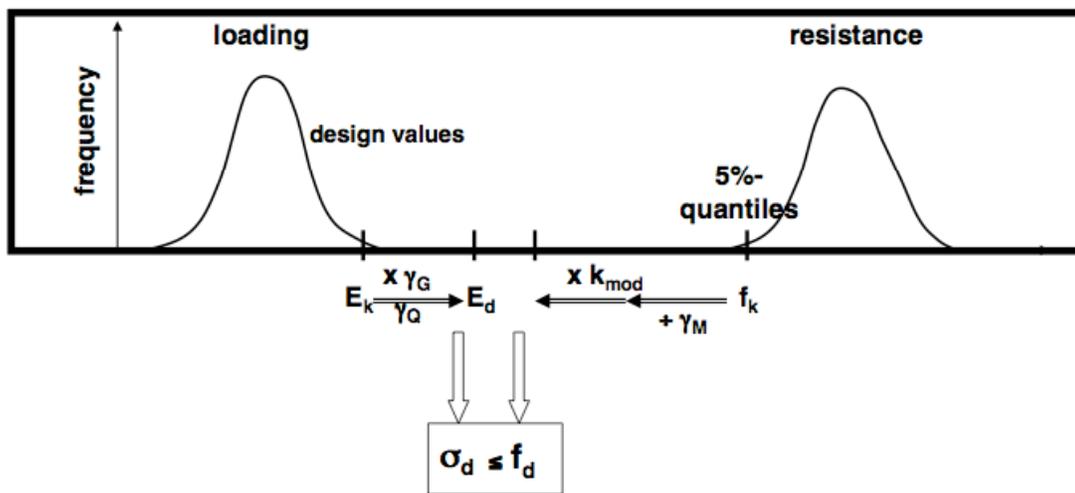
By applying modification factors and load factors, and taking into account the return period and sampling duration (for wind load), the Eurocode employs a reliability index. This is a measure of the number of standard deviations between the effect of loading and resistance probability distribution functions, and is known as reliability based design. The reliability index establishes a set level of safety for the structure and all elements in it, and is shown in Figure 14 below.

**Figure 14** Probability distribution functions of the effect of loading and of the load carrying capacity [13]

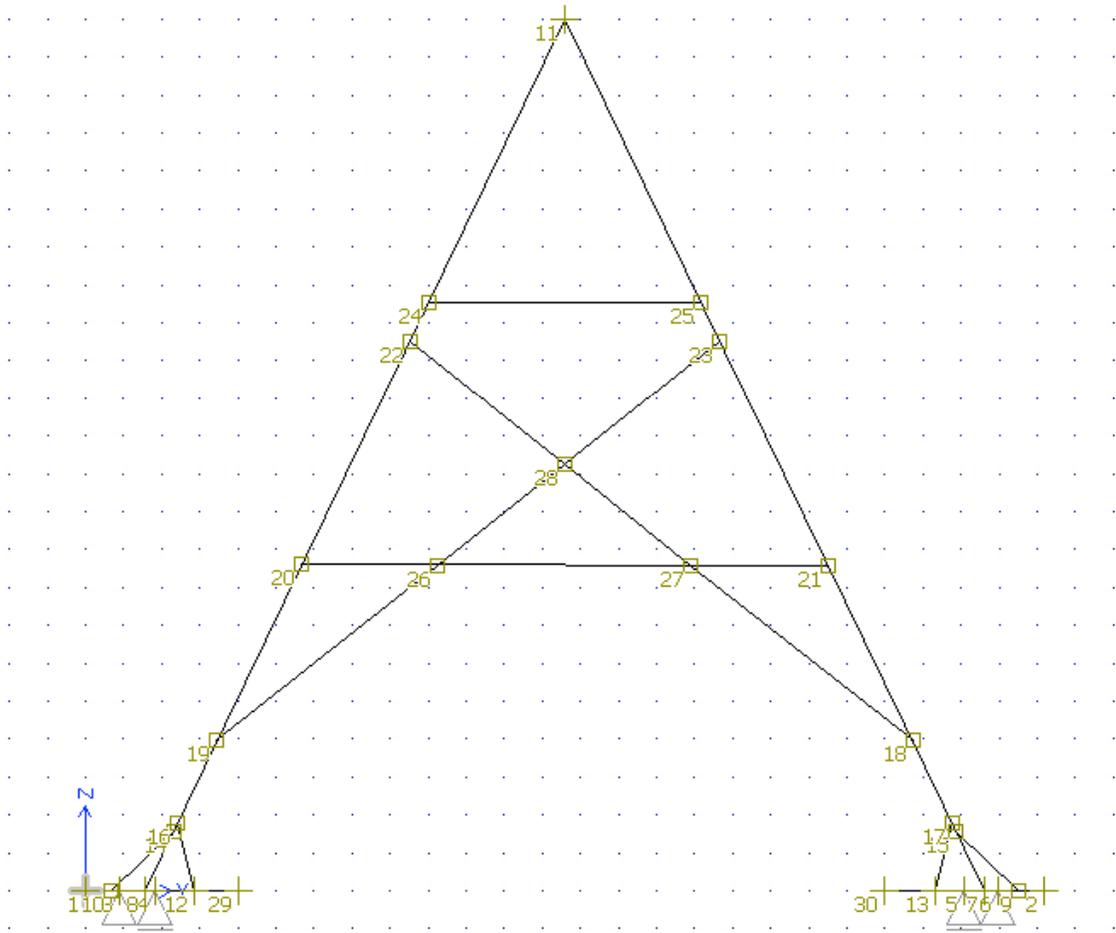
On interior joints on the truss, both members are cut back so that they fit into each other. On Figure 15 below, joints 26, 27, and 28 are of this nature. The members crossing a joint are both continuous.

**Figure 15** Standard truss of St Anne's Church

The stiffness of the joint is compared to the stiffness of the continuous member. Joint 28 of Figure 15 is examined. A unit rotation is applied to one end of the beam, as seen in Figure 18.

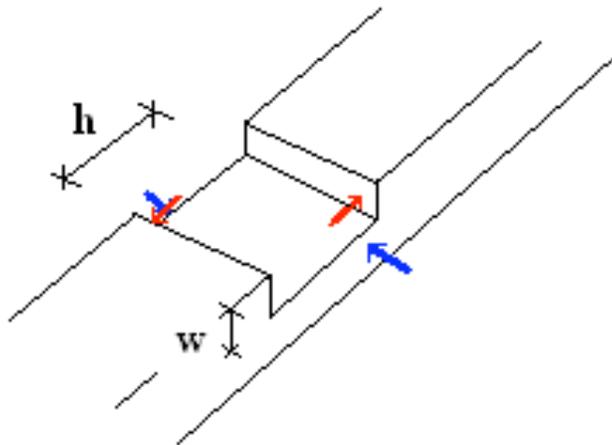
In Figure 16 below, one member is shown how it is cut back at a joint. Rotation of the other member causes two couples, indicated by the blue and red arrows.

**Figure 16** Member of dimension 20 cm by 12 cm, cut out at the joint

The members do not cross at a  $90^\circ$  angle, but at a  $102.8^\circ$  angle, resulting in  $h = 205.1\text{mm}$ . When one member is rotated, it is resisted at the locations indicated by the blue and red arrows in the previous figure. These forces are all equal, so only one pair will be examined, and then the second will be accounted for later.

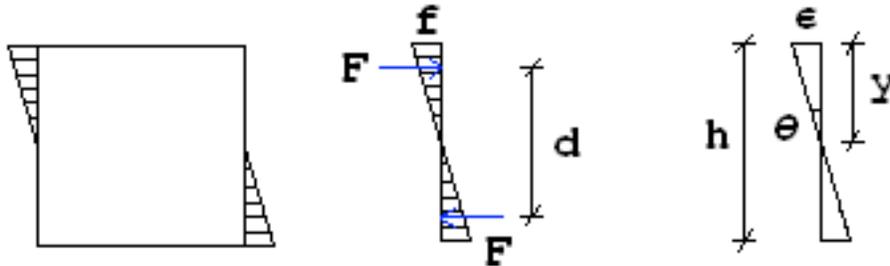
**Figure 17** Approximate the strain as linear and perpendicular to the surface of the beam

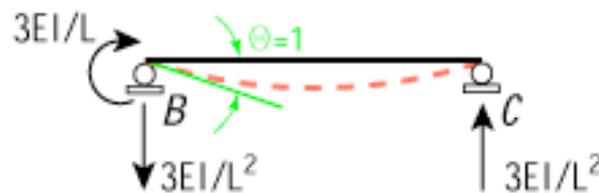
**Figure 18** Forces resulting from a unit rotation on a beam

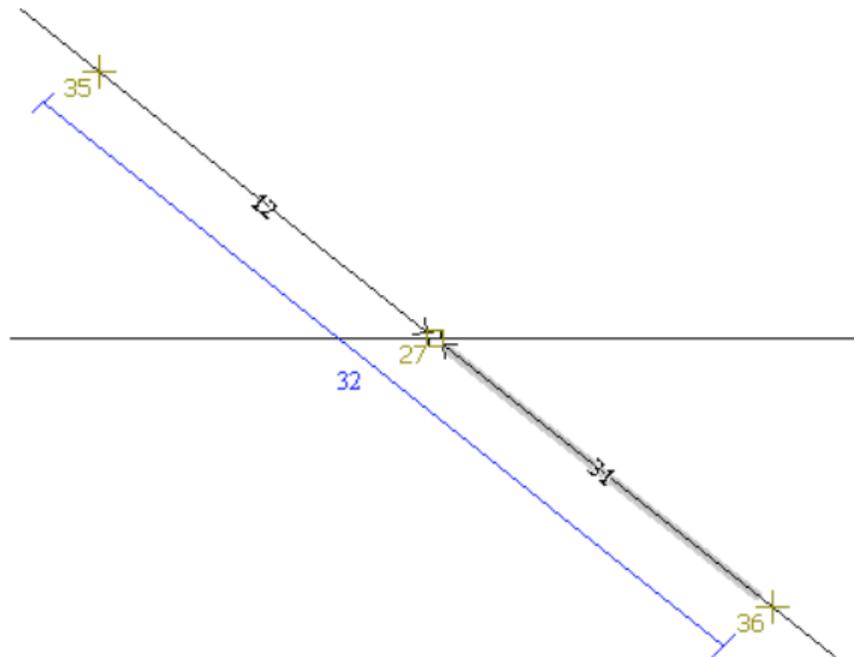
In all three models, both members are continuous past the joint. A fixed connection is easily input in FINE. The pinned and spring joints are modeled by first creating a relative joint (27 on Figure 19 below) on one of the intersecting members. The other member is split into two members, which are attached by a pin or a spring to this relative joint. Close to the joints, the members are divided, creating new members 12 and 31. Joints 35 and 36 are fixed to keep the members continuous. To complete the continuity of the member, a short member 32 is added from joint 35 to 36. The dimensions of members 12, 31, and 32 are adjusted for the appropriate cross section.

**Figure 19** Schematic of the joint in FINE for a spring connection

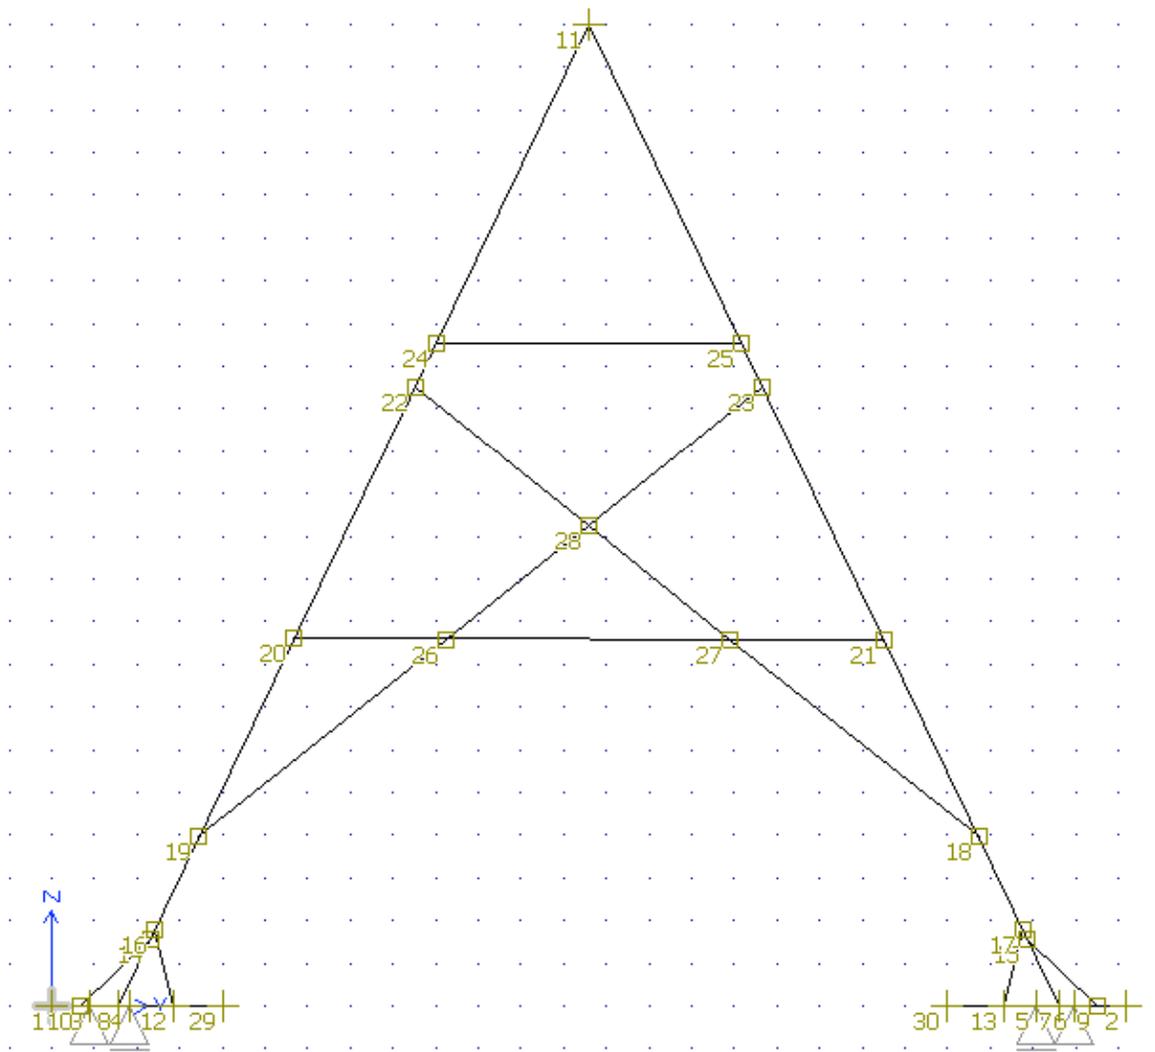
Figure 20 Joints

The following three figures show the geometry of the FIN 2D model. The tables following these figures in the results section reference the member and joint numbers shown on them. All joints are pinned, with the exception of joints 26, 27, and 28, which have the members passing each other, and are modeled as fixed, pinned, or springs in three separate models.

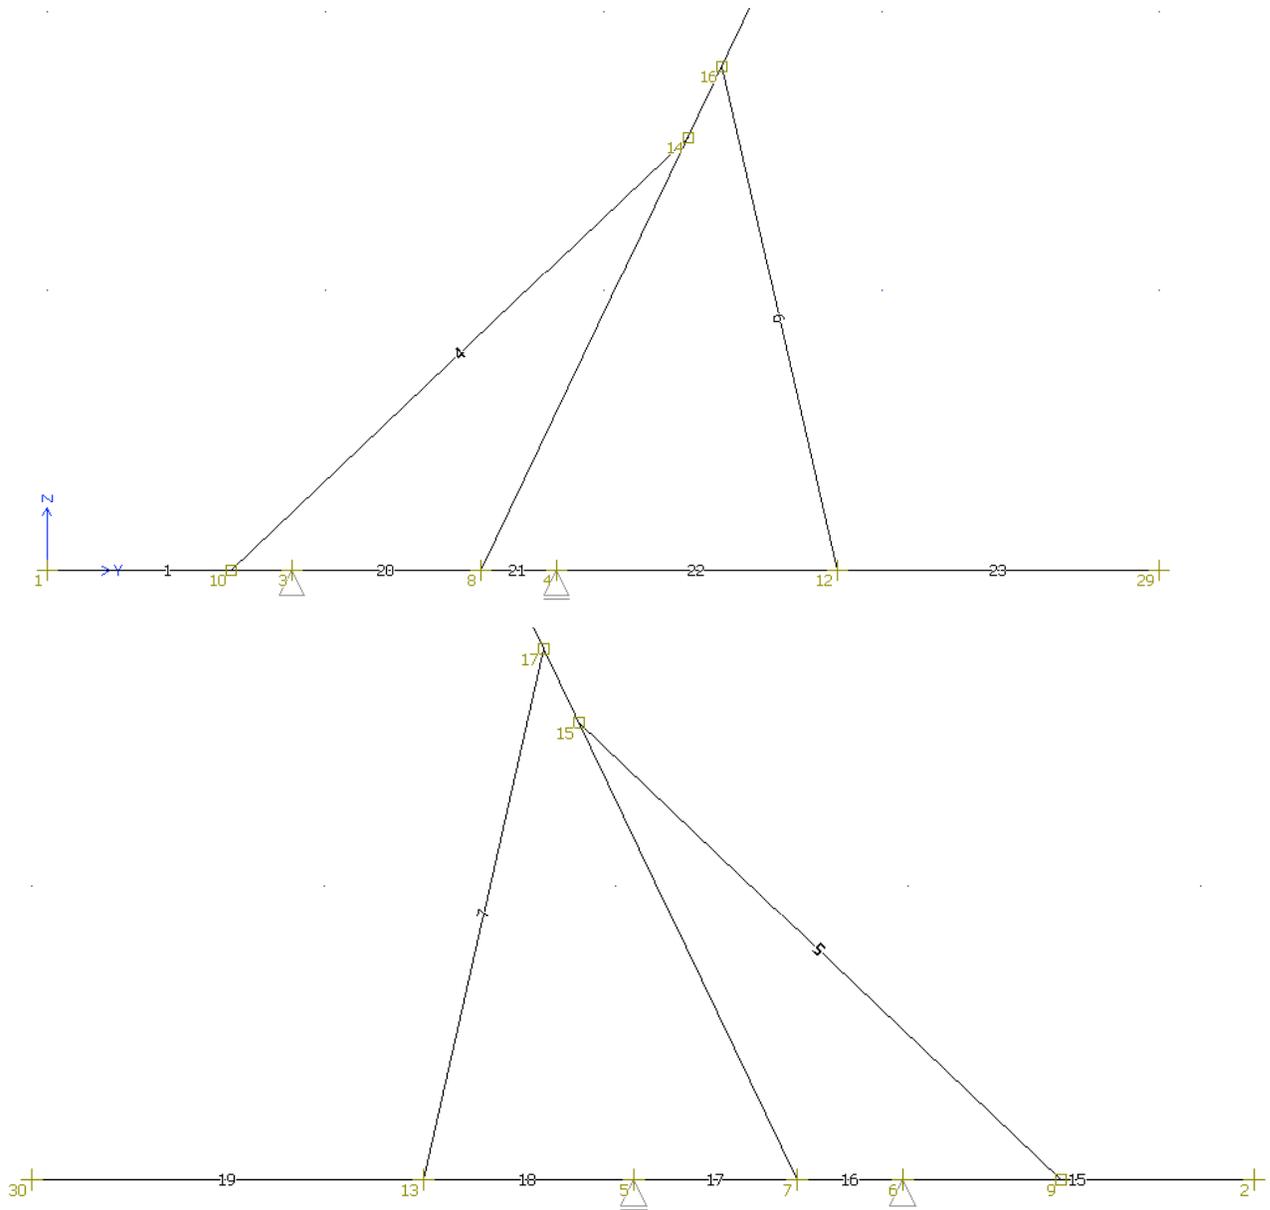
**Figure 22** Node and member numbers at the supports

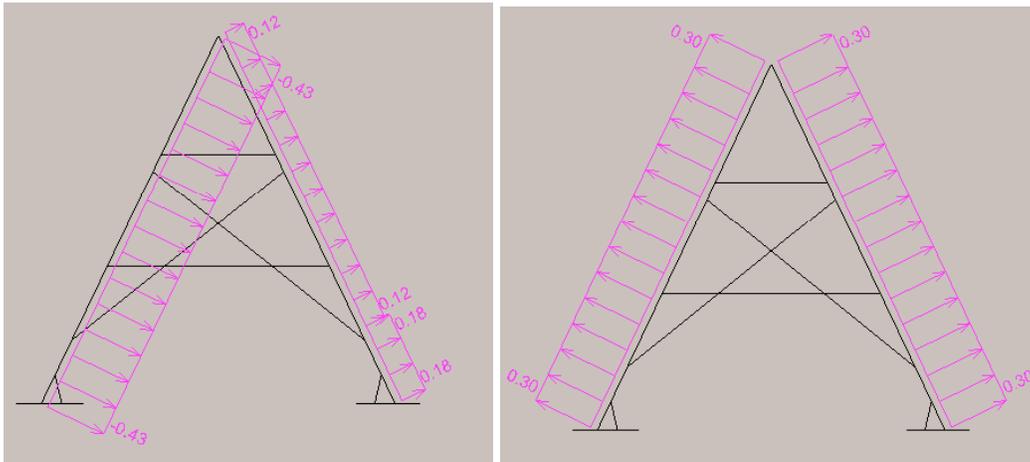
**Figure 23** External wind pressure from wind load case 1 (left picture, shown in Figure 10) and wind load case 2 (right picture, shown in Figure 11)

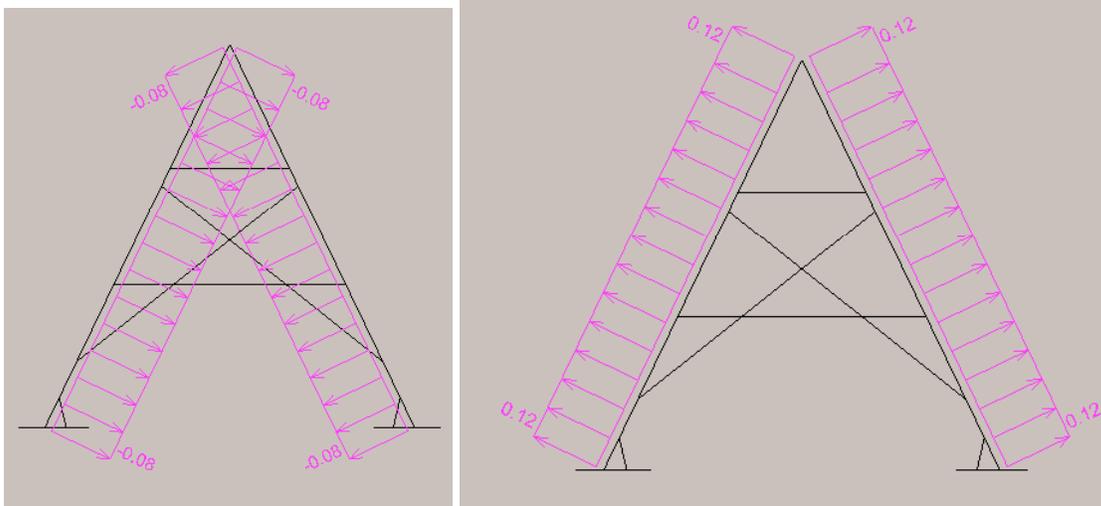
**Figure 24** Internal wind pressure, suction case (left) and pressure case (right)

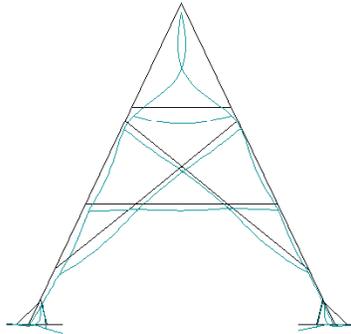
**Figure 25** Deflected shape from load combination 1.35 DL + 1.5 LL

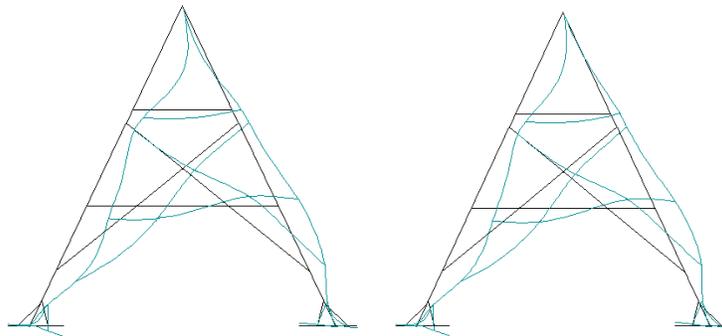
**Figure 26** Deflected shape from load case 1.35 DL + 1.5 WL case 1, with internal suction (left) and internal pressure (right)

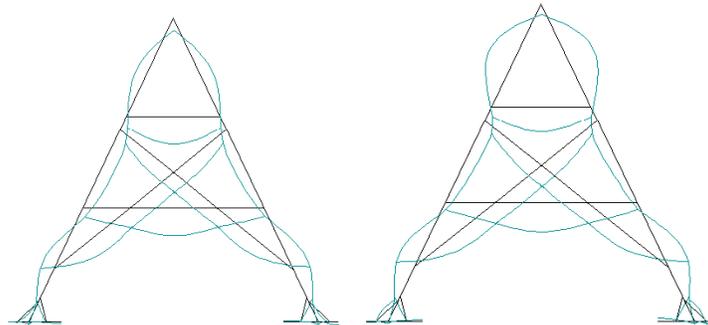
**Figure 27** Deflected shape from load case 1.35 DL + 1.5 WL case 2, with internal suction (left) and internal pressure (right)

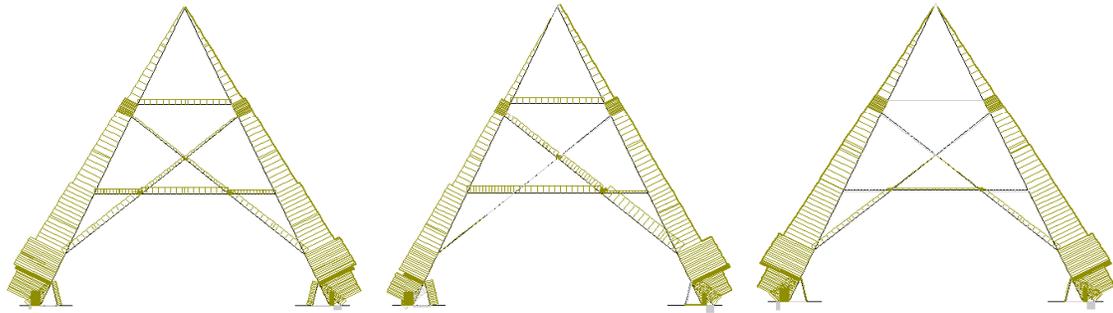
**Figure 28** Axial force diagrams for load combinations  $1.35 \text{ DL} + 1.5 \text{ LL}$ ,  $1.35 \text{ DL} + 1.5 \text{ WL}$  case 1 internal suction, and  $1.35 \text{ DL} + 1.5 \text{ WL}$  case 2 internal suction

Examining the axial force diagrams above, it can be seen that the truss is well designed to prevent buckling. As the axial force increases closer to the base of the truss, the effective length of each truss segment decreases. The stiff roofing boards would prevent buckling, however, the original geometry of the construction did not have roofing boards but a gap between the members and spaced runners supporting the tiles. The roofing boards were not present to prevent buckling of these members.

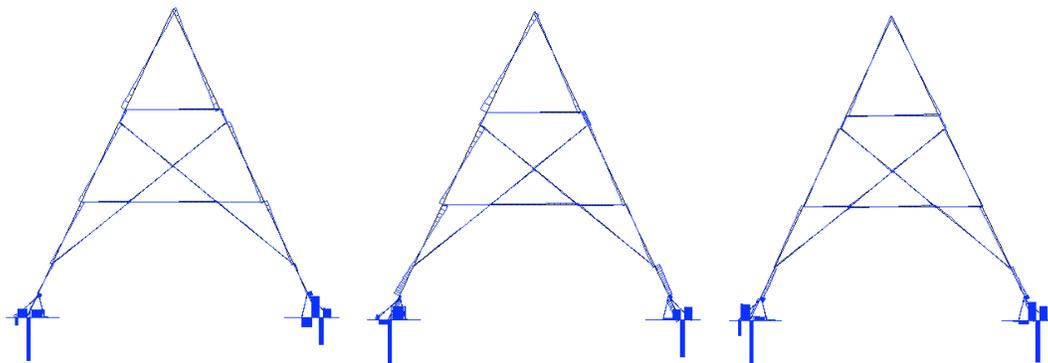
**Figure 29** Shear force diagrams for load combinations  $1.35 \text{ DL} + 1.5 \text{ LL}$ ,  $1.35 \text{ DL} + 1.5 \text{ WL}$  case 1 internal suction, and  $1.35 \text{ DL} + 1.5 \text{ WL}$  case 2 internal suction

As seen in the shear force diagrams above, the maximum shear forces occur in the members at the bottom of the truss. This is because the supports are not directly under the truss members, as seen previously in Figure 22 (page 53). However, these bottom horizontal members are not original, but are new glulam beams of very high strength.

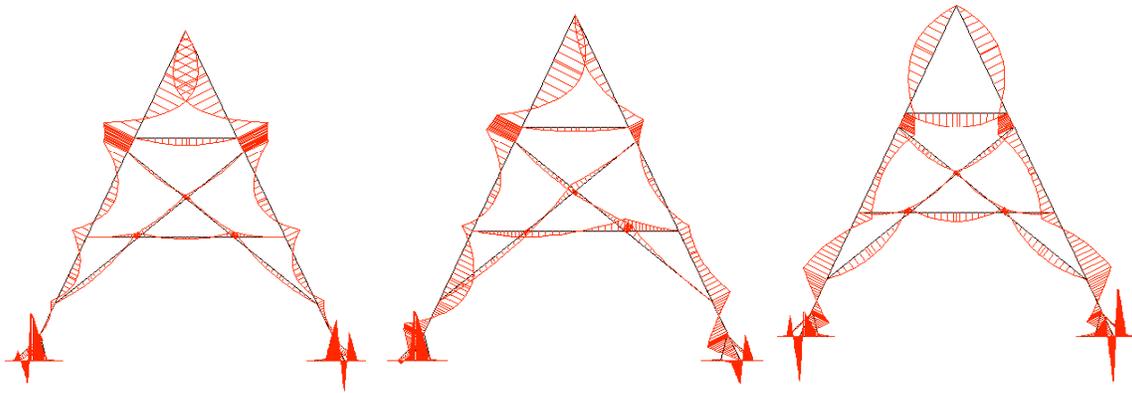
**Figure 30** Bending moment diagrams for load combinations 1.35 DL + 1.5 LL, 1.35 DL + 1.5 WL case 1 internal suction, and 1.35 DL + 1.5 WL case 2 internal suction

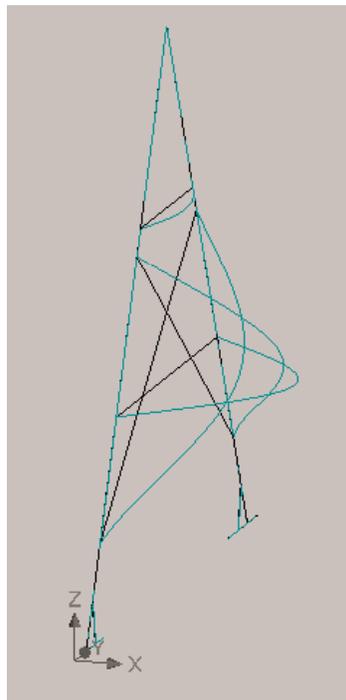
The two dimensional model of the truss does not allow for out of plane movement, so the truss is checked in FIN 3D. The shape at instability is shown in Figure 31 below.

**Figure 31** Shape at failure for the load case 1.35 DL + 1.5 WL, case 1, internal suction

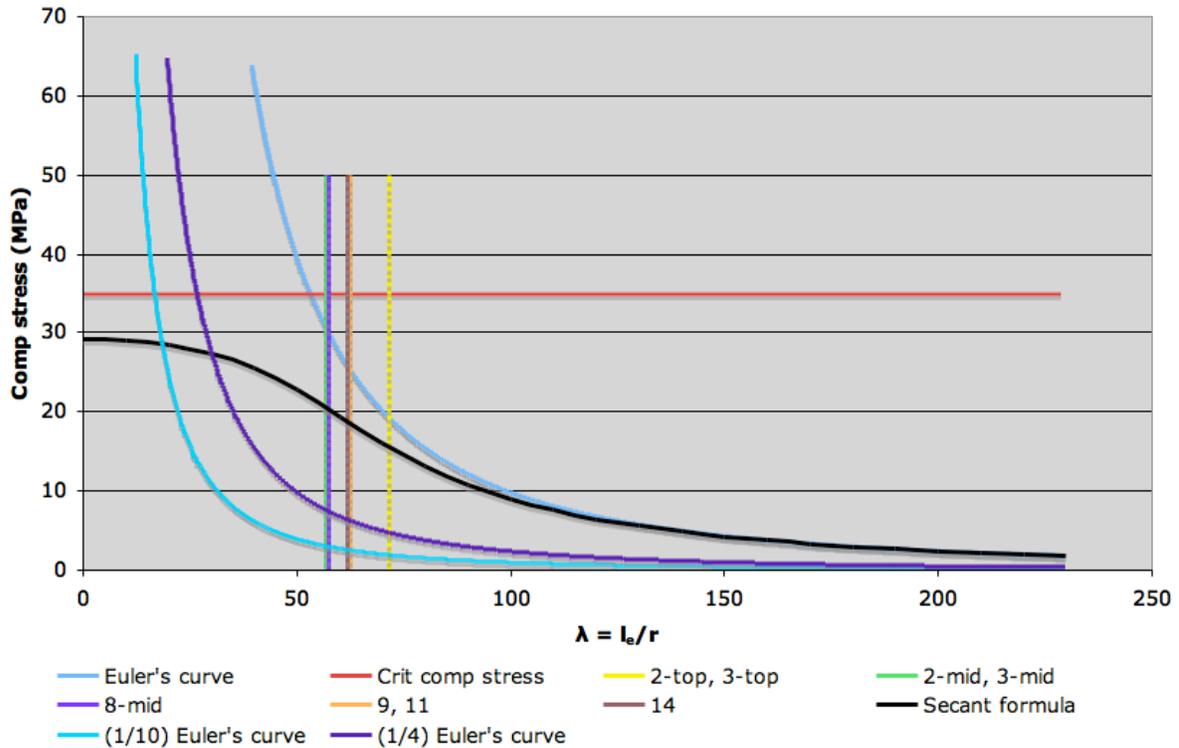
The buckling behavior of the members is illustrated in Figure 32 below. The slenderness of the most slender member, the top section of member 2, is shown by the yellow line marked “2-top.”

**Figure 32** Behaviour in compression of members subject to buckling (non-short columns)

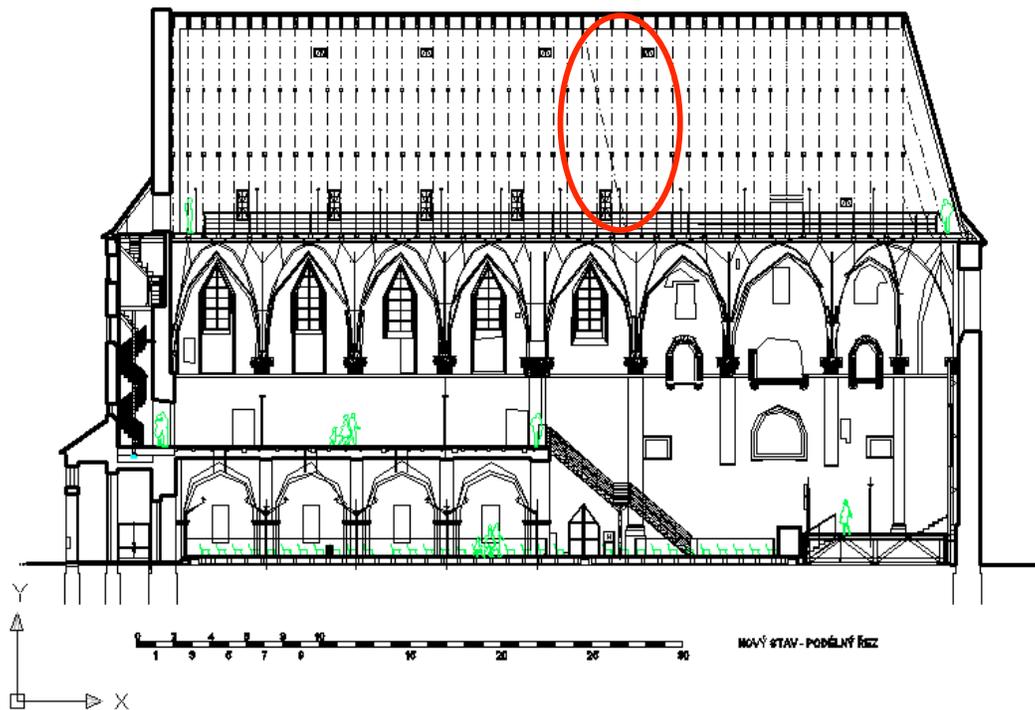
The location of the trusses is shown in Figure 33 below.

**Figure 33** Truss section with irregular geometry as indicated by the red oval

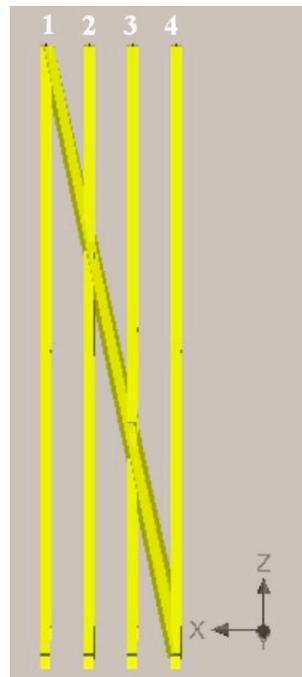
**Figure 34** Section with irregular geometry, viewed from the south

There are two members connecting the four trusses, seen in Figure 34 extending from the top of truss 1 to the bottom of truss 4. These members start at the peak of truss 1, and run along the surface of the roof to either side of the base of truss 4. The following pictures further illustrate the geometry.

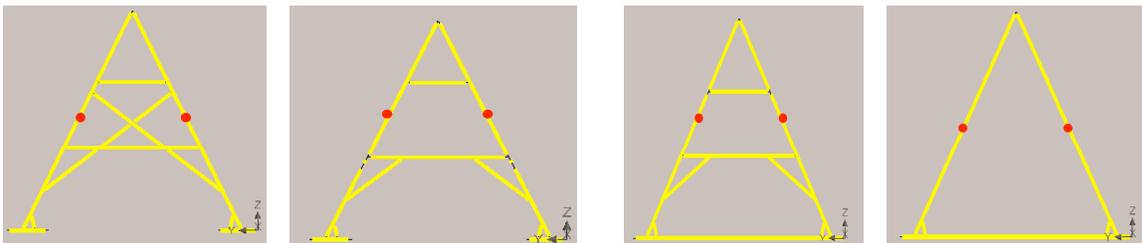
**Figure 35** Trusses 1, 2, 3, and 4 from Figure 34
