Name: Justin Hettinga  
Email: justin.hettinga@gmail.com  
Title of the Msc Dissertation: Structural analysis of the roof of St Anne's Church  
Supervisor(s): Professor Pavel Kuklik  
Year: 2008 - 2009

Buildings in Prague with an original Gothic roof structure are the focus of this thesis. An overview of buildings from the Gothic period (13<sup>th</sup> to 16<sup>th</sup> c.) and relevant architects is given. As the history of Prague, Bohemia, and the Holy Roman Empire is relevant to the construction of Gothic structures in Prague, it is discussed briefly. The majority of the Gothic buildings in Prague suffered considerable damage from wars, invasions, or fires, and few still have their original roof trusses. St Anne's Church, Old New Synagogue, Pinkas Synagogue, and Church of St Wenceslas in Zderaz all have original gothic roof structures. Access to St Anne's Church was granted, so it was studied for this thesis.

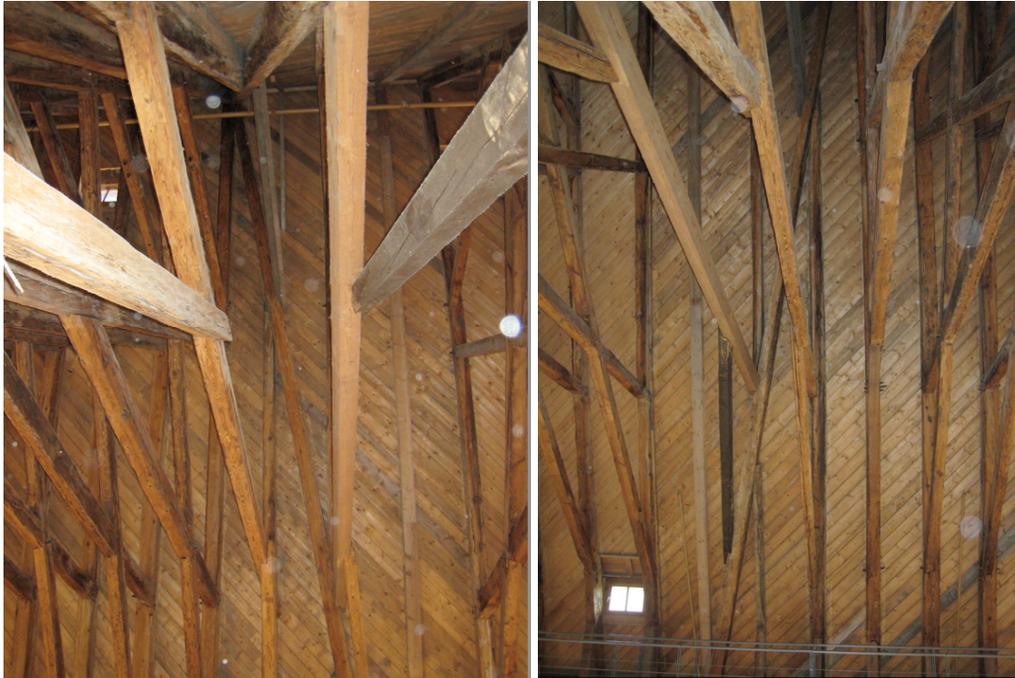
**Figure 36** Interior views of the section with irregular geometry

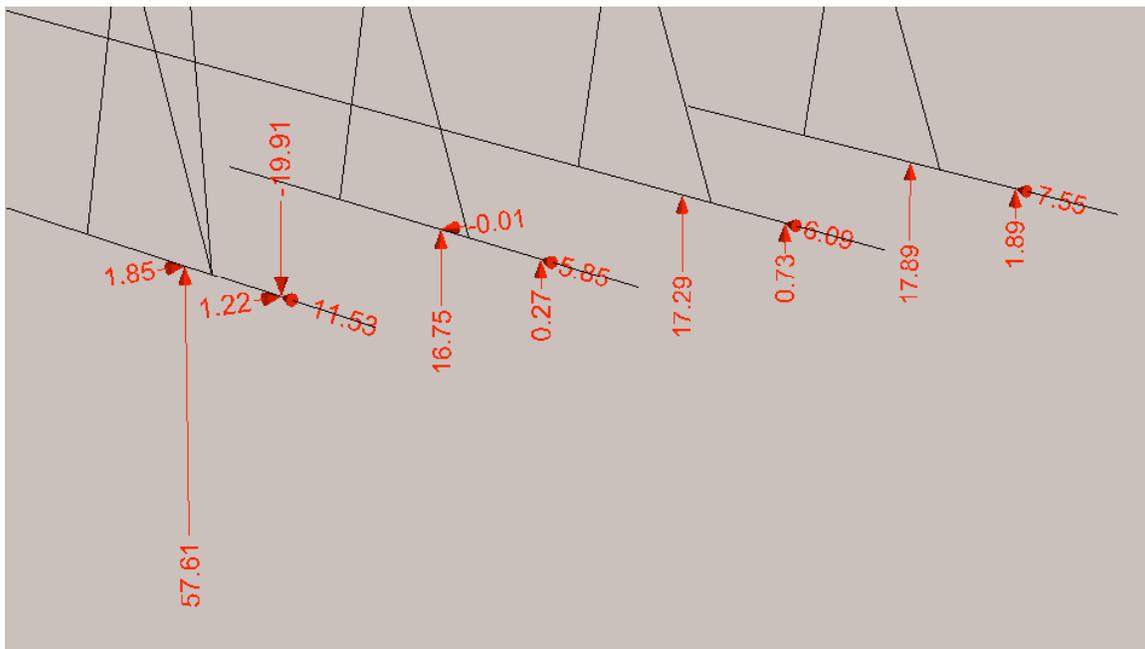
The loading distribution on the trusses is based on the stiffness of each truss. To start, the load is evenly distributed on all of the trusses. As shown in Figure 37 below, the diagonal members redistribute some of the load, as seen by the uneven reactions.

**Figure 37** Reactions at the supports on the north side of the trusses with irregular geometry, for load case  $1.35DL + 1.5 LL$

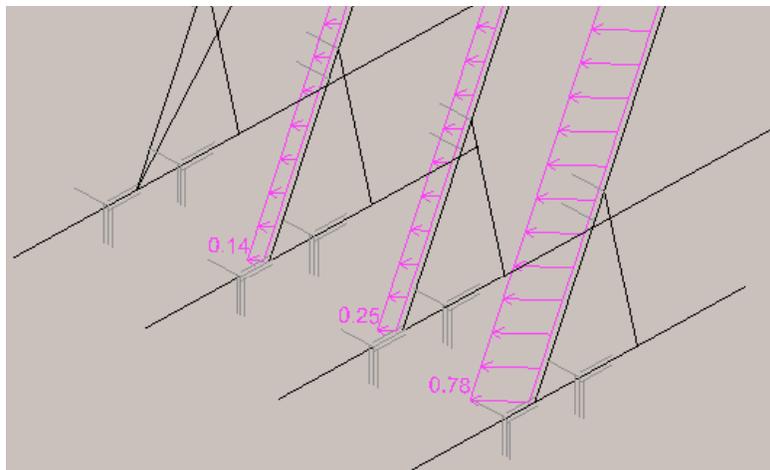
**Figure 38** Load distributed based on stiffness for load case 2 (external wind loading)

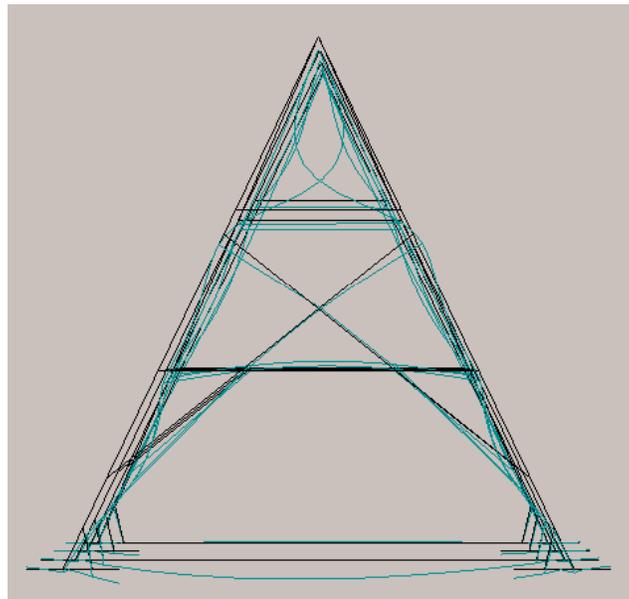
**Figure 39** Deflected shape of the four trusses for combination 1.35 DL + 1.5 LL

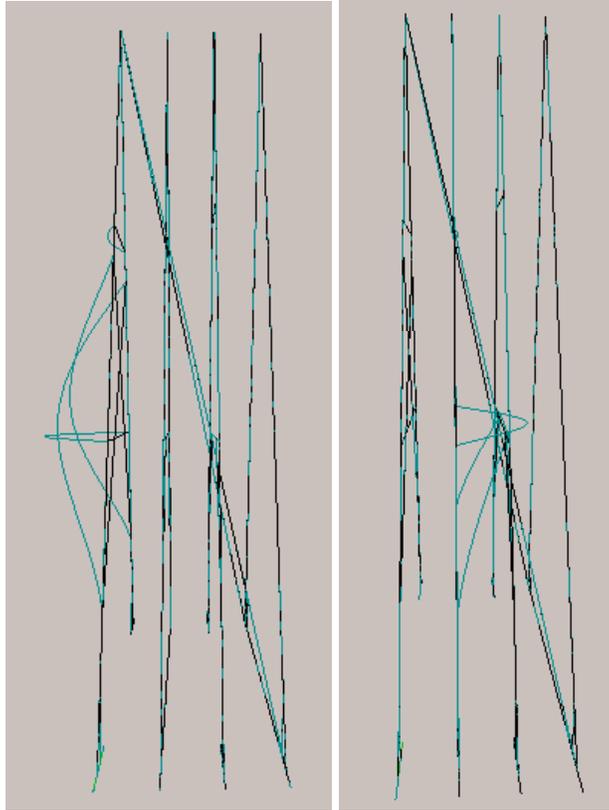
**Figure 40** Shape of the structure at failure due to linear stability for load cases 1.35 DL +1.5 LL, 1.35 DL + 1.5 WL case 1 int suct, and 1.35 DL + 1.5 WL case 1 int pres (left), and for load case 1.35 DL +1.5 WL case 2, int suct (right)

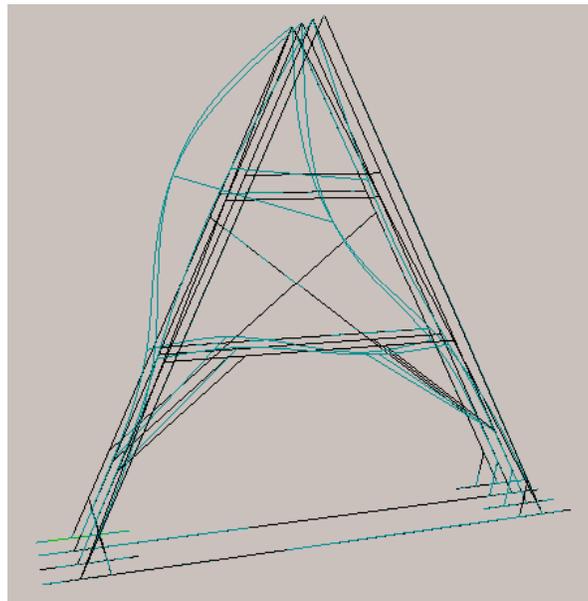
**Figure 41** Shape of the structure at failure due to linear stability for load combination 1.35 DL +1.5 WL case 2, internal pressure

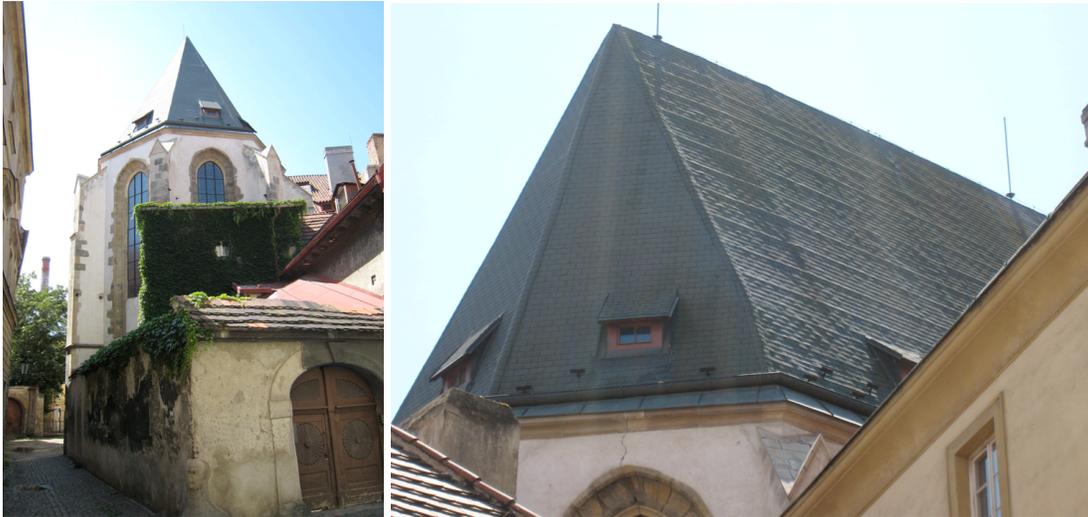
**Figure 42** External views of the east end of St Anne's Church

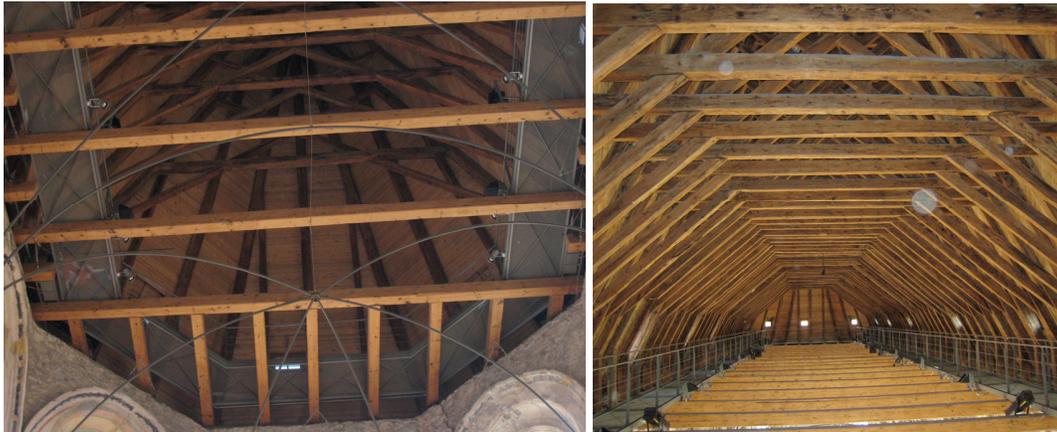
**Figure 43** Internal views of the east end of of the church

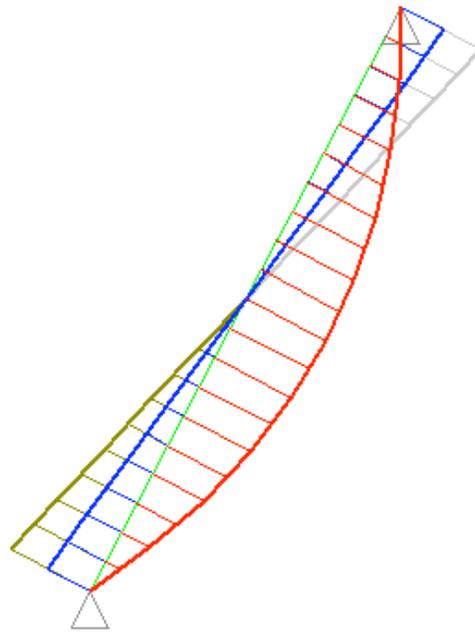
**Figure 44** Bending moment (red), axial force (grey), and shear force (blue) diagrams for a member on the end of the roof

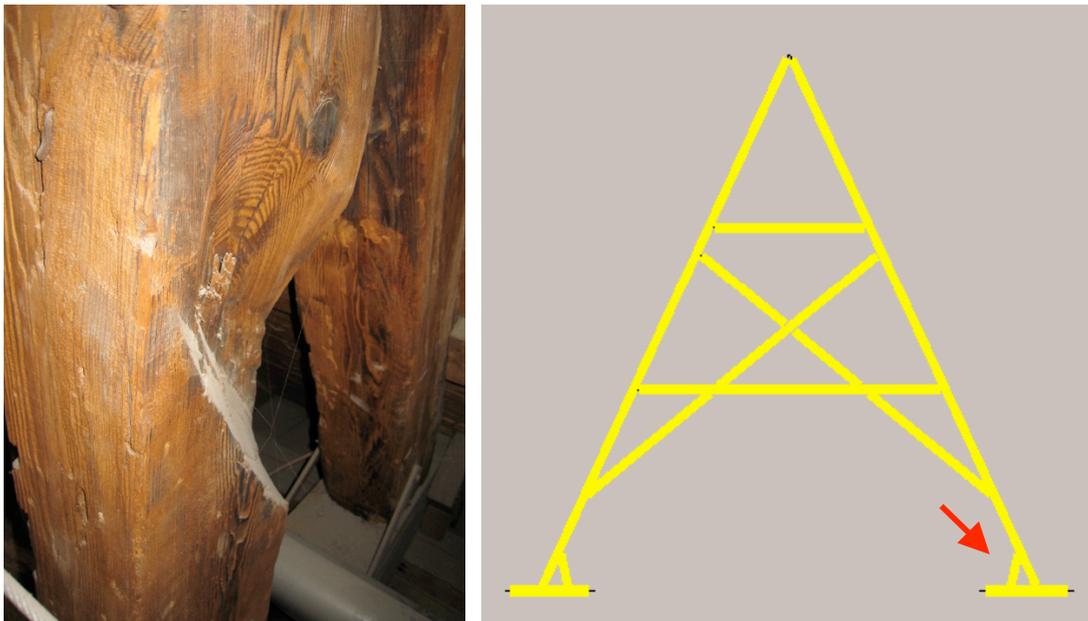
**Figure 45** Truss member with material missing, and the location of the member on the truss

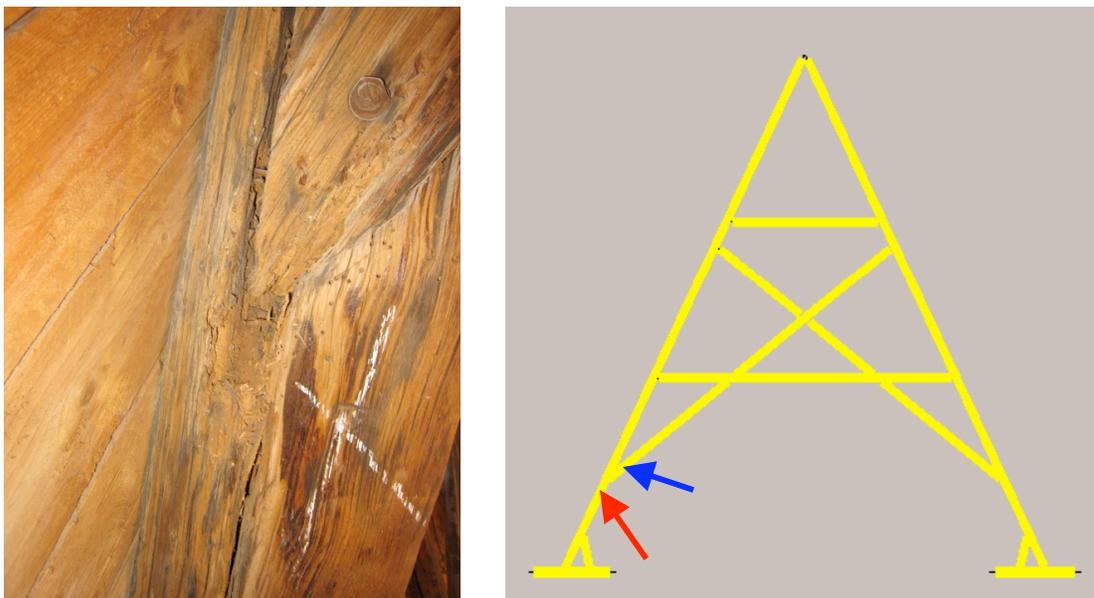
**Figure 46** Truss members with significant and insignificant damage, marked by the red and blue arrows, respectively

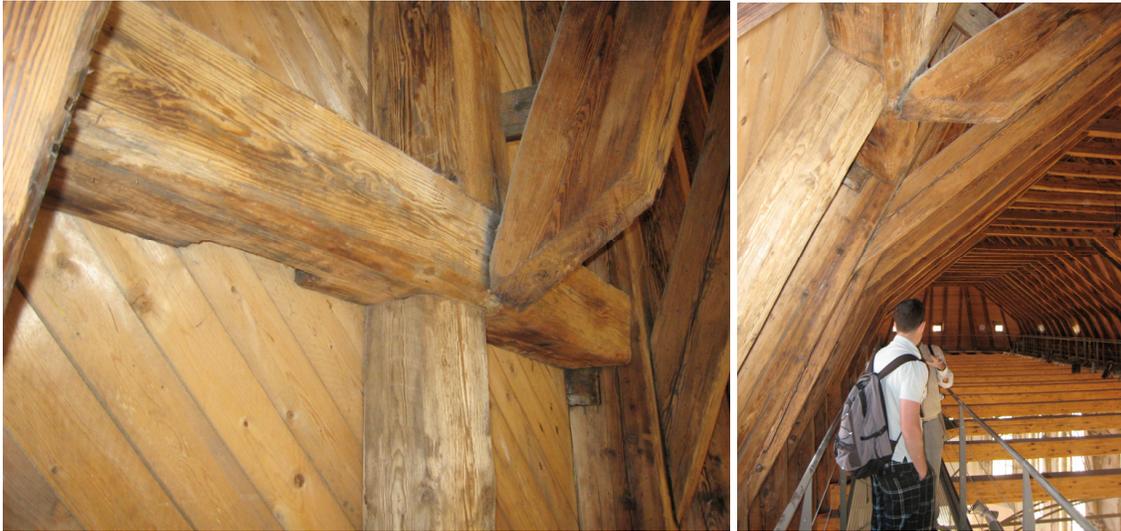
**Figure 47** Poor connection, with a large gap between the members

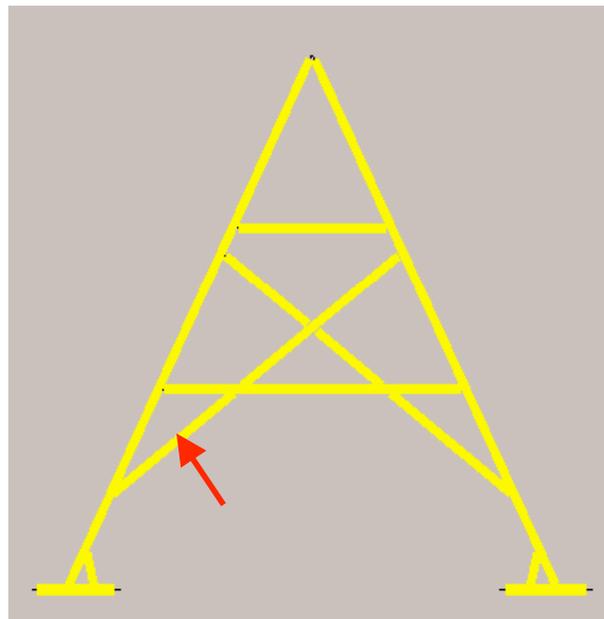
**Figure 48** Location of the member on the truss

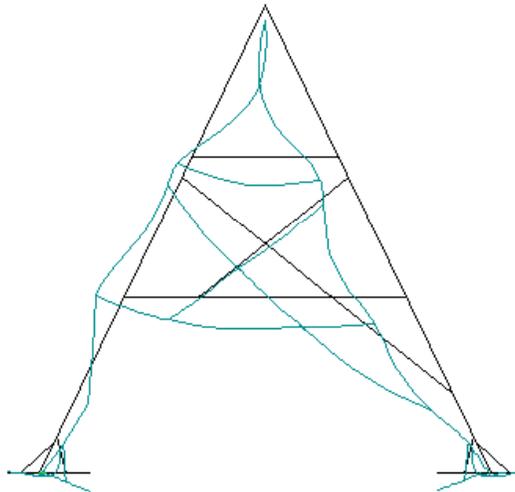
**Figure 49** Deflected shape of the truss with one member removed

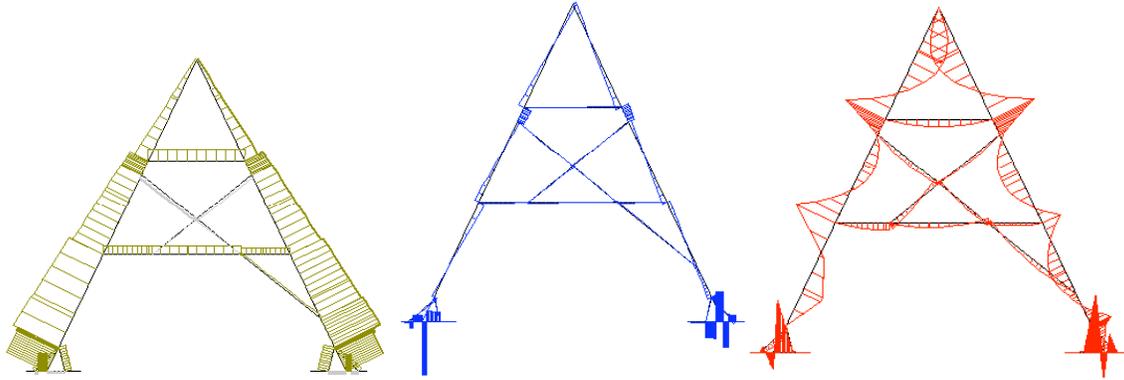
**Figure 50** Axial force, shear force, and bending moment diagrams for the truss with a missing member, for load combination  $1.35 \text{ DL} + 1.5 \text{ LL}$

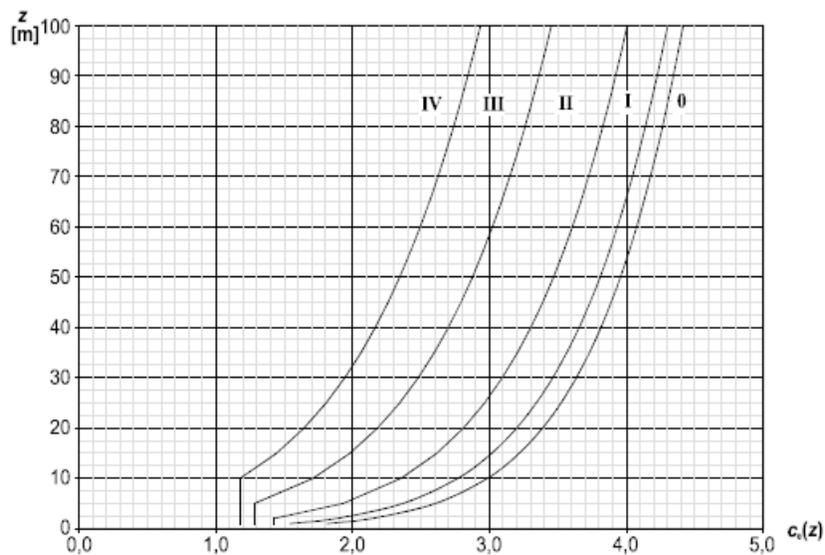
**Figure A1:** Illustrations of the exposure factor  $c_e(z)$  for  $c_0 = 1.0$ ,  $k = 1.0$

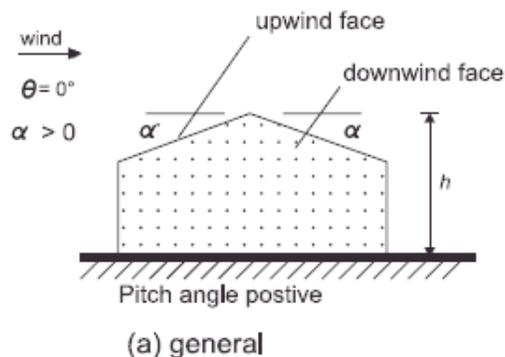
**Figure A2:** Wind loading on a structure

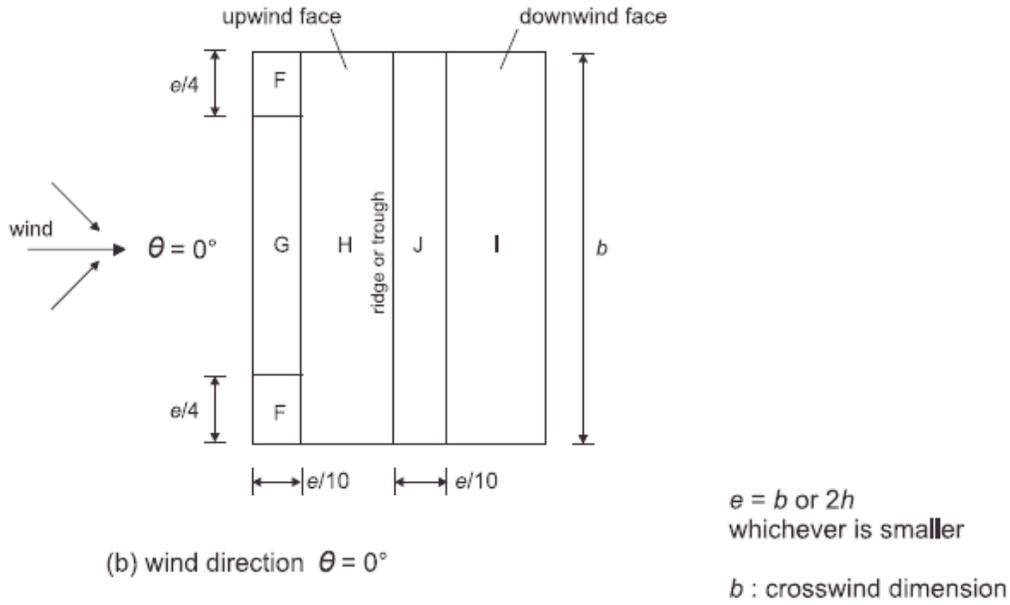
External coefficient ( $c_{pe,10}$ ) at wind direction  $\theta = 0^\circ$

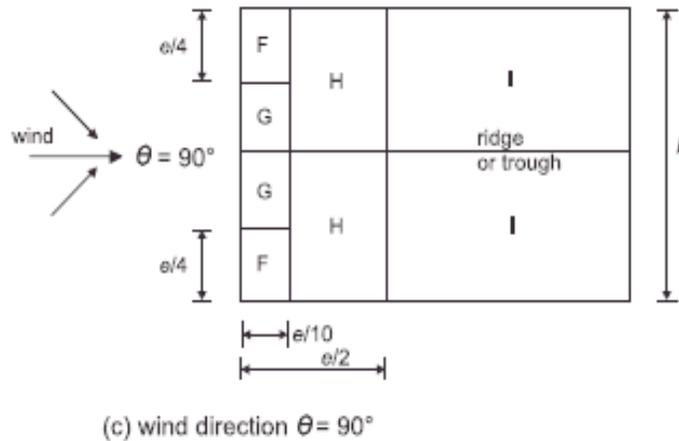
External coefficient ( $c_{pe,10}$ ) at wind direction  $\theta = 90^\circ$

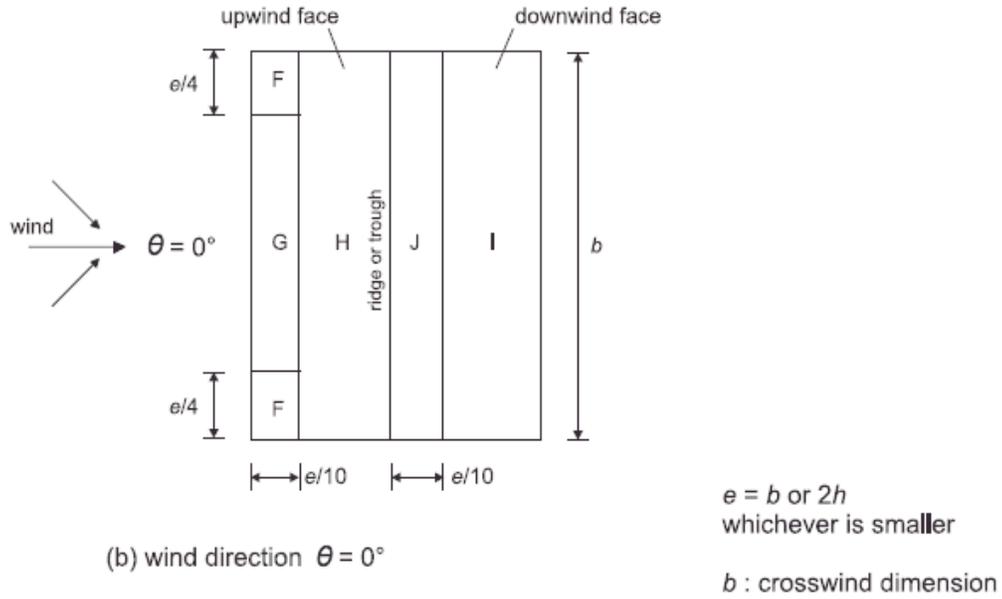
External coefficient ( $c_{pe,10}$ ) at wind direction  $\theta = 0^\circ$

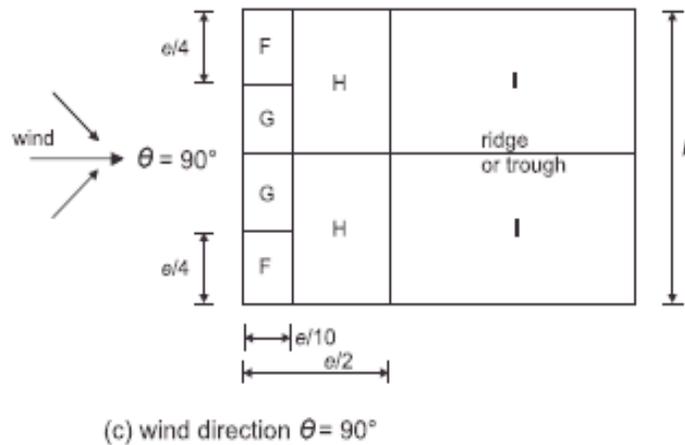
External coefficient ( $c_{pe,10}$ ) at wind direction  $\theta = 90^\circ$
