ADVANCED MASTERS IN STRUCTURAL ANALYSIS
OF MONUMENTS AND HISTORICAL CONSTRUCTIONS

Master's Thesis

Research on the restoration
of heritage structures:
Portland cement and concrete
repair applications and
repercussions

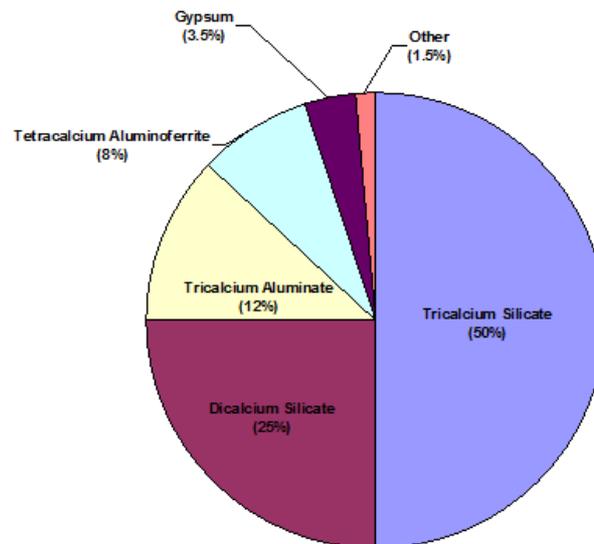
Figure 2.2 Oxide Composition of a Typical Portland Cement [14]

When Portland cement is mixed with water each of the individual chemical constituents undergoes a series of chemical reactions that leads to hydration, or the eventual hardening after transformation. The reactions occur at different times and rates respectively, and together their results determine how the cement hardens and gains strength.[14] Figures 2.1 and 2.2 explain the constituents and composition of a typical mix of Portland cement.

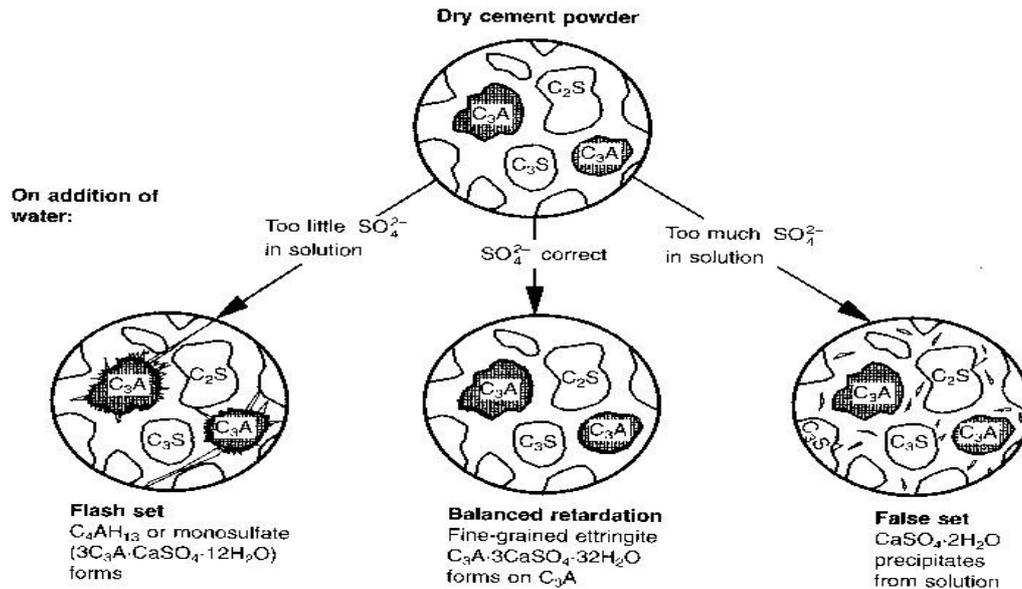
Figure 2.3 Potential setting problems during concrete hydration process [14]

techniques after placement. The amount of water used in the mix influences the resulting strength and permeability of the concrete. Excess water present during the hydration process produces more permeable concrete which is more susceptible to the damaging effects of weathering and deterioration. In modern concrete, admixtures are often utilized to further adjust concrete properties, which can enhance the final properties of a concrete batch if utilized properly.[13]

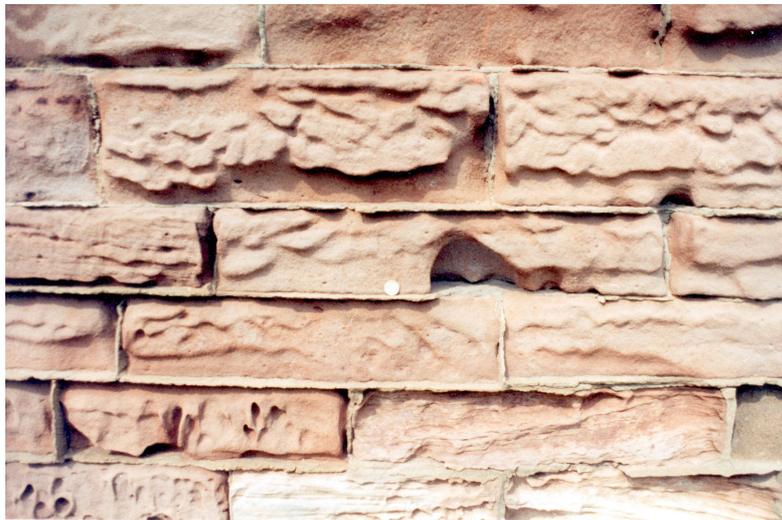
Figure 4.1 Cementitious Repointing: cement mortar harder than stone units, accelerating decay [22]

During the 20th century masons began to use mortars with a high percentage of Portland cement when replacing the deteriorated mortar found in joints in masonry walls. Portland cement was a popular choice for masons because it was simpler to use and more workable than other mortars. Historic mortar, particularly in the buildings constructed before 1920, is much softer and had less compressive strength than the masonry blocks it held together[10]. This mortar expanded and contracted due to changes in humidity and temperature, or to settlement. This process helped reduce stress on masonry units, which made them less likely to crack or spall. If a mortar mixture that is harder than the masonry units is used in repointing, which was sometimes the case in restorations using Portland cement, over time it is likely that bonds would break and cracks would proliferate, allowing passage of moisture. This damage would result in accelerated spalling, or loose, cracked units. In cases where Portland cement based mortars were used with softer units, such as sandstone and primitive bricks, serious problems often resulted.(Figure 4.1) Most masonry units created past 1930 were hard enough to be used with Portland cement.

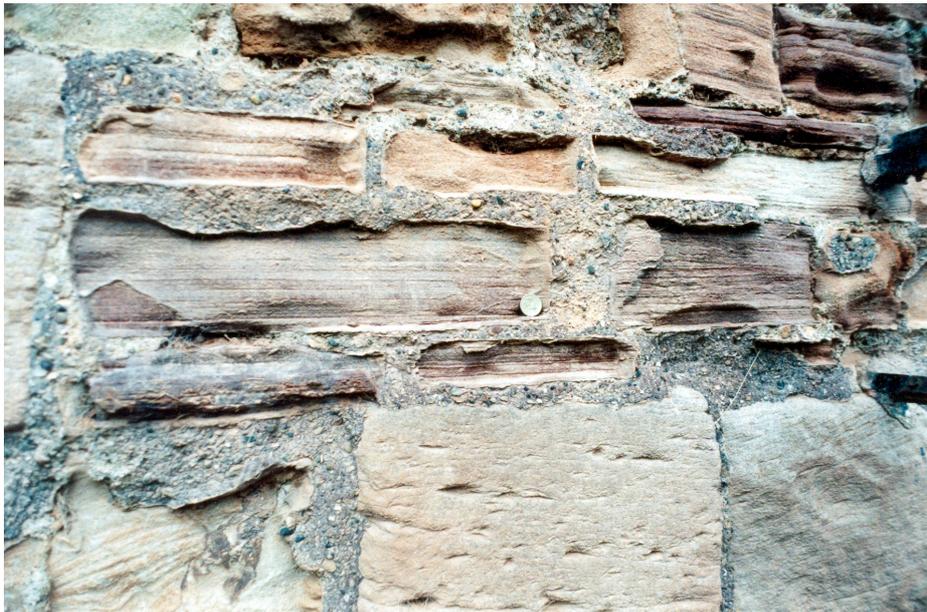
Figure 4.2 Hard cementitious repointing: Loss of permeability of joints, loss of original character and color scheme of masonry[22]

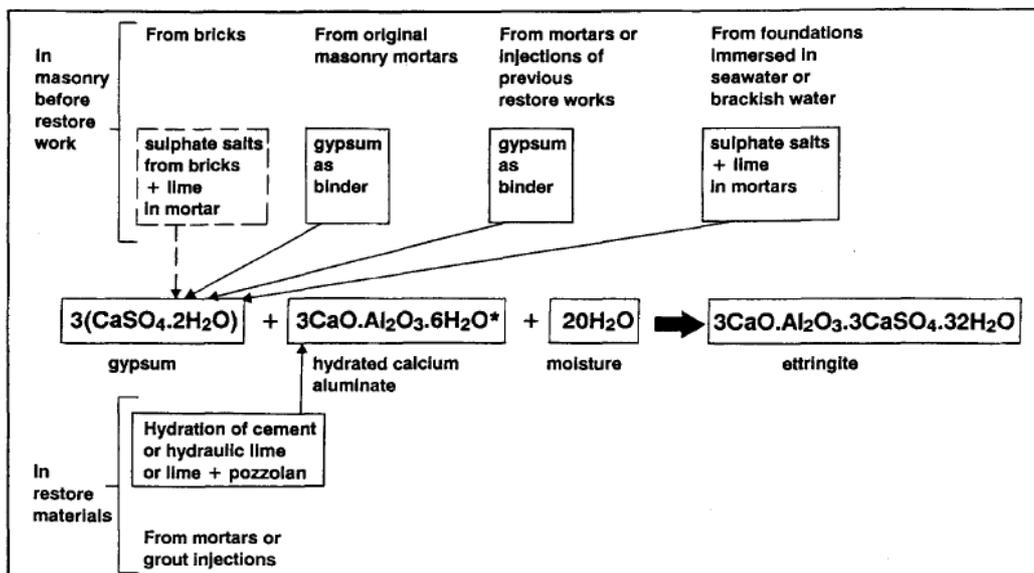
Figure 4.3 Interaction of Limestone Mortar and Sulfate Salts to Produce gypsum leading to Ettringite[11]

- The presence of sulfates in masonry
- The presence of calcium aluminates in repair mortar
- The presence of moisture in masonry

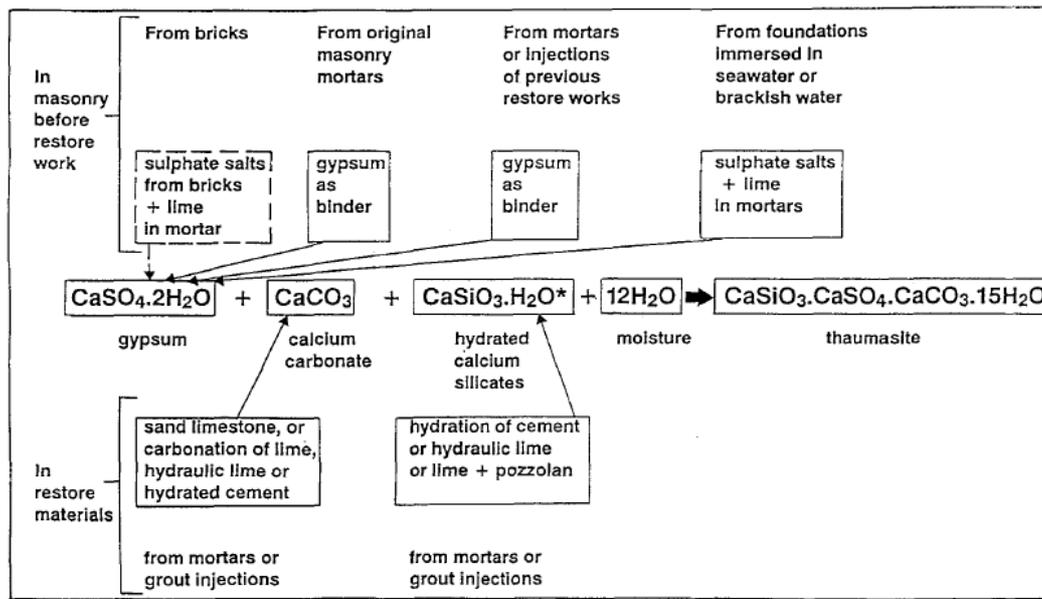
Figure 4.4 Interaction of Cement Mortar and Sulfate Salts to Produce gypsum leading to Thaumasite[11]

- The presence of sulfates in masonry
- The presence of calcium silicates in repair mortar
- The presence of moisture in masonry

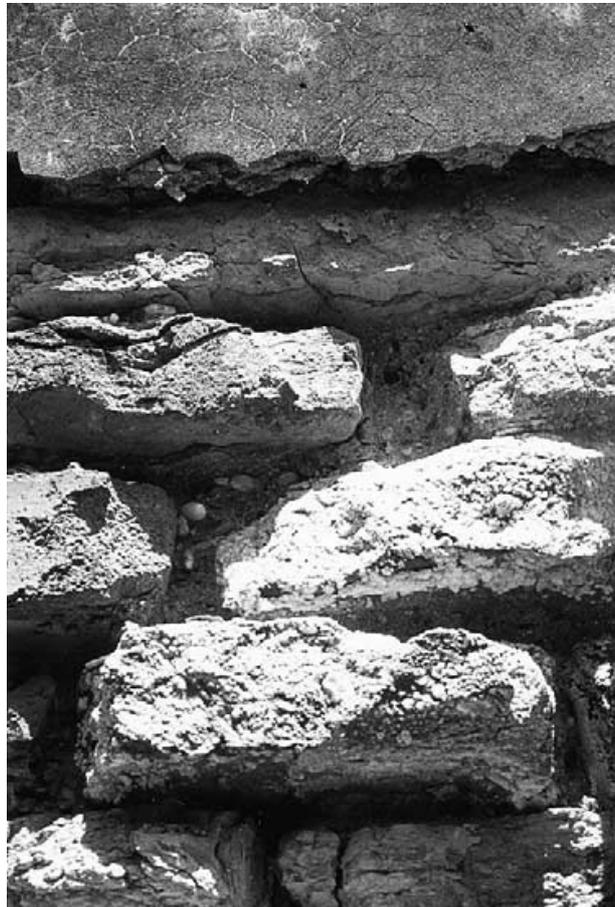
Figure 4.5 Severe deterioration of mortar stemming from thaumasite attack [5]

The formation of ettringite is linked to expansion, swelling and loss of strength in cohesion.[11] Thaumasite production does not cause significant expansion, but after formation the mortar loses its resistance properties and be transformed into a disjointed mass in the presence of moisture. This can result in a progressive removal of mortar due to washing out by rainwater. Ettringite forms more rapidly than thaumasite, but the presence of thaumasite usually precedes the formation of ettringite depending on temperature and moisture conditions. Low temperatures favor both processes, and in cold climates the formation of thaumasite is especially accelerated.

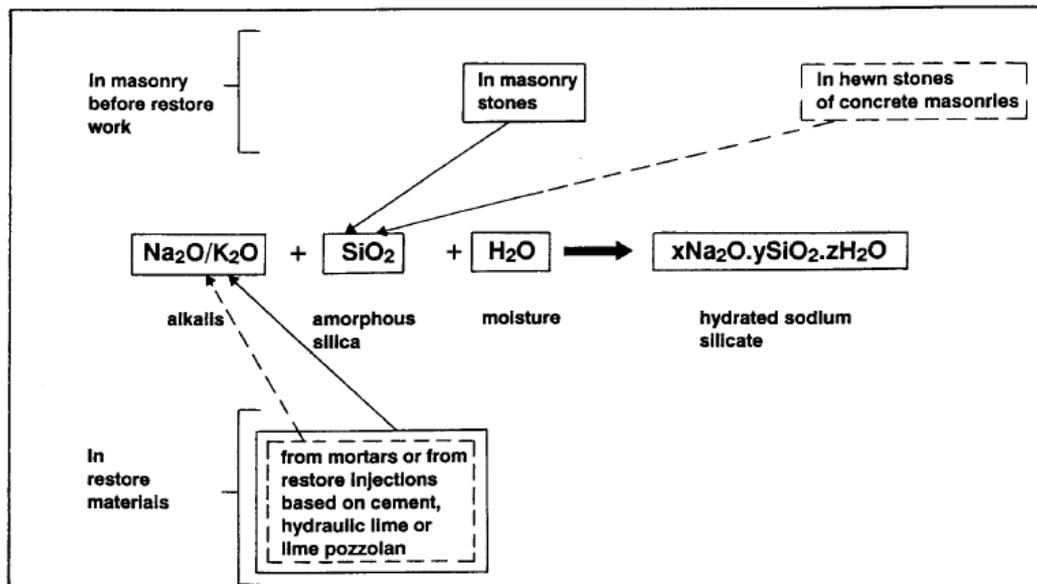
Figure 4.6 Interaction between cement binders and silica of stone and cement masonry units (Cement Units-Dashed Line)[11]

From the chemistry of concrete it is known that cement alkalis can react with amorphous silicas present in stone or concrete units to produce voluminous products, usually hydrated sodium or potassium silicates that cause accompanying expansive and disruptive phenomena on wall surfaces.[11] For this to happen the presence of moisture with masonry is necessary. If original stone units contain amorphous silica or partially crystallized forms of cristobalite and tridymite, the following reaction can take place when cement binders used in restoration are rich in alkalis.

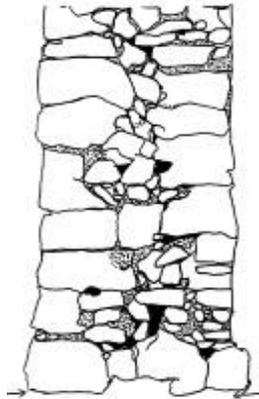
Figure 5.1 Poor Masonry Section with low void content[2]

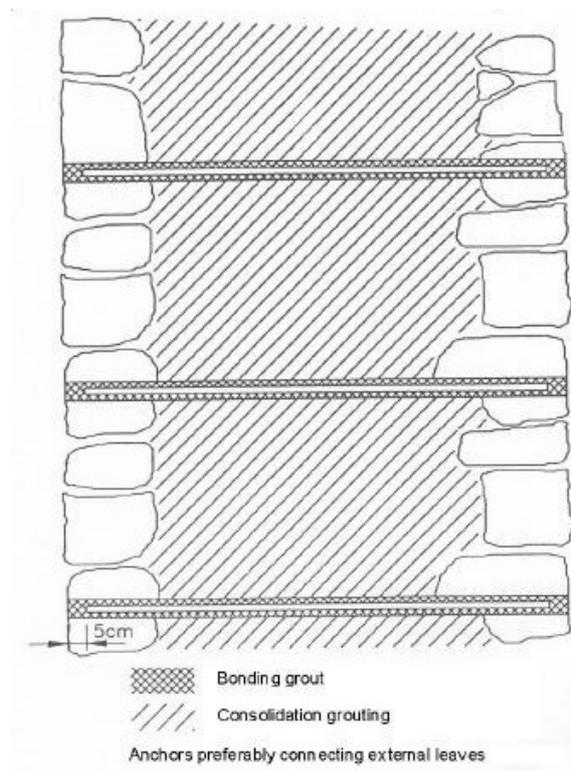
Fig 5.2 Grouted and Anchored Masonry Wall[9]

To consolidate walls, techniques typically followed a procedure of creating holes in walls with up to 40 mm diameter drills before adding rods and injecting cement grouts. This method hoped to fill gaps in walls and to reach a state of elastic continuity based on adhesion and resistance to traction of the concrete interventions. This process was also utilized to fill the gaps between two or more leaves of a wall when badly connected.[2] Grouted anchors installed properly increased the tensile strength of existing masonry. These actions were based on the principle of improving homogenization of otherwise heterogeneous masonry units, allowing the masonry to act as a completely autonomous structure during its life cycle. (Figure 5.2)

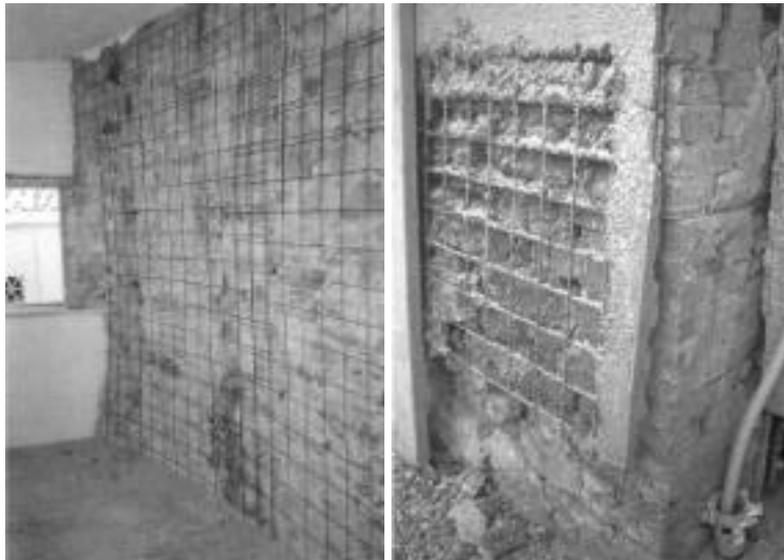
Figure 5.3 and 5.4 Discontinutites caused by lack of proper connection between nets in masonry rehabilitation[2]

The jacketing technique often utilized on walls and piers is comprised of the positioning of a reinforcing net on both faces of a wall, connected by steel ties, and then covered on both faces by a cement based mortar. Goals of the technique were to improve the connection of the wall, and to increase tensile and shear strengths and ductility.[2] The technique was commonly used to irregular multiple leaf stone masonry walls. In many cases the inhomogeneity of the walls, and the cost and problems associated with connecting both faces, made carrying out the process is quite difficult. Common mistakes in this intervention technique often include:

- Lack of proper connection between nets in walls and in correspondence with floors, causing discontinuities
- Lack of overlapping between two different sheets of the net
- Missing or over-spaced steel connectors causing separation of reinforced layers from walls
- Use of short connectors
- Insufficient cement cover leading to steel corrosion
- Lack of uniformity of distribution of repaired areas in structures, causing torsion stresses due to non uniform stiffness

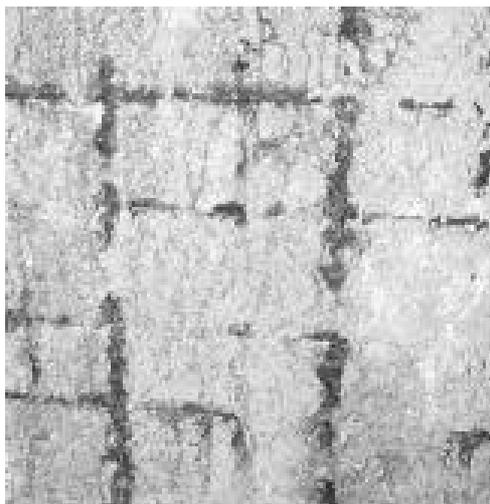
Figure 5.5 Corrosion of netting in rehabilitation[2]

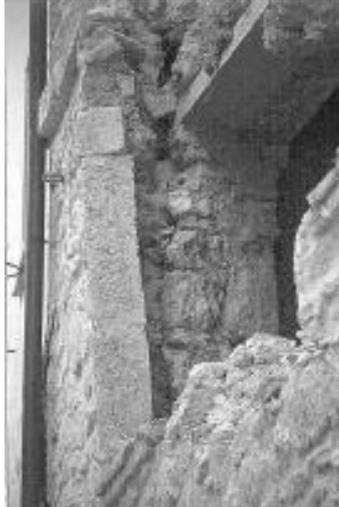
Figure 5.6 Eccentric loading damaged influenced by concrete tie positioning [2]

In many old structures concrete beams were utilized to replace floor timbers and mixed concrete and clay blocks were used in place of roofs. In this process a concrete tie was placed at each floor, positioned along the four sides of a structure to serve as a linking point from floor to wall. The goal of this technique is to induce the structure to work in the form of a stiffened box to resist horizontal seismic loads. Altering existing buildings in this form required partial demolition of each wall section to insert concrete ties into each section. This fact made it very difficult to ensure a stiff connection to existing walls, especially in the cases of multiple leaf irregular stone masonry. Typical damage

patterns in buildings altered in such a fashion includes: partial eccentric loading of walls, and poor connections of tie beams to walls. (Figure 5.6)

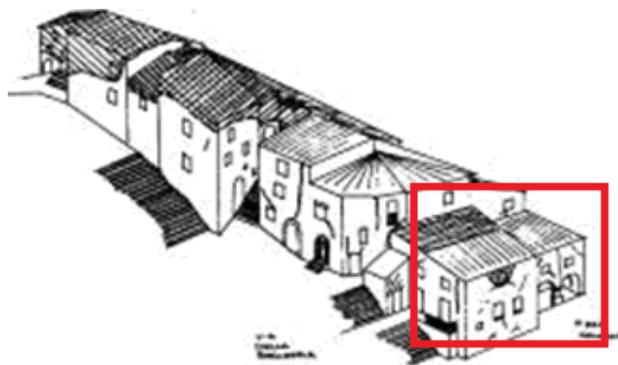
Figure 5.7 Block effect damage in rows of buildings, failure at end of row[2]

Recent post seismic event studies in Italy and Portugal have identified the need to better understand and define the typical mechanisms of large blocks of houses where buildings are attached together in rows. In such cases these buildings have been identified as “building blocks.” Studies have identified interesting cases of failure during seismic events, especially when one or more of the houses in the “blocks” have been altered from their original makeup, which have changed the theory behind ensuring safety in such constructions.[2] In post seismic event studies done on block structures of this nature, it was noticed that the first and last buildings in each block have seemed to endure the most damage in the form of local collapse and large cracks. When collapse occurred in the interior of such blocks, it was always an unrepaired building surrounded by two repaired structures.[2]

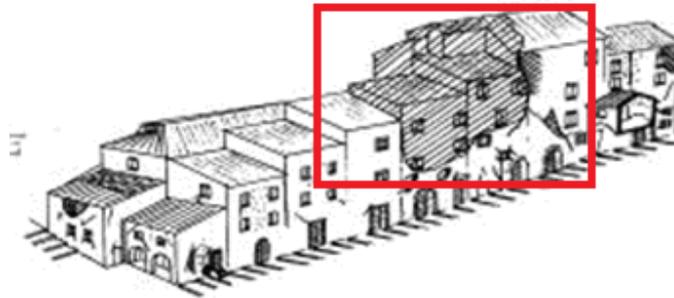
Figure 5.8 Block effect damage in interior of row; unchanged interior buildings surrounded by repaired structures[2]

In most cases, the repairs in masonry based houses of this layout were typically replacement of timber floors and roofs with reinforced concrete slabs. In typical structural models, single structures in each block were modeled as separate entities, but after actual events it was noted that for horizontal loading, namely seismic forces, that this approach was flawed. Such structural system when under the force of horizontal loading have been identified to absorb and distribute forces as a whole entity, not house by house as previously believed. The structural performance of modified buildings, such as the case of structures with floors and roofs replaced with reinforced concrete, affect the structural performance of every house in the rest of the block.[6] Specifically, reinforced concrete floors and roofs induce severe changes in stiffness in the buildings, which is known to produce damage through pounding effects. This topic is explained in greater detail in Case study 3.

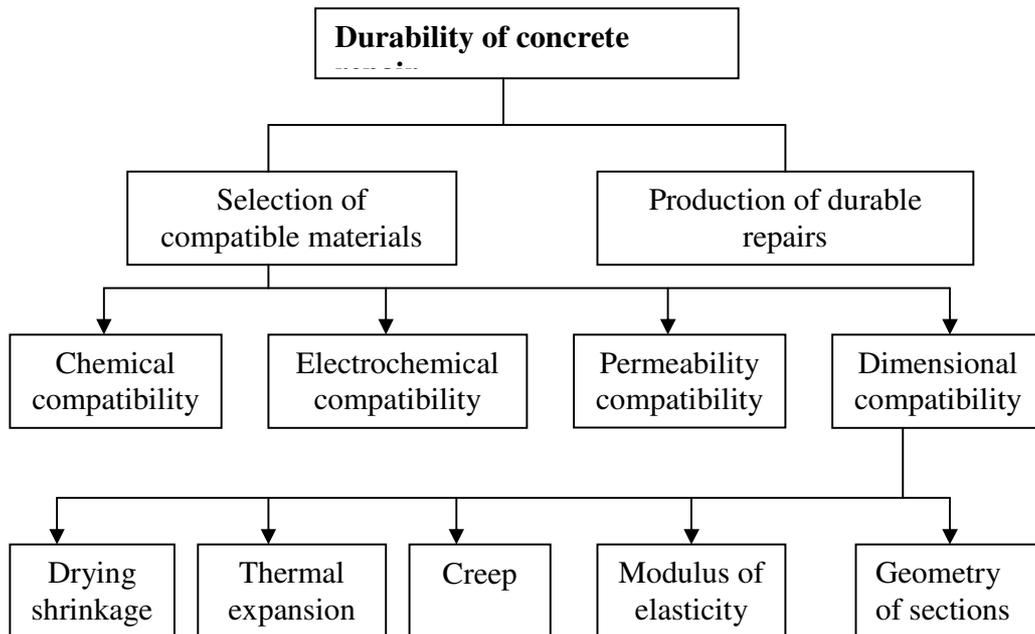
Figure 6.1 Considerations affecting potential concrete durability

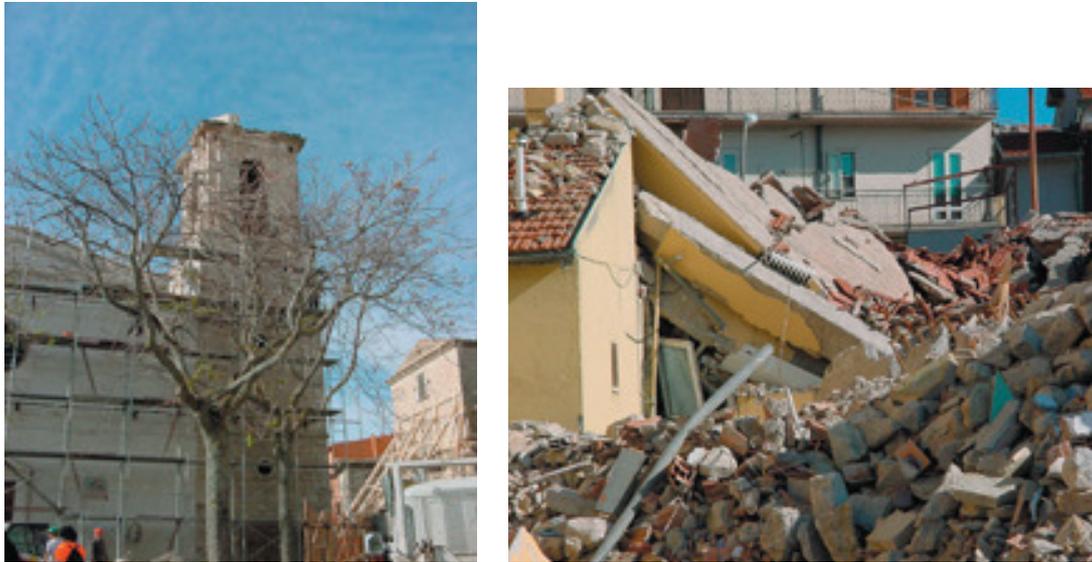
Figure 7.1 LEFT) San Giacomo Church; the spire of the bell tower which was recently reconstructed in reinforced concrete has collapsed, original unreinforced masonry bell tower left undamaged RIGHT) collapsed school in San Giacomo, visible: heavy concrete slab of second floor was supported by the now collapsed poor quality stone masonry units[3]

Historic churches in the area were proven to be particularly susceptible to seismic forces, and this fact was exacerbated by retrofits that were proven to be incompatible with the natural vibrations of the original masonry walls. Roofs that were constructed of reinforced concrete, and the addition of thick concrete tie beams and floors dramatically increased the inertial forces that could not be accommodated by the original structures.[1] In most cases, seismic retrofitting was the predominant reason for roof replacement. An example of this was found in the village of Santa Croce di Magliano where two recently retrofitted churches, Sant Antonio da Padova, and San Giacomo suffered severe damage and partial collapse, while abandoned Greek churches already in poor states showed only slight worsening of damage.

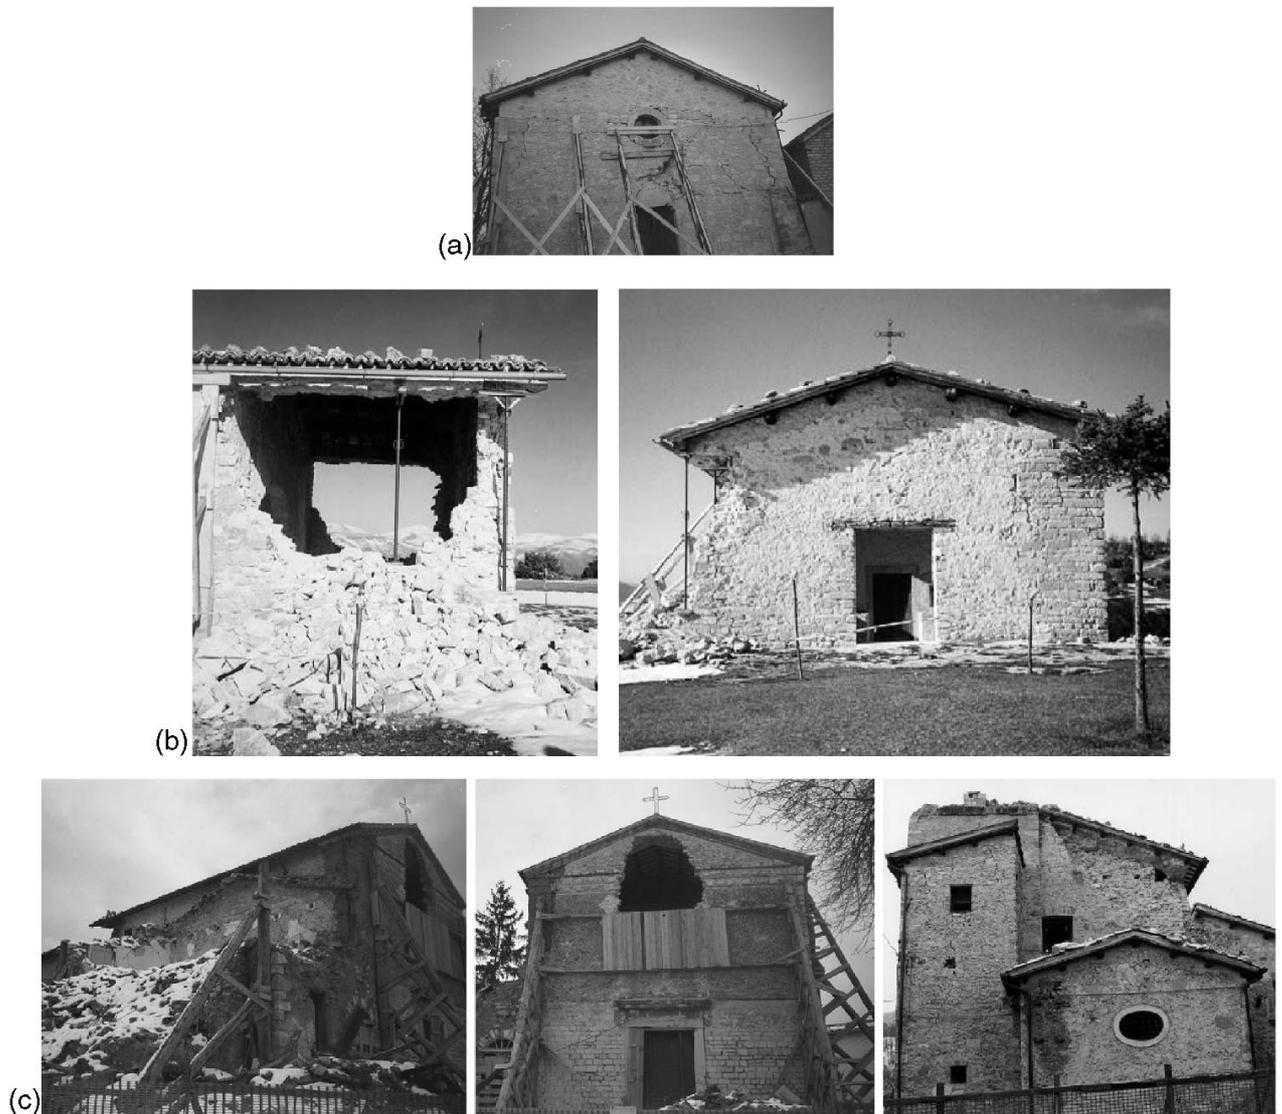
Figure 7.2 Churches damaged by Earthquake In Umbria Region presumed to be caused by added weight of concrete roofs A) cracked supporting walls B)caused total collapse of walls C) damaged external wythe curtain walls[4]

Damage mechanisms first viewed observed in the 1997 earthquake were repeated once again after the Molise earthquake in 2002. 75 churches in the earthquake epi-central and surrounding areas were inspected to identify various collapse mechanisms and causes of damage, and the most common damage patterns included: damage due to crushing and shearing of masonry pillars due to increased weight of reinforced concrete tie beams and slabs on vaults, sliding and overturning of bell towers as a result of increased rigidity and weight after intervention, and damages in apses from reinforced concrete roofs. Observations confirmed that the monuments were particularly vulnerable to seismic actions largely because of details such as slender walls and heavy architectural elements.

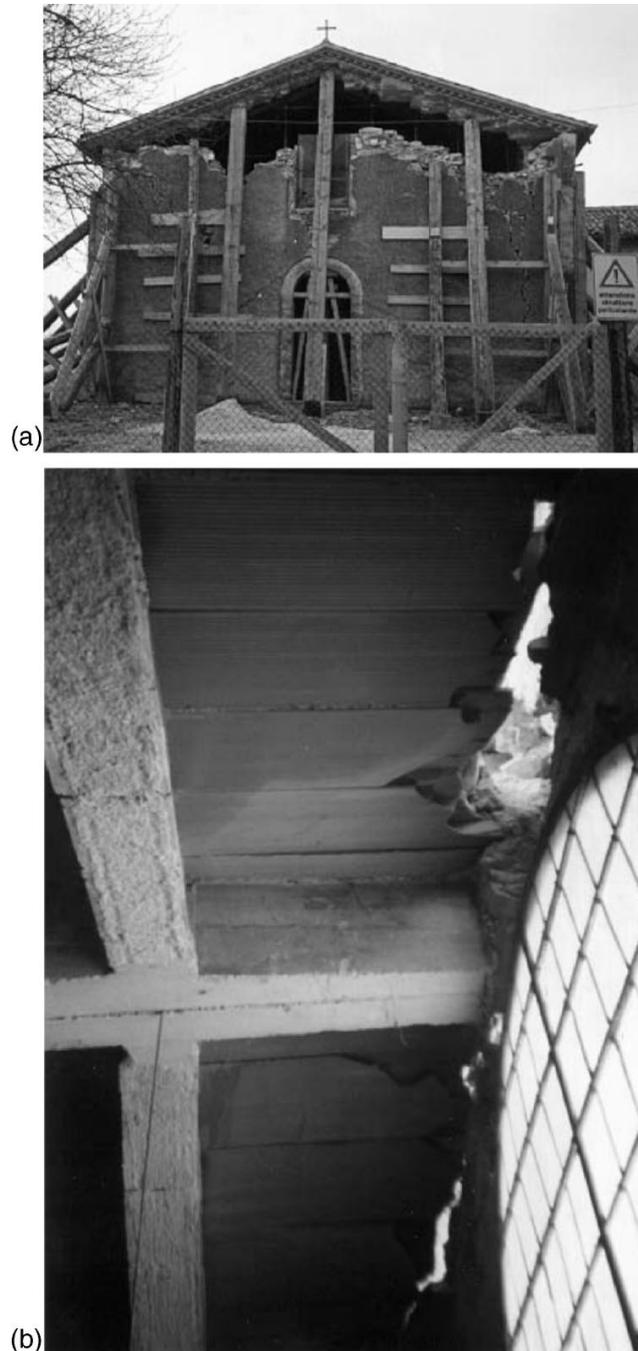
Figure 7.3 Out of plane failure of façade gables; common failure mechanism in structures where wall is not well connected to roof, hammering effect issues[4]

Figure 7.3 depicts the out of plane failure of gable end walls. Failures of this type are common in structures where walls are not well connected to roofs. Inertial forces corresponding to the weight of the roof itself are thought to ensure failure, but in these cases post earthquake study postulated that failures showed the effects of hammering of the roof on the masonry below.[4] It is believed that the increase of weight and stiffness on the roof led to an increase in the horizontal seismic forces that induced collapse of the masonry walls, with the stiffness of the topmost tie beam obstructing the natural vibration mode of the masonry, in turn inducing high local stress in the masonry.[4]

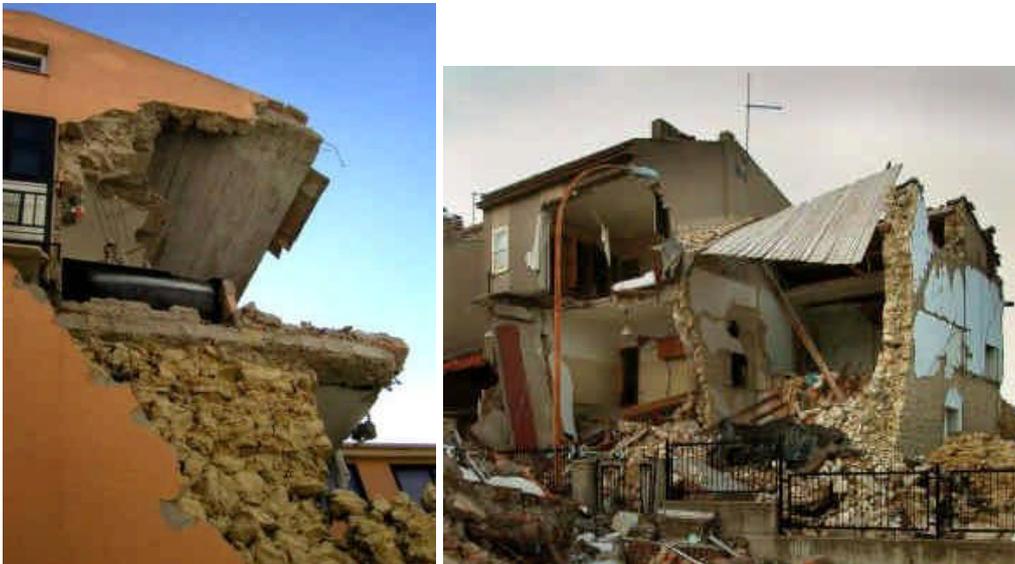
Figure 7.4 LEFT: Reinforced concrete floors retrofitted onto old buildings without wall ties; contributing to damage RIGHT: two buildings of mixed construction lost their façade and floors because of lack of ties between floors and walls[1]

Buildings in the area that underwent modifications during their lifetime were proven to be more vulnerable during the seismic event. A common modification was the replacement of old wooden floors with newer, heavier reinforced concrete beams, which were installed without upgrading the strength of masonry bearing walls. The post earthquake study showed that alterations and interventions often took place without heed of any regulations or seismic design criteria. The earthquake was particularly ruthless on these buildings because the floors were not tied through the original masonry walls and did not contribute to holding them together, which increase the chances of collapse. While new

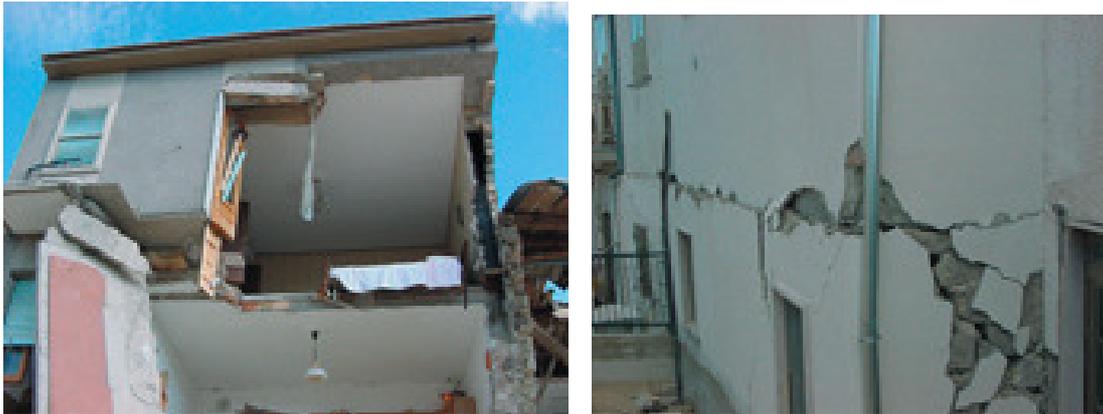
Figure 7.5 LEFT: Failure of exterior masonry wall not properly connected with concrete slab RIGHT: Detachment and shifting of top story comprised of reinforced concrete from bottom floor stone masonry wall [3]

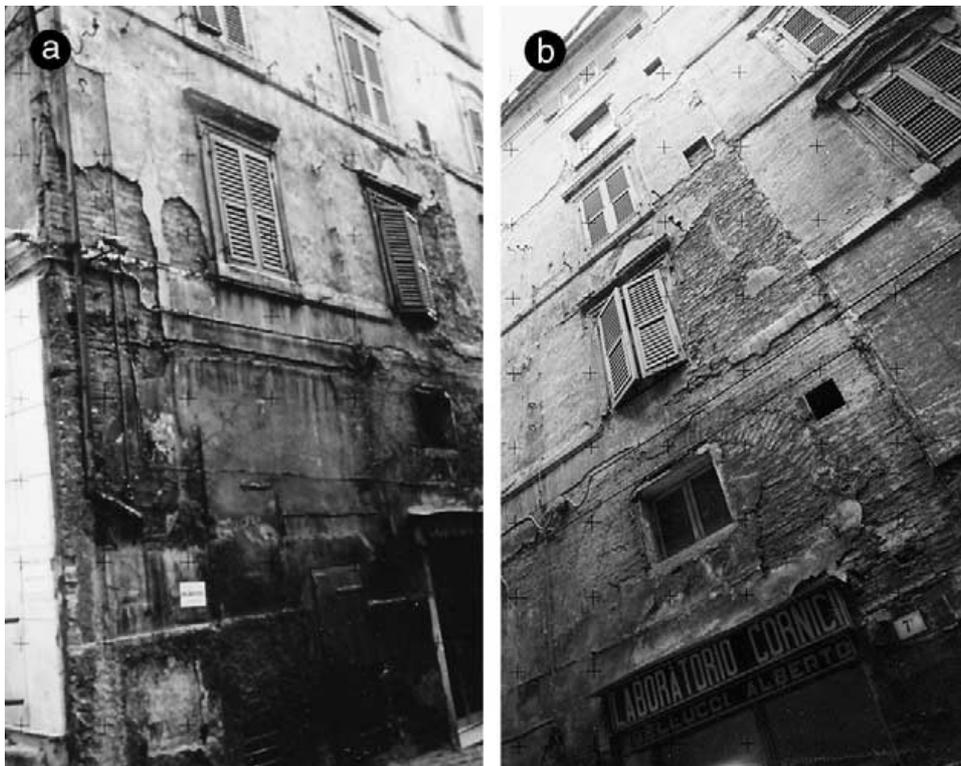
Figure 7.6 Deterioration of mortar in Ancona historic center caused by A)ettringite and B)thaumasite [5]

- Presence of gypsum and ettringite found in interior mortar attributed to migration phenomena
- Presence of gypsum and ettringite found on exterior mortar evidence of hydraulic binder incompatibility during later interventions
- Absence of thaumasite attributed to washout by atmospheric agents
- No capillary rise observed in masonry, ettringite attributed to sulfate attack from environment

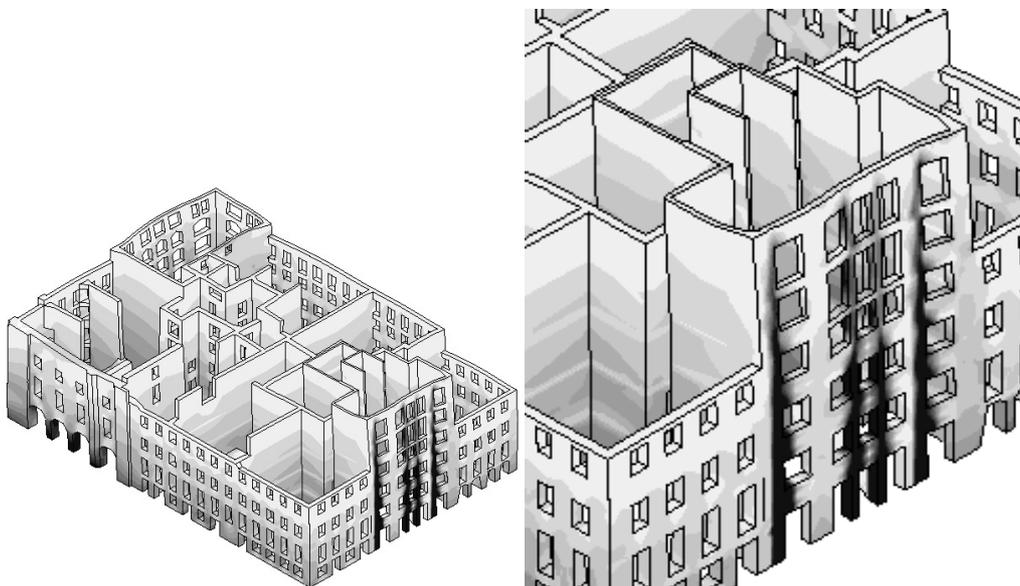
Figure 7.8 FEM model highlighting increased stresses in RCC elements within altered structures[21]

In the proposed study, a historically significant block was chosen and analyzed and modeled to assess the global block effect on such structural arrangements. The finite element model concluded that stress peaks were over 3.5 times higher in areas where columns were replaced by reinforced concrete than in original masonry columns. (Figure 7.8) The increased stress statistics have been linked to the stiffness and weight properties of the concrete sections that differ drastically from that of original materials. It was also noted that areas where reinforced concrete elements were implemented would experience much smaller displacements than unchanged sections, which would lead to increased damage linked to pounding or collapse of slabs, if masonry bonds are not strong enough to resist high forces imposed on them. Modeling has also predicted the failure of corner buildings due to their inability to produce structural behavior necessary to withstand predicted seismic forces.(Figure 7.9) The results of past events have corresponded with the study's predictions as that the large masses associated with such concrete elements has usually resulted in the untimely collapse of masonry walls, such as in the case of block arrangements in the Umbria and Molise Earthquakes in 1997, and 2002 respectively.

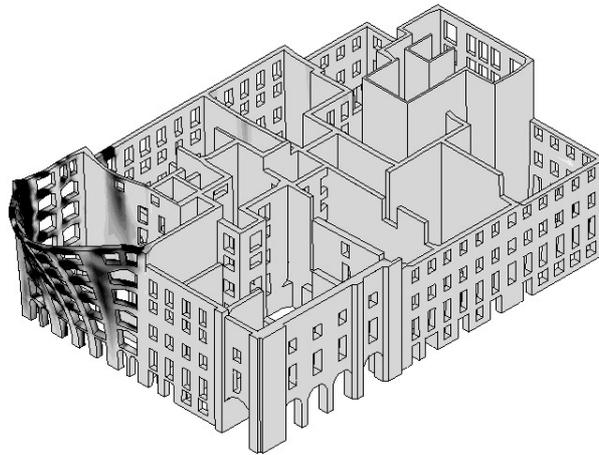
Figure 7.9 Predicted failure in corner building of model analyzed as entire block for horizontal loading[21]

This study has proven the erroneous nature of modeling singular structures in such arrangements in hopes of gaining an estimate of actual performance when exposed to seismic forces. It has identified the changes in behavior of blocks as global structures if even one singular building in each group has been altered by intervention. The authors have recommended safer and more thorough modeling theories that must be undertaken to accurately predict potential performance of such block types in seismic events, and what actions must precede any future alterations to any structures within each grouping.
