ADVANCED MASTERS IN STRUCTURAL ANALYSIS
OF MONUMENTS AND HISTORICAL CONSTRUCTIONS

Master's Thesis

Monitoring and Structural Assessment of Monuments in the Historical Centre of L'Aquila struck by the 2009 Earthquake: the Case Study of St. Silvestro Church

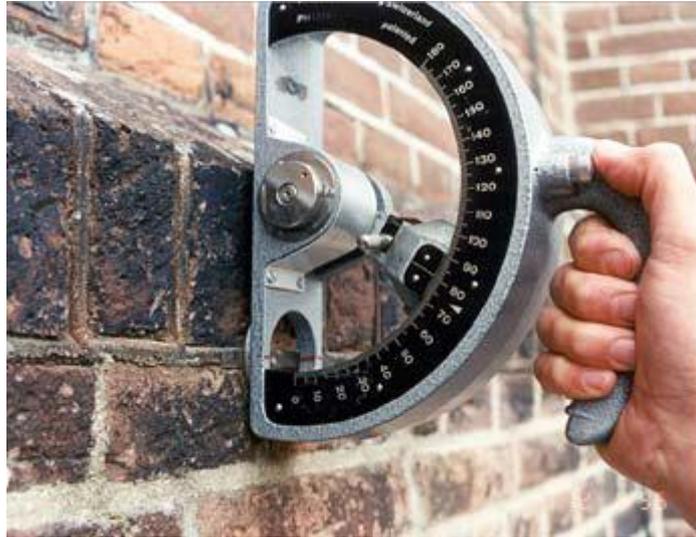
Figure 2-9: Schmidt Hammer

The calibration equation that relates the rebound of the hammer with the compressive strength has to be known before, but it is usually found with a destructive test on the material.

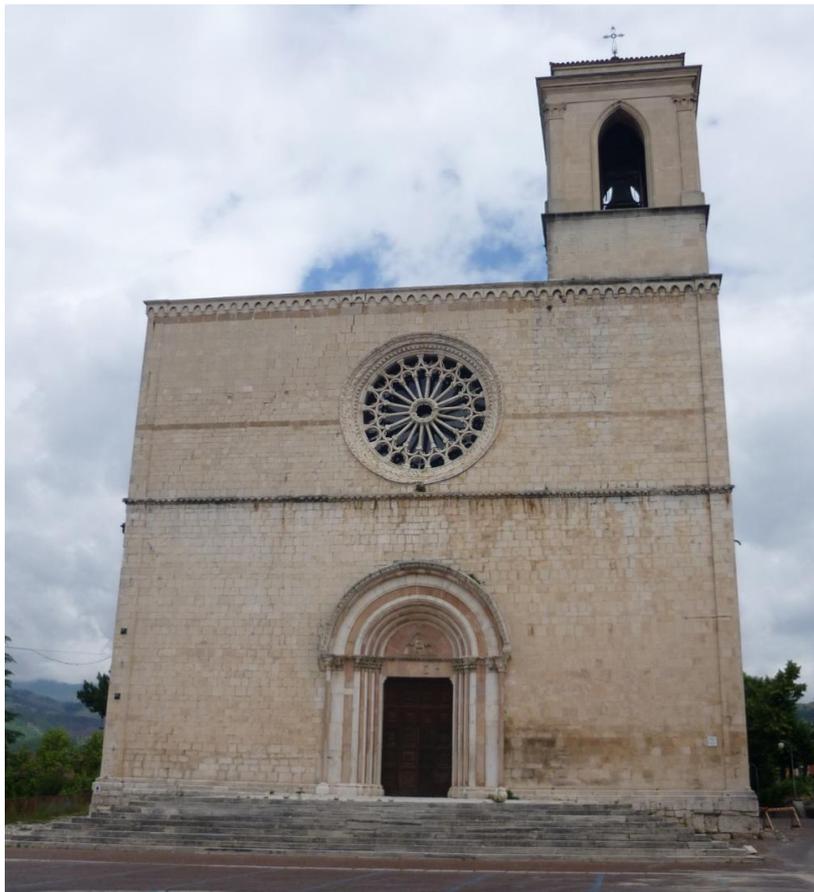
Figure 4-6: St. Silvestro Façade

Figure 4-6 shows the front façade of the building. It is characterized by a portal with the original timber doors dating back to 1539, but following the same style that can be observed in St. Giusta and St. Marco and coming from the XIV century. Just above the portal is the rose window: it is finely decorated and follows the gothic style, even if its central part seems to be from the XVI century.

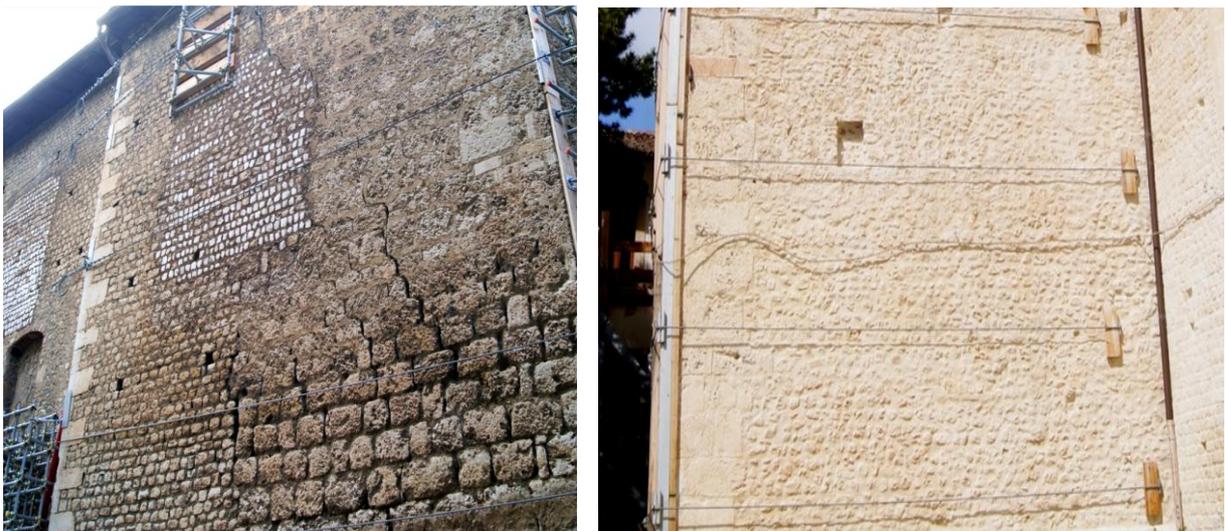
Figure 4-7: The "apparecchio aquilano" layout of the east wall (left) and west wall (right)

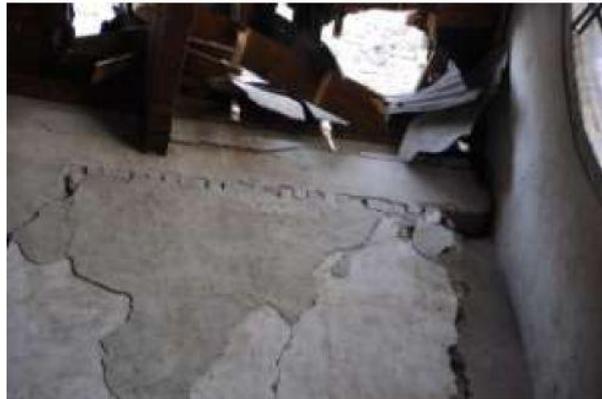
Figure 4-9: The RC curb (Borri, et al., 2010)

Other materials found in the Church are the RC curb (Figure 4-9) added in 1967 by Moretti and steel ties already described before.

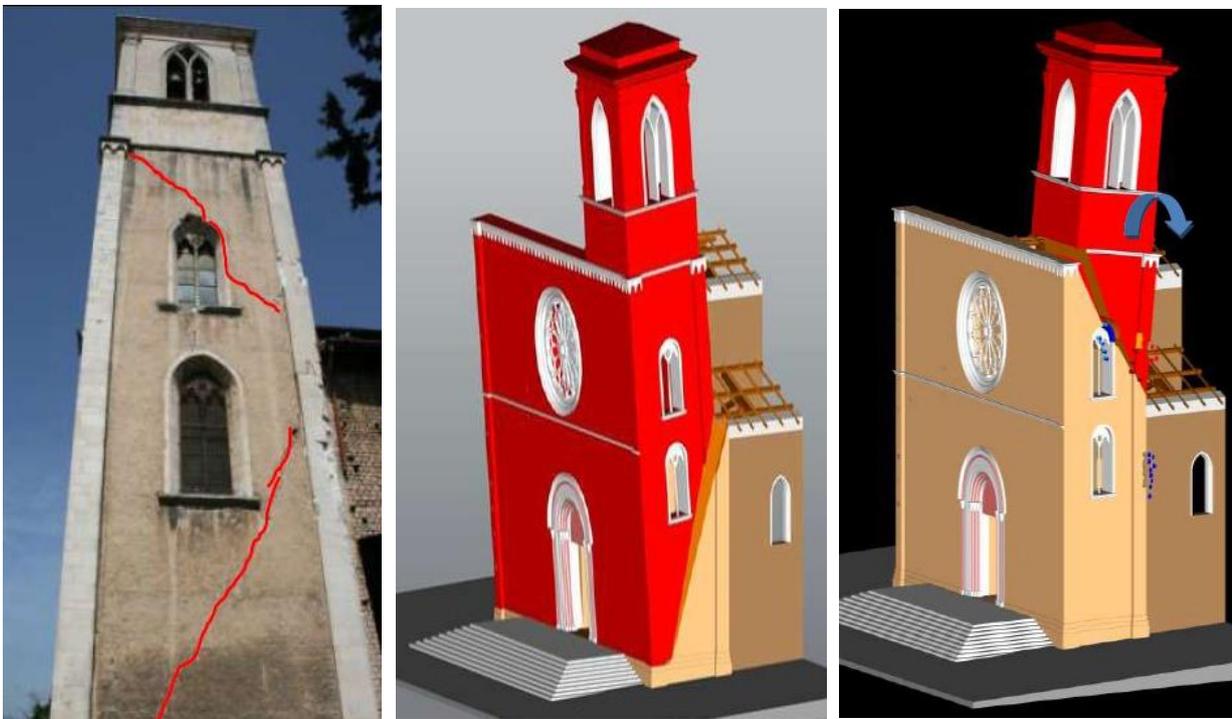
Figure 4-13: Overturning mechanisms of the bell tower (Borri, et al., 2010)

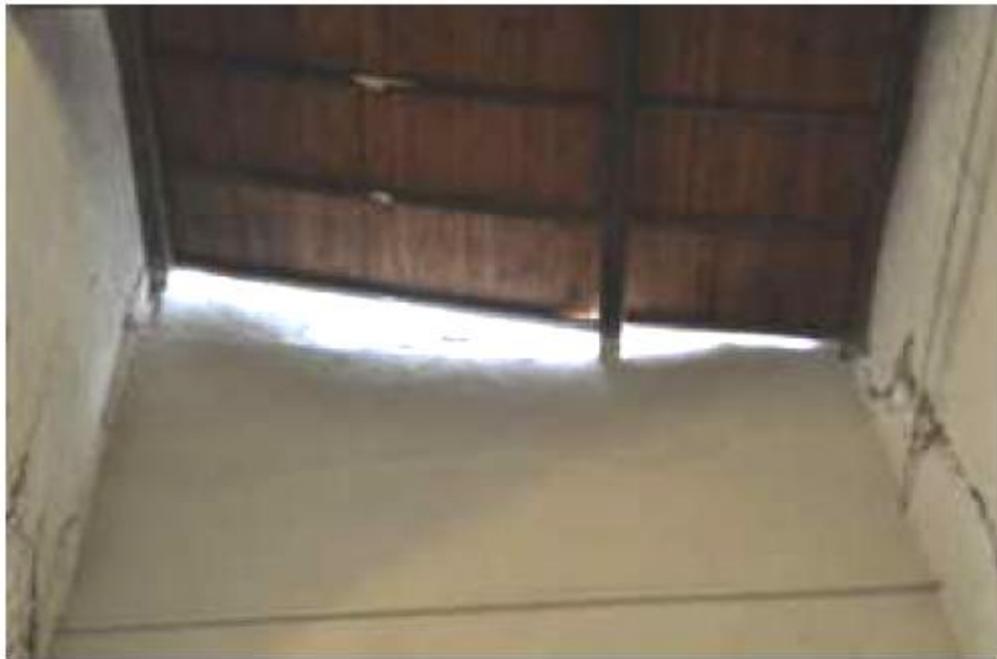
Figure 4-18: Roof collapse (Borri, et al., 2010)

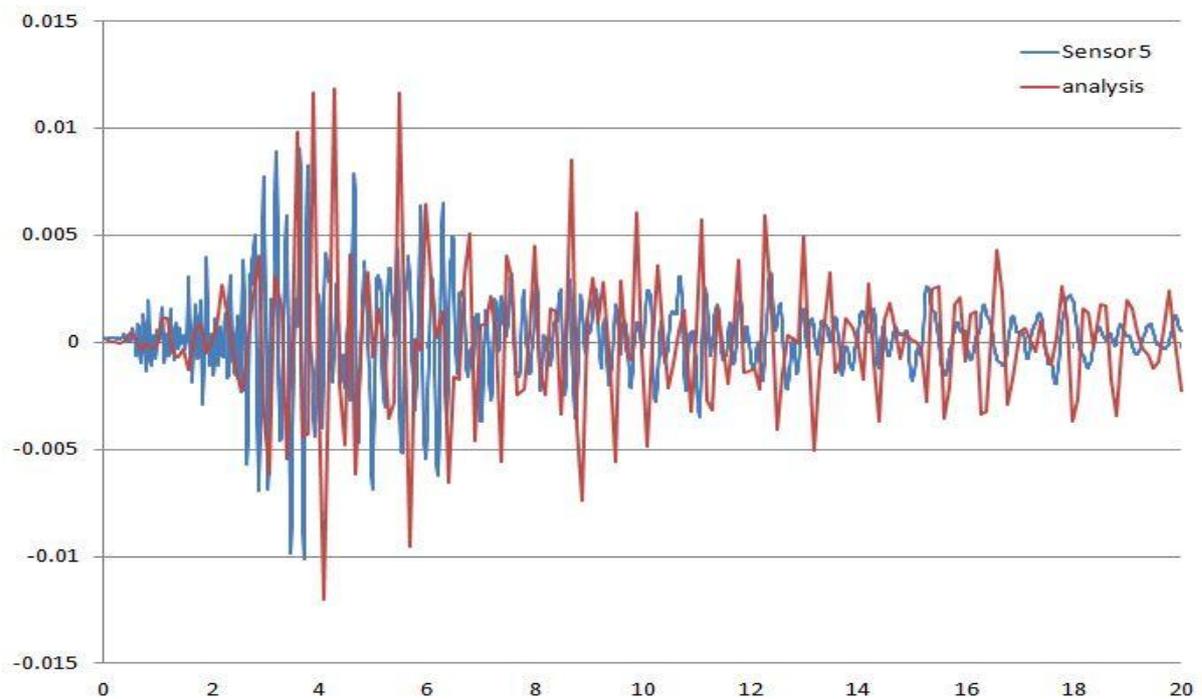
Figure 7-18: Comparison between experimental data (blue) and numerical data (red) for Channel 5 (y direction – midheight of the bell tower)
