ADVANCED MASTERS IN STRUCTURAL ANALYSIS
OF MONUMENTS AND HISTORICAL CONSTRUCTIONS

Master's Thesis

Thermo-Mechanical Analysis of Charles Bridge in Prague

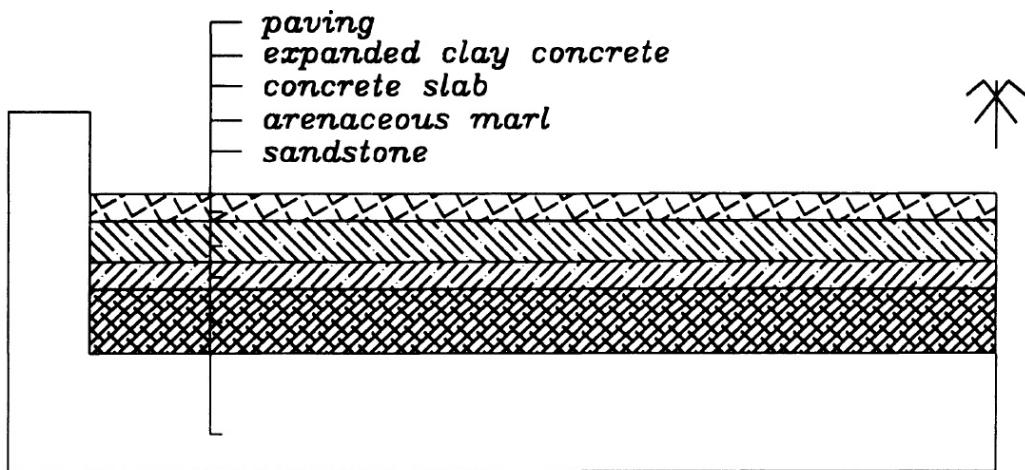
Figure 2.9 – Cross-section at the top of the arch before the last repair (Zak, 1995)

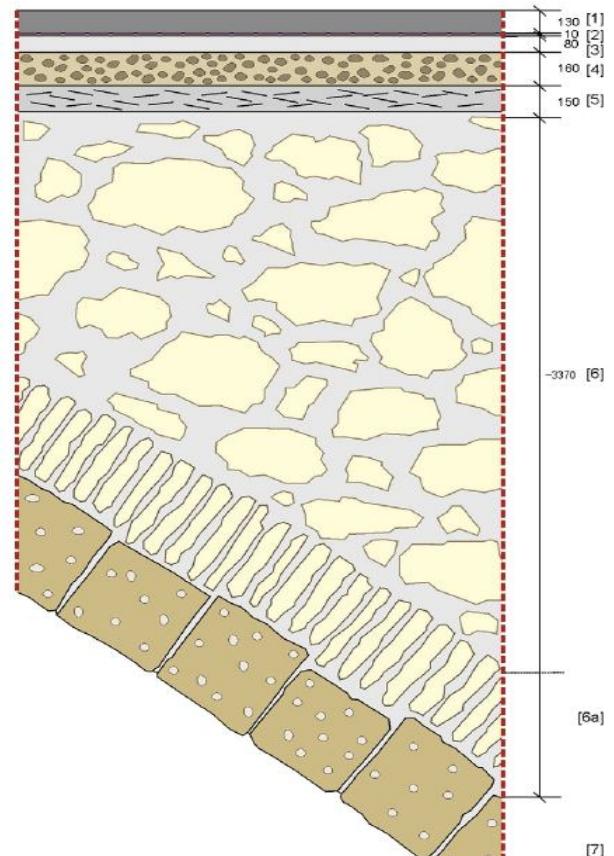
The layers are the same in every vault, except the 5th, 6th and 7th calculated from the Old Town, that present lightening spaces above the arches (Velflik system), built after the 1890 flood.

Figure 2.11 – Cross-section through the fill masonry of arch XIV (Přikryl, 2010), dimensions in mm

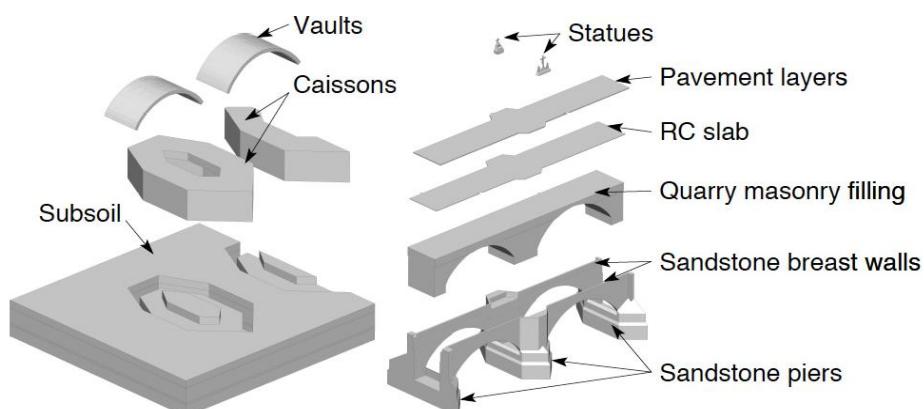
Due to floods, the original foundations (millstones) were gradually replaced: piers 5 and 6 were founded on a vault supported by two six-meter caissons (1892 reconstruction), while (in 1902–1903) piers 3, 4 and 7 were rebuilt on a concrete slab resting on seven caissons of 2.5 m diameter (Zeman, 2008) (compare to Figure 2.15).

Figure 2.15 – Schematization of the bridge elements (Zeman, 2008)

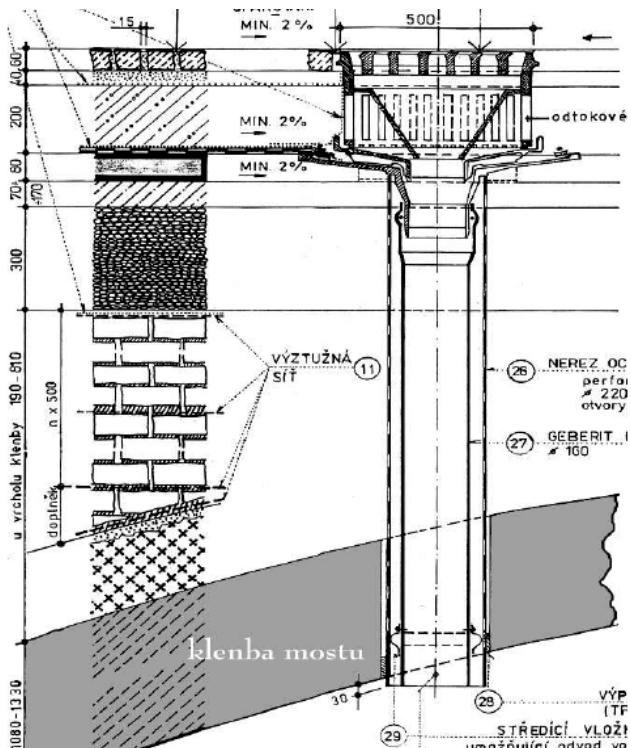
Figure 2.17 – Replacement of the layers upon vault

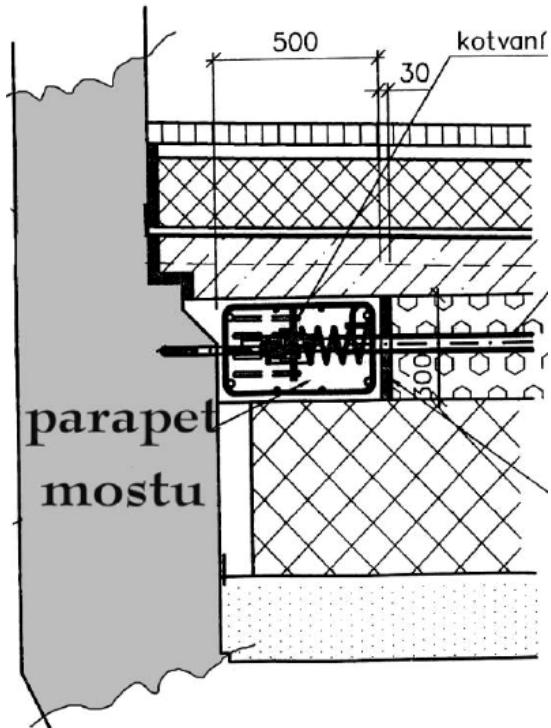
Figure 2.18 – Suggested prestressing (V. Křížek, 2012)

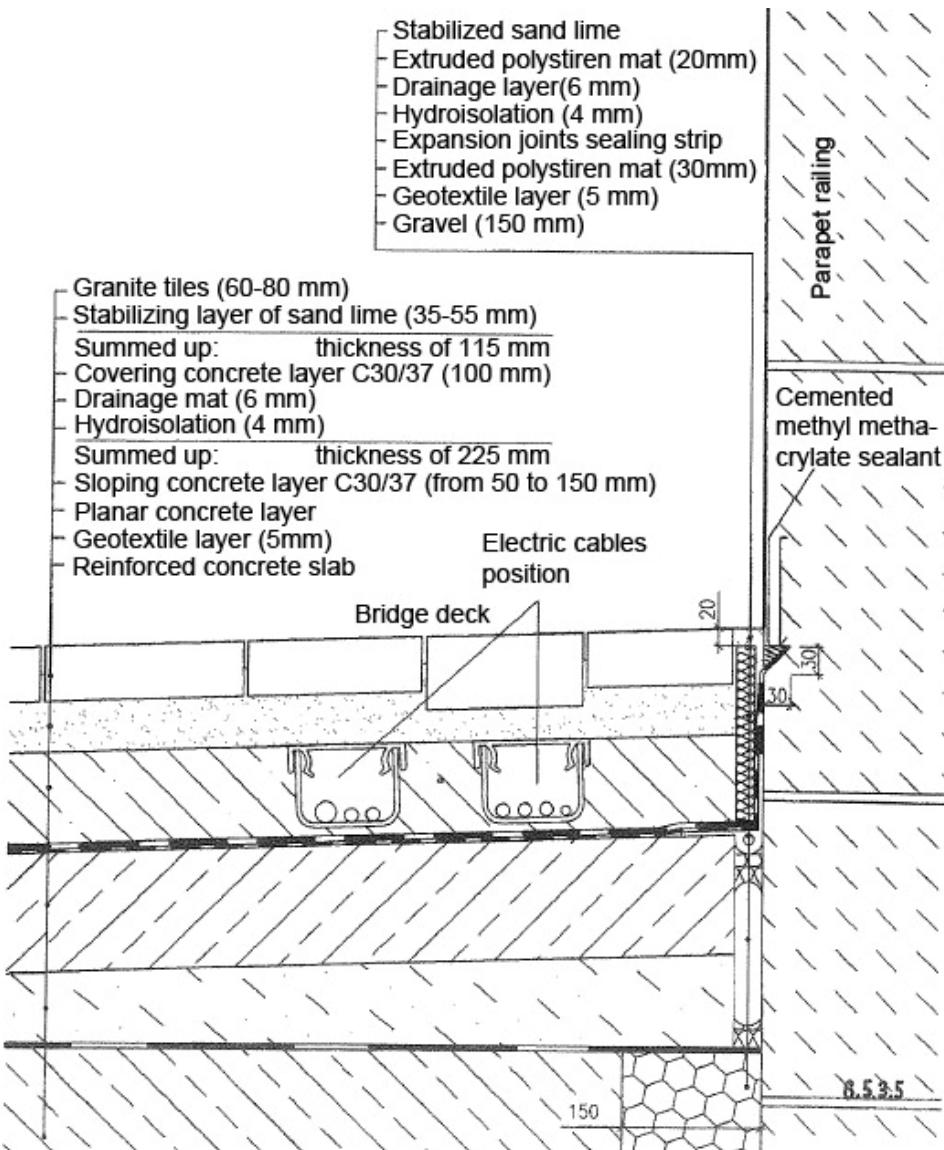
Figure 2.20 – Detail of the connection between parapet and pavement (Mott MacDonald, 2011)

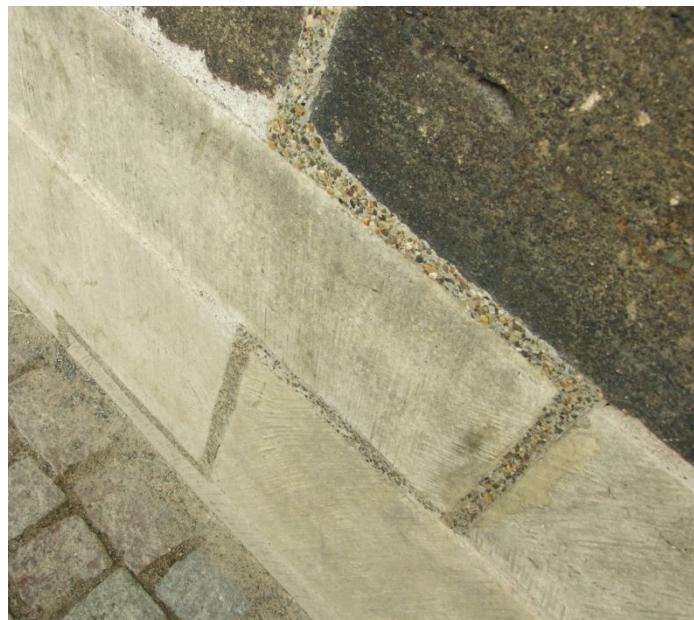
Dilatation joints have been made in the stone railing masonry in correspondence with vault/pier intersection (and usually every 4 m); they are done of a “plastic” mortar mixed with stone fragments (Figure 2.22). Despite all the efforts, the replacement was strongly criticized because the new stones do not match aesthetically the historical ones they are next to.

Figure 2.22 – Dilatation joint and contrast between old/new blocks

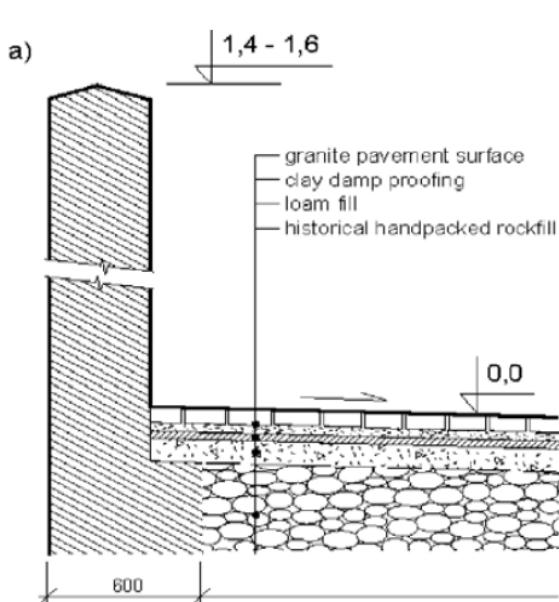
Figure 2.23 – Historical section of the bridge

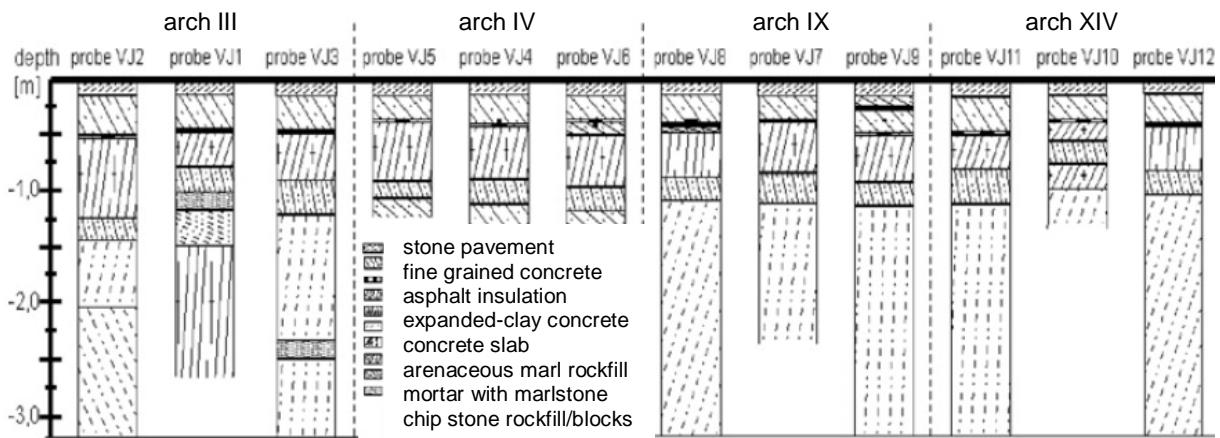
Upon the slab there is a layer of expanded-clay concrete (thickness varying from 0.15 m to 0.50 m) and the damp proofing (Witzany, 2007). The dug holes and boreholes performed revealed great differences in the bridge original layers but also about the recent interventions, rising questions about their function (some holes did not detect the concrete slab or the diagonal meshing) (Figure 2.25). The insufficient anchorage of the slab into the breast walls reduces the possible positive effect of the slab as a tie against out of plane mechanisms, without avoiding the back-effect of the element as a strut of the breast walls (Witzany, 2008).

Figure 2.25 – Composition of the bridge body filling layers as recorded in test holes in 2000 (Witzany, 2007)

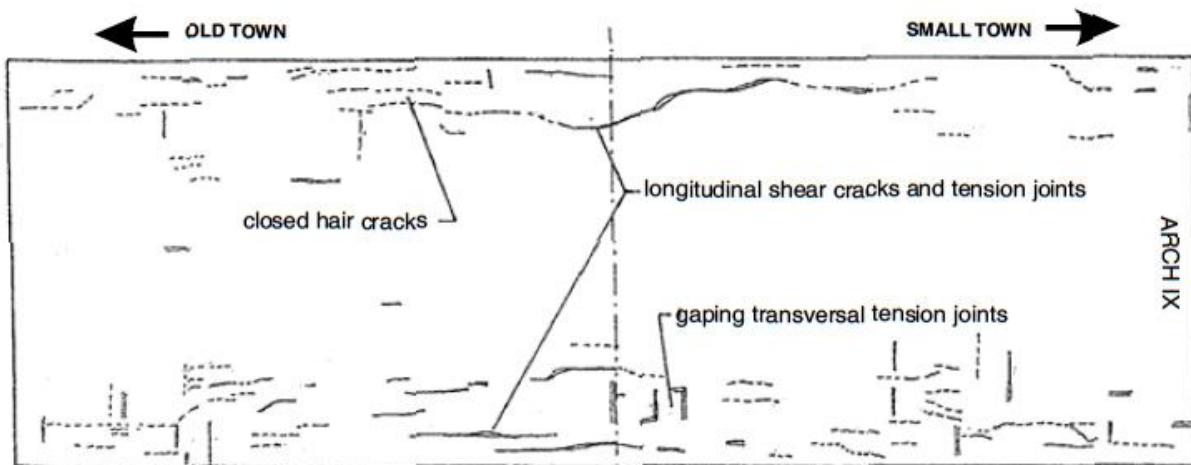
The cyclical temperature effects are also hair cracks on the face of vault arches, developing to tension joints and shear cracks passing through both the joints of the stone masonry and the stone blocks (Figure 2.26) (Witzany, 2007).

Figure 2.26 – Tension joints and shear cracks in the face surface of vault arch IX (Witzany, 2007)

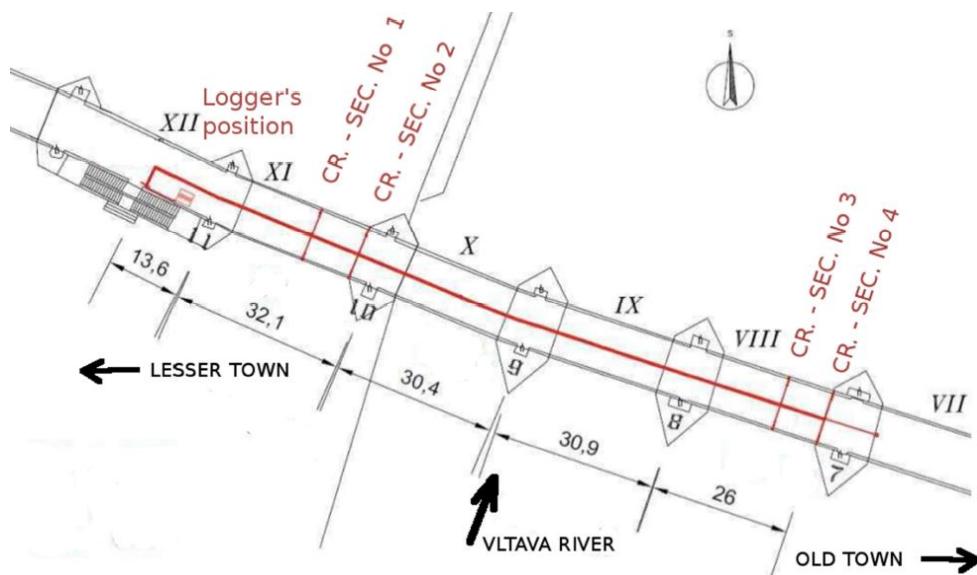
The net of sensors includes 4 cross-sections of the bridge: in the middle of the span of 8th and 11th vault (CR.-SEC. No 3, CR.-SEC. No 1), and in their vertical connection with piers (CR.-SEC. No 4, CR.-SEC. No 2). The control system is located under the 12th vault on the Lesser Town's side (Krejci, 2014). Cross-sections 1 and 2 (situated in the 11th vault) are respectively 34 m and 36 m far from the logger while cross-sections 3 and 4 (in the 8th vault) are 128 m and 134 m far from it (Figure 2.27).

Figure 2.27 – Selected cross-sections for monitoring side (Krejci, 2014)

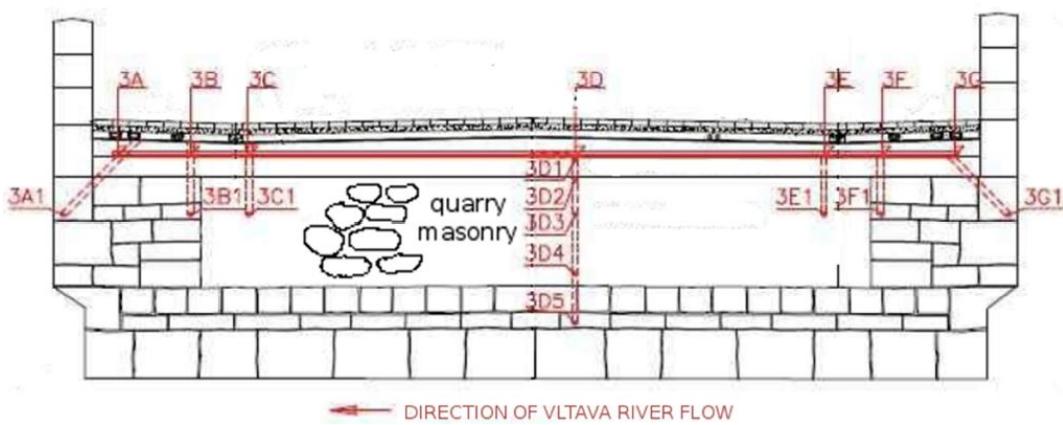
Each measuring point has three temperature sensors and one moisture sensor; CR.-SEC. No 1 has 11 points, CR.-SEC. No. 2 has 13 points while CR.-SEC. No. 3 has 11 points (Figure 2.28) and CR.-SEC. No 4 has 15 points (Figure 2.29).

Figure 2.28 – CR.-SEC. No. 3 (11 gauge points = 33 temperature sensors and 11 moisture sensors)

Since the temperature sensors are not accessible, they are placed in triplets to enhance the reliability of the data detecting defects (2 correct solutions on 3). It was not possible to do the same with moisture sensors due to their higher price.

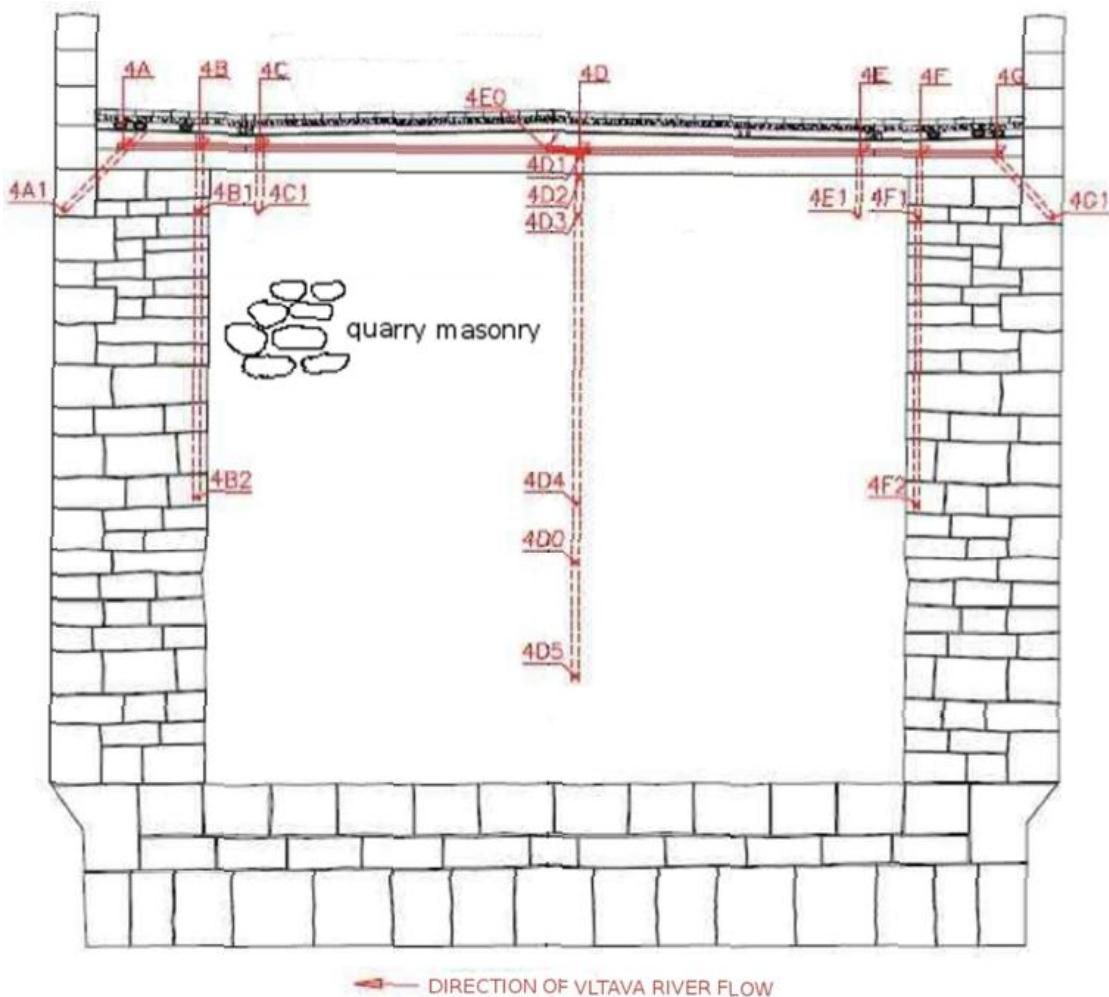
Figure 2.29 – CR.-SEC. No. 4 (15 gauge points = 45 temperature sensors and 15 moisture sensors)

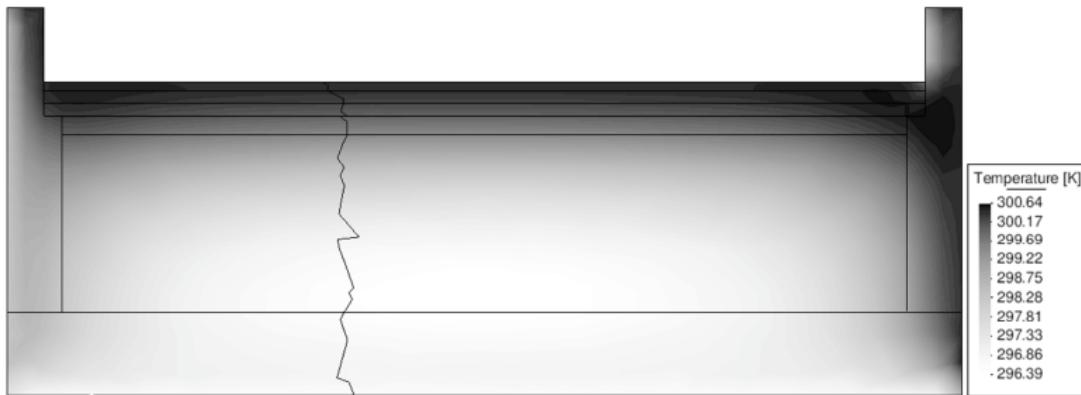
Further studies (Krejci, 2014) highlighted that the maximum summer temperatures on the southern surface are 7–8 °C higher than on the opposite northern surface, due to radiation of sun (Figure 3.8, Figure 3.9). Moreover it was noticed a possible shift between simulated and monitored data, ascribed to imprecise material parameters (additional testing is required).

Figure 3.8 – Spatial distribution of temperatures during summer at the crown of the arch (Krejci, 2014)

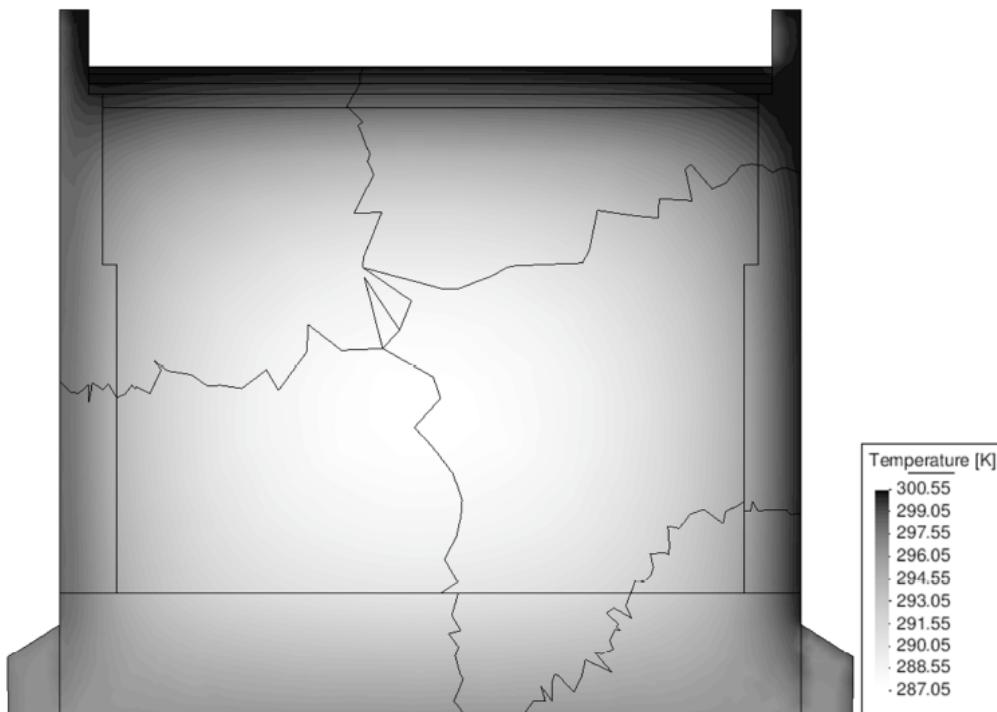
The shift is bigger in points closer to the surface of the vault, because there the temperature is influenced by the shielding against sun and also by the water running under the bridge (Figure 3.8). The analysis of data displayed also that stronger daily fluctuations are found closer to the bridge surface in respect to the smoother fluctuations in the internal areas of the bridge (Krejci, 2014).

Figure 3.9 – Spatial distribution of temperatures during summer in the pier (Krejci, 2014)

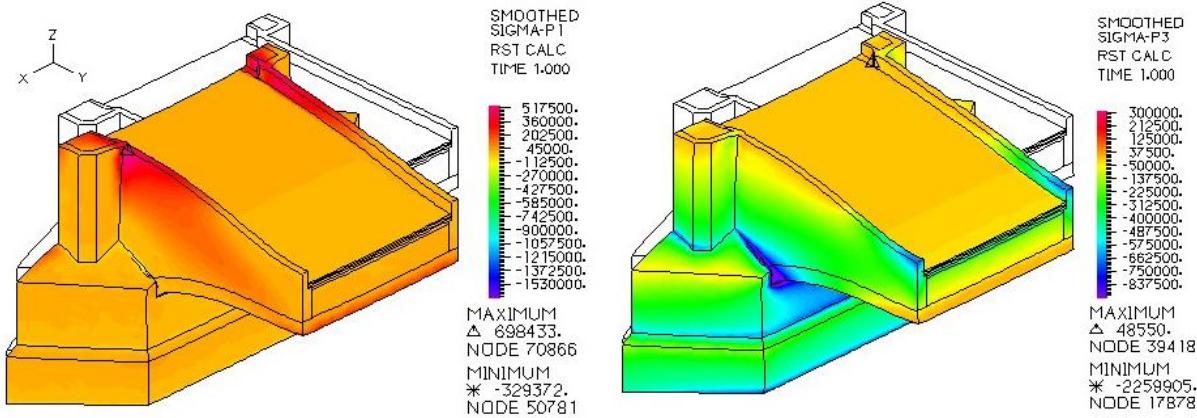
Figure 4.10 – Maximum and minimum principal stresses (smoothed), related to only self-weight

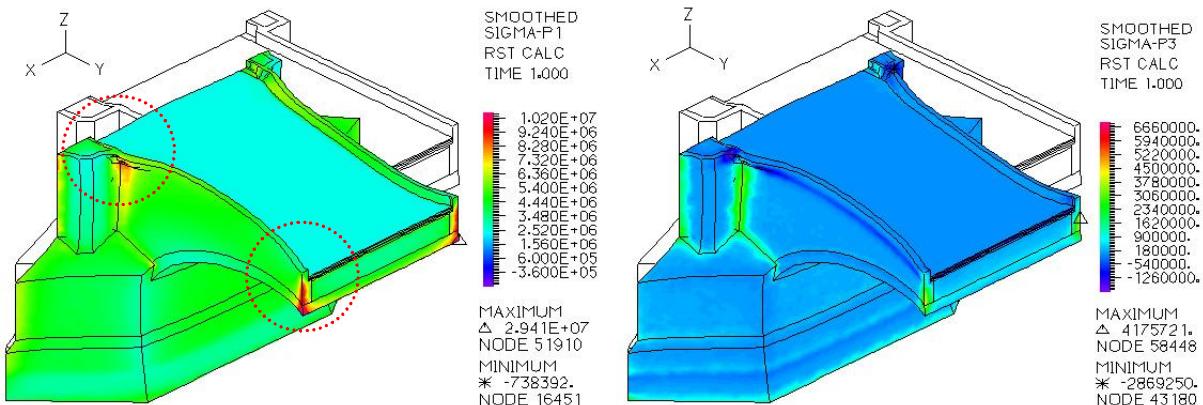
The images show the result for Comb. C and Comb. D but the stresses have same propagation than in Comb. A and Comb. B respectively. The analysis between the extreme values winter-summer and summer-winter is used to consider maximal temperature changes and it allows to be in favour of safety.

Figure 4.12 – Maximum and minimum principal stresses (smoothed), Comb. D

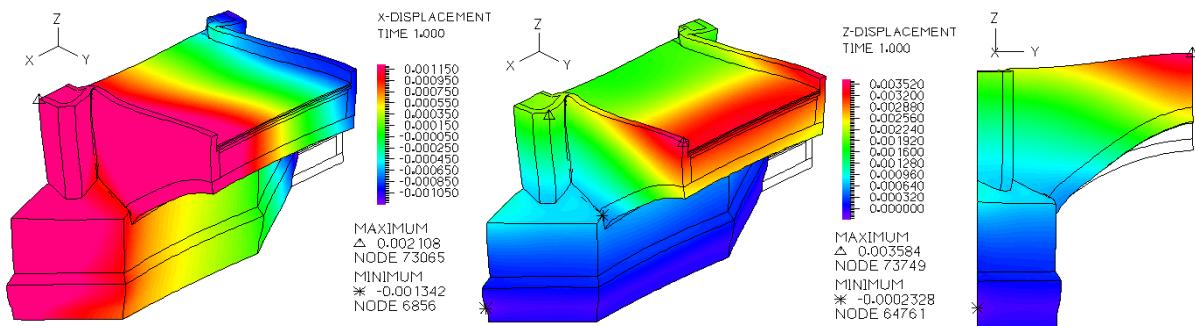
Since the structure has different boundary conditions (there is no more X-constrain on the vertical planes and X,Y-constraints at the basement, except than for one node) the vertical displacement is reduced (highest value of -5.10 mm instead of -5.60 mm) while the horizontal one is increased (2.11 mm to compare with 1.44 mm). The new configuration changes the deformed shape due to temperature loading, as can be see from Figure 4.13 and Figure 4.14, if compared with Figure 4.5 – Figure 4.9, where the X-constrain on the symmetry axis created an unrealistic deformed shape in the railing. Another difference is the deformation of the pier on the symmetry plane, now free to move in X (and Z) direction.

Figure 4.13 – X and Y displacement with deformed shape (Comb. C: from average temperature to summer)

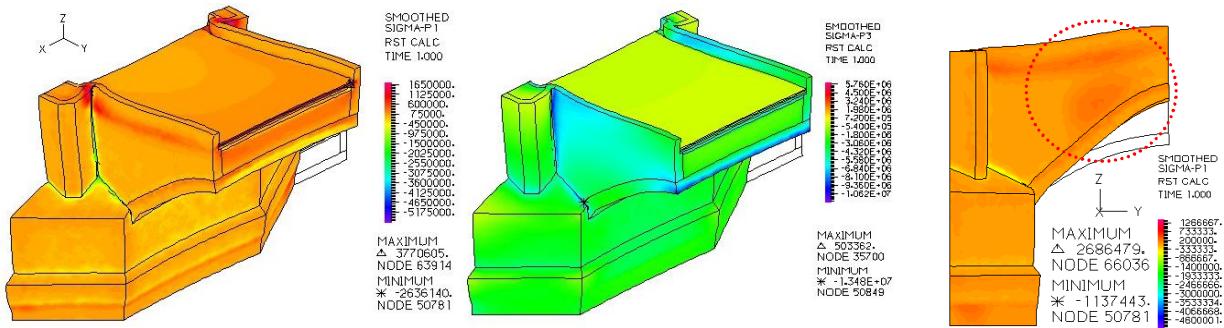
The stress configurations are similar to those already shown in Par. 4.1.4. but comparing them with Figure 4.15 and Figure 4.17 it is possible to notice how the stresses are proportionally lower at the crown of the arch (in respect to the connection between railing and pier) than before. This is due to the different boundary conditions used.

Figure 4.15 – Maximum (σ_1) and minimum (σ_3) principal stress (smoothed), Comb.CFigure 4.16 – σ_1 , Comb.A

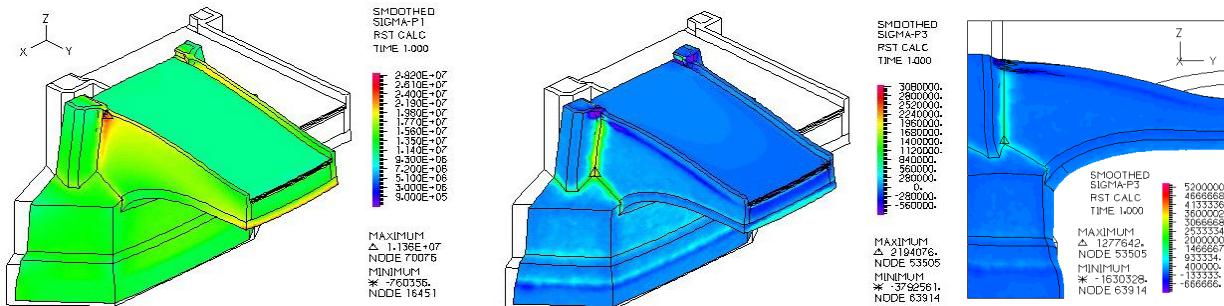
The combinations between average temperature and summer (Comb. A) or winter (Comb. B) lead to lower stresses but there are some changes in their pattern. In Comb. A there are tension areas in the breast walls also close to the vault (red rectangle in Figure 4.16), while in Comb. B (Figure 4.18) the compression band in the railing is proportionally lower to the other stresses than in Comb. D.

Figure 4.17 – Maximum (σ_1) and minimum (σ_3) principal stress (smoothed), Comb. DFigure 4.18 – σ_3 , Comb.B

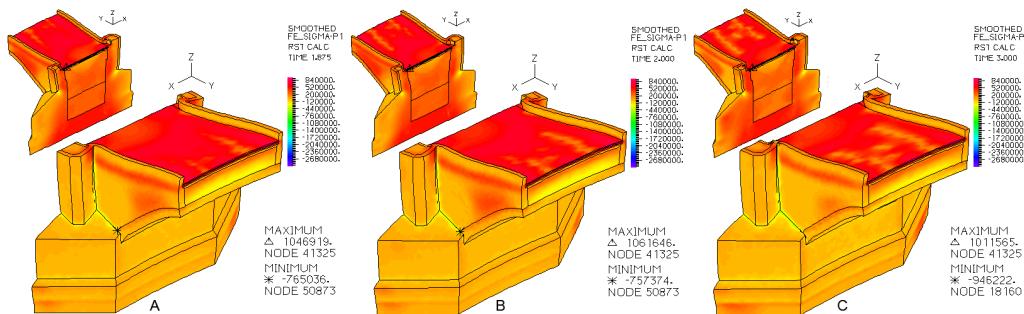
Figure 4.28 – Evolution of the release of stresses on the pavement (time steps: 1.875 2.00 3.00)

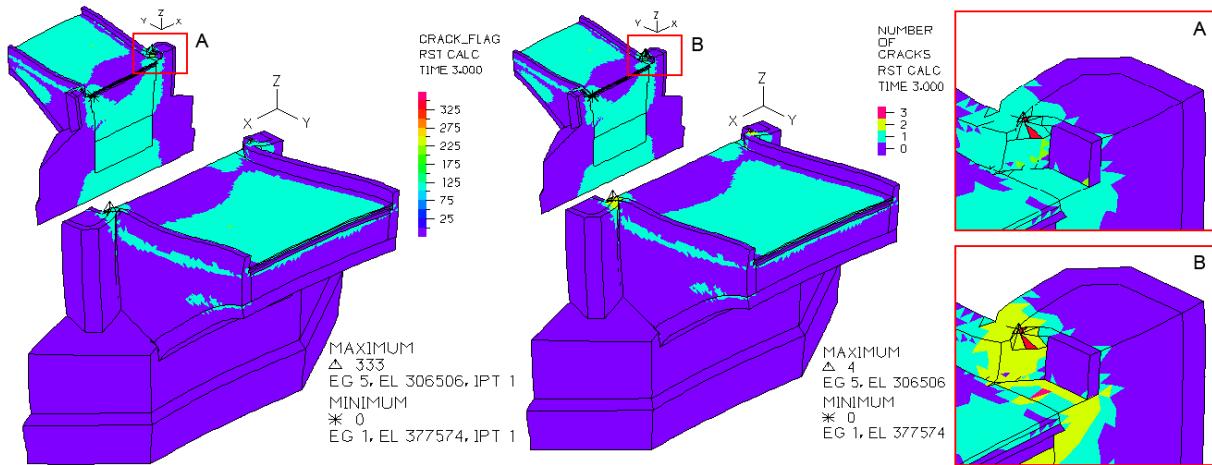
increase of temperature (Comb. A). “Number of cracks” explains where damage is most active: peaks of 2-3-4 cracks per integration point in the connection railing-pier (Figure 4.29, red rectangle “B”).

Figure 4.29 – Crack flag and number of cracks in 1975 model (Comb. A)

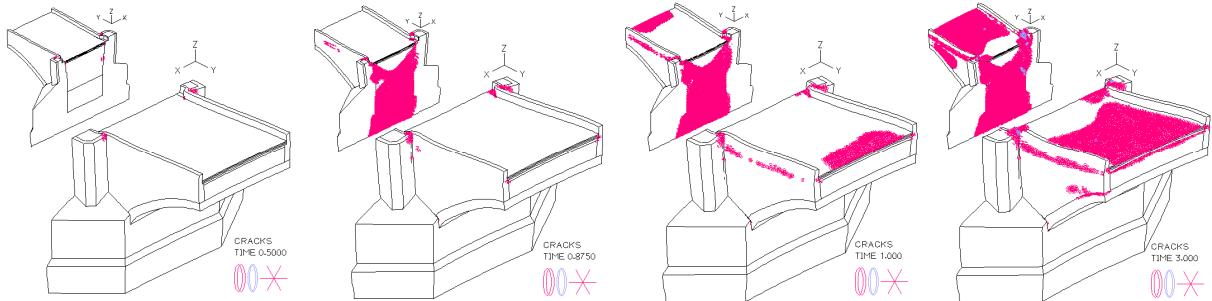
According to Figure 4.30, the damage starts at the connection between railing ad pier, then inside the pier (at the boundary with the filling), successively cracks develop on pavement and railings too.

Figure 4.30 – Crack evolution at step 4 of 25, 7 of 25, 8 of 25 and 25 of 25

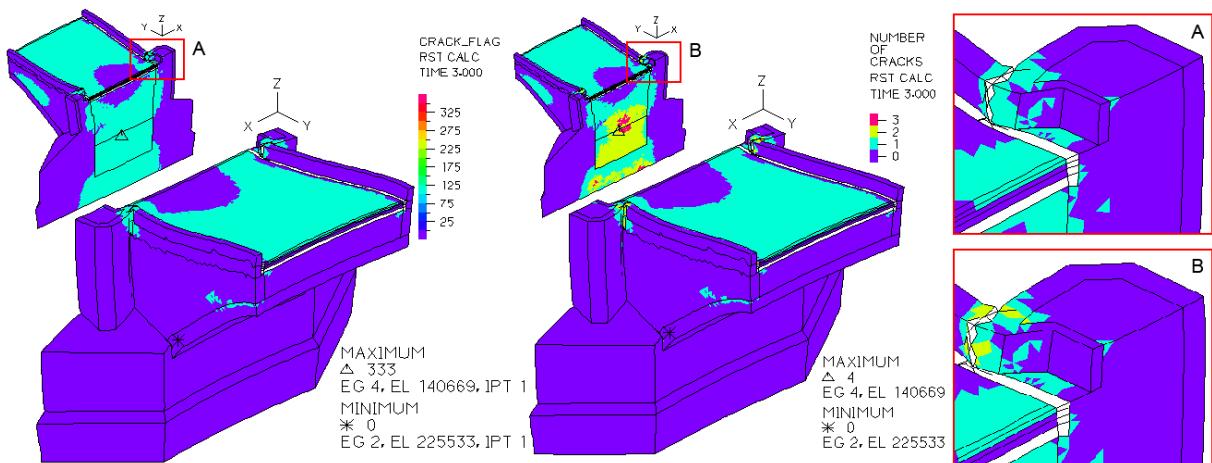
The effect of the 2010 intervention was studied. It lets to avoid tensile cracks along the railing thanks to the releave of the connection railing-slab (Figure 4.31). It allows also to reduce the global stress state (compare to Table 4.15) and that between railing and pier, decreasing the peak number of cracks from 4 to 2 (red rectangle “B”), moving the high damaged area from the pier to the railing itself.

Figure 4.31 – Crack flag and number of cracks in 2010 model (Comb. A)

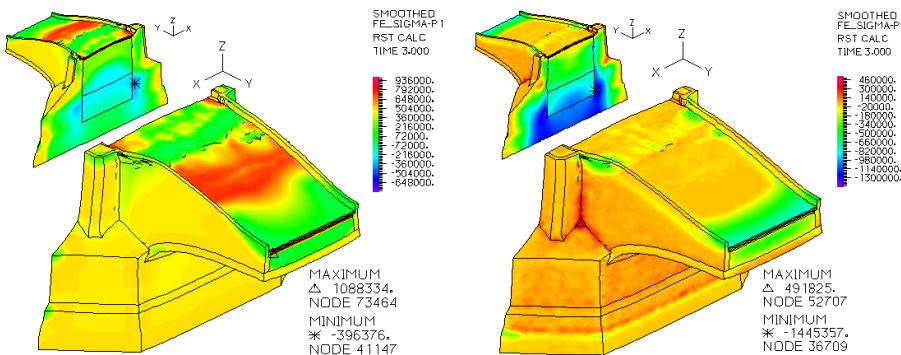
Figure 4.34 – Tensile and compressive stress plots (Comb. A), 1975 model

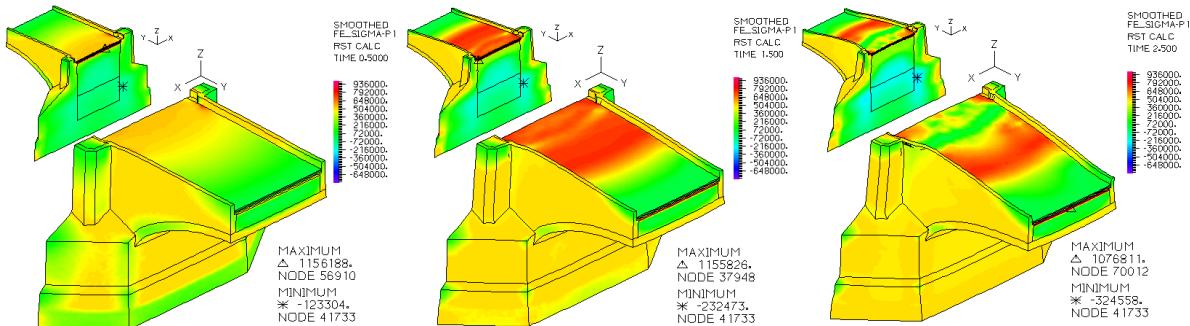
Figure 4.35 – Evolution of the release of tension on the pavement (time steps: 0.5 1.5 2.5)

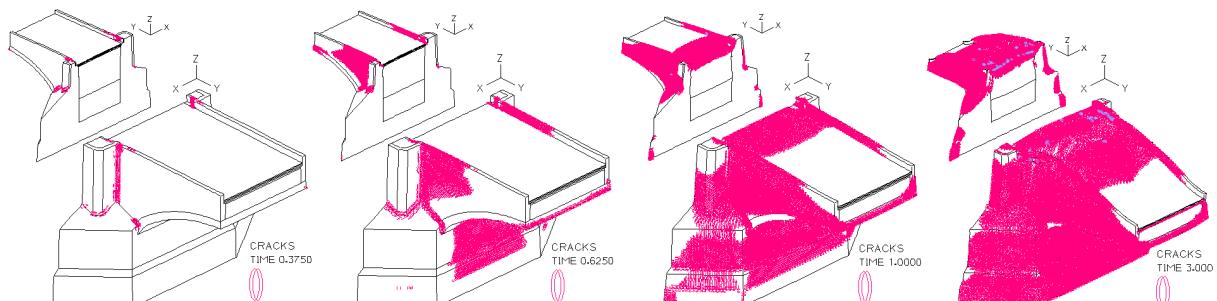
Figure 4.36 – Crack evolution (Comb. B) for different steps

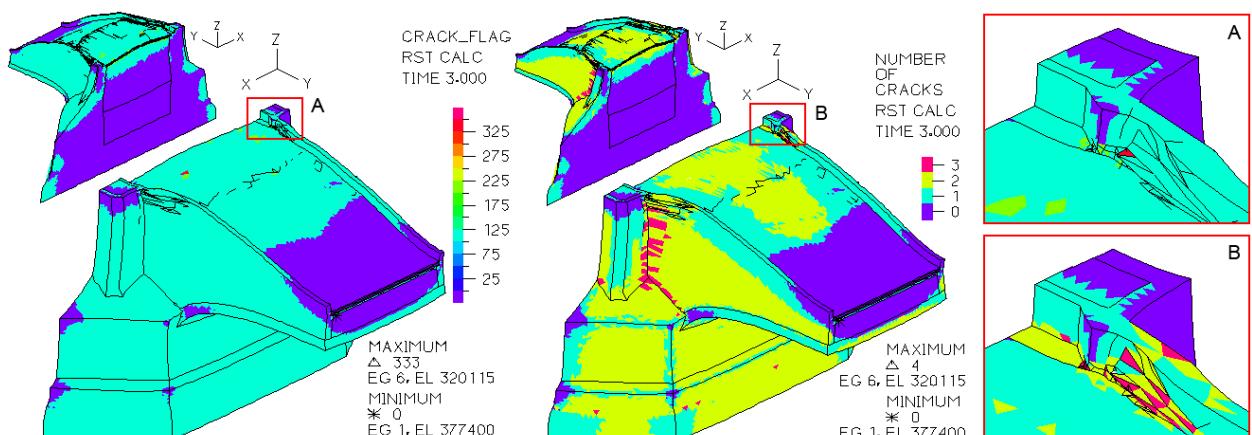
Figure 4.37 – Crack flag and number of cracks in 1975 model (Comb. B)

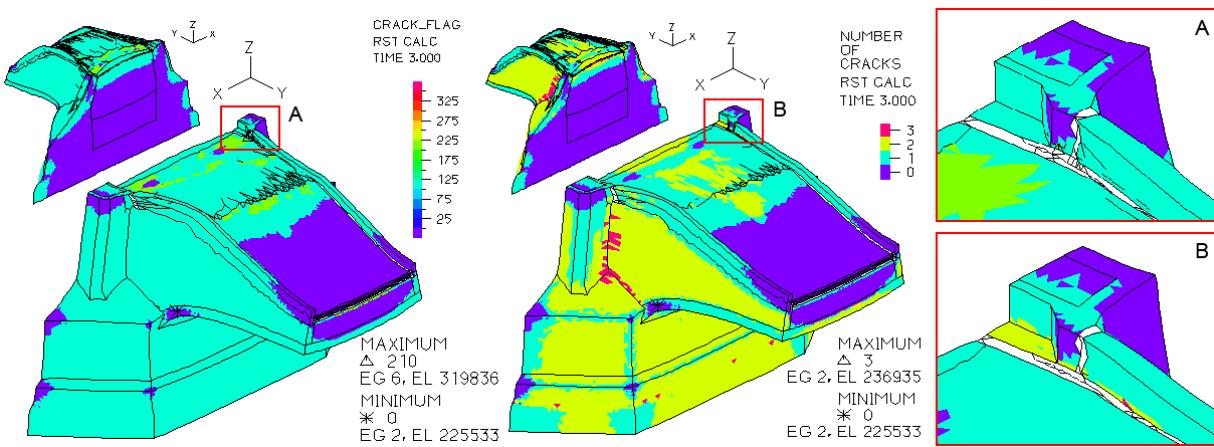
Figure 4.38 – Crack flag and number of cracks in 2010 model (Comb. B)

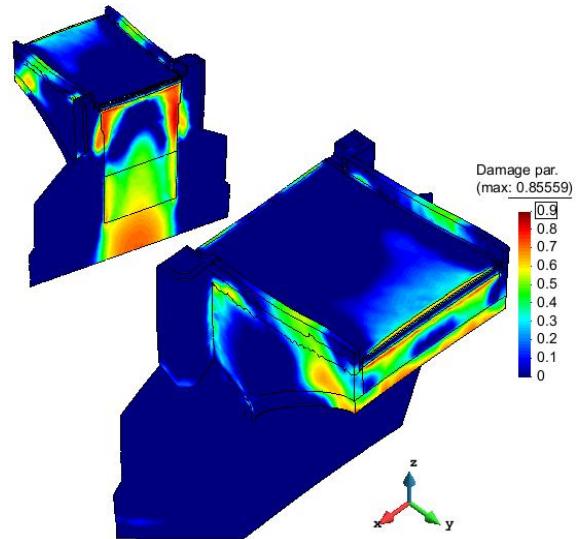
Figure 4.46 – Damage parameter (2010 model), Comb. A

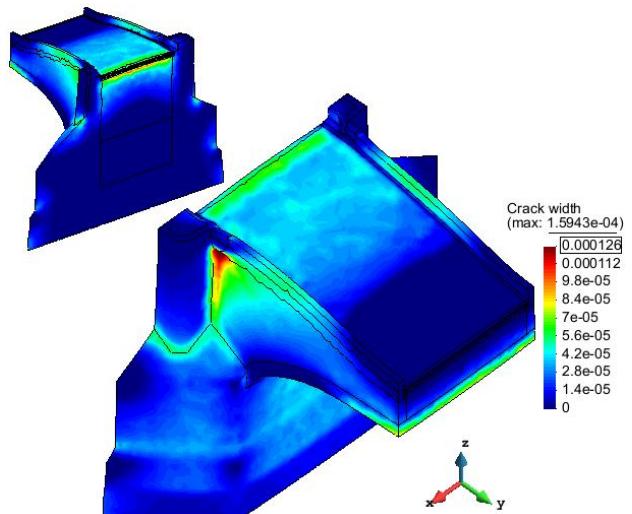
Figure 4.66 – Crack width (m) (2010 model), Comb. D

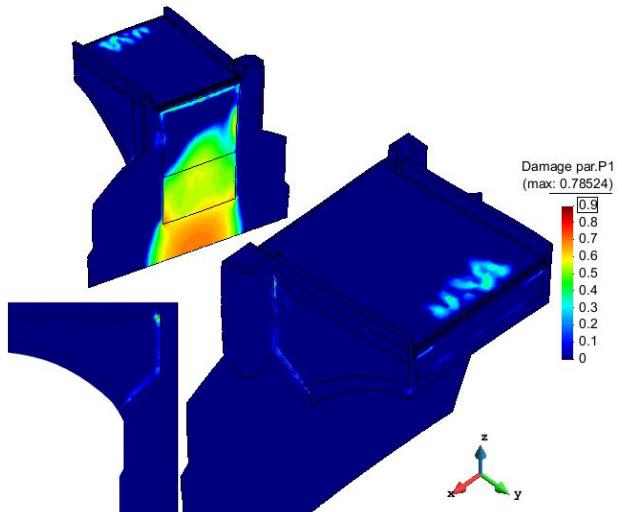
Figure 4.70 – Damage par. P1 (2010 mod.), Comb. A

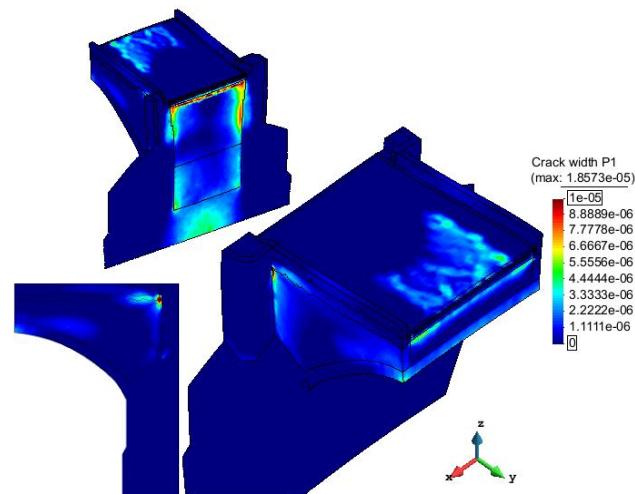
Figure 4.78 – Crack width P1 (2010 model), Comb. A

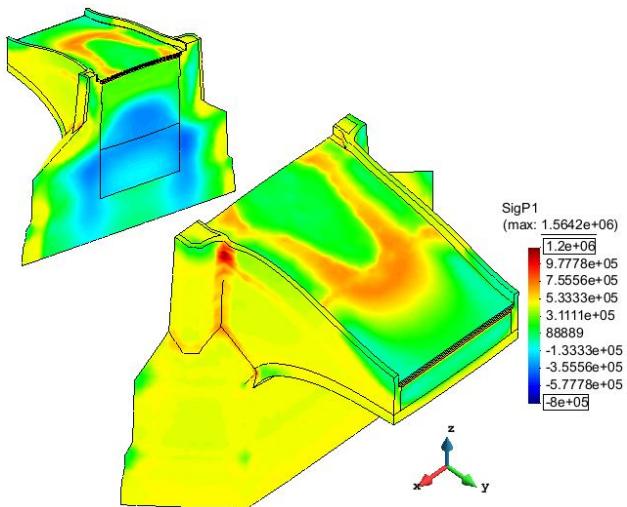
Figure 4.81 – Max. princ. stress (1975 model), Comb. B

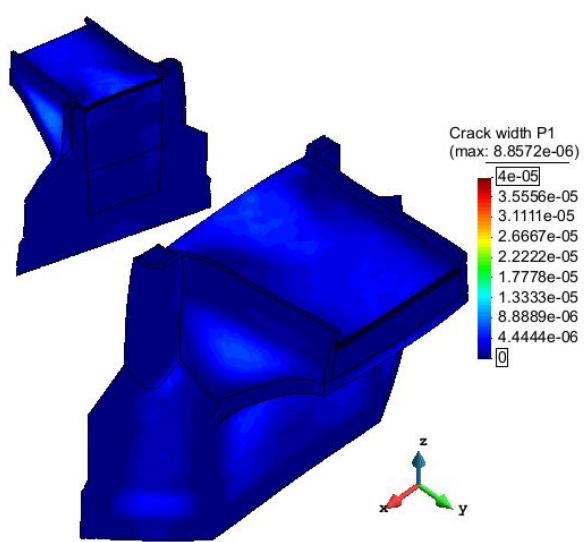
Figure 4.96 – Crack width P1, 1975 model (10/11/11)

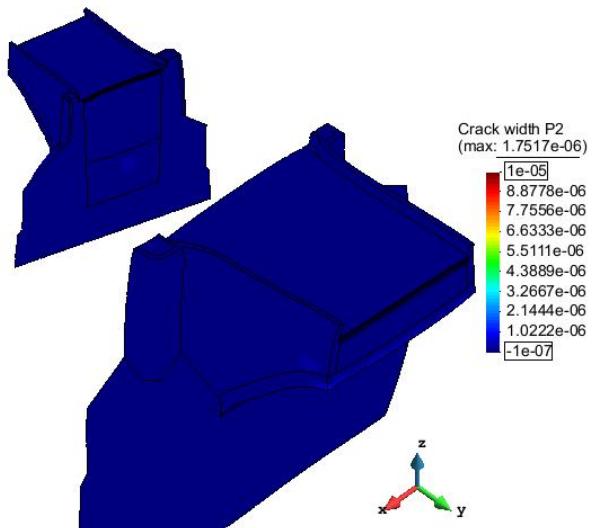
Figure 4.100 – Crack width P2, 1975 model (10/11/11)

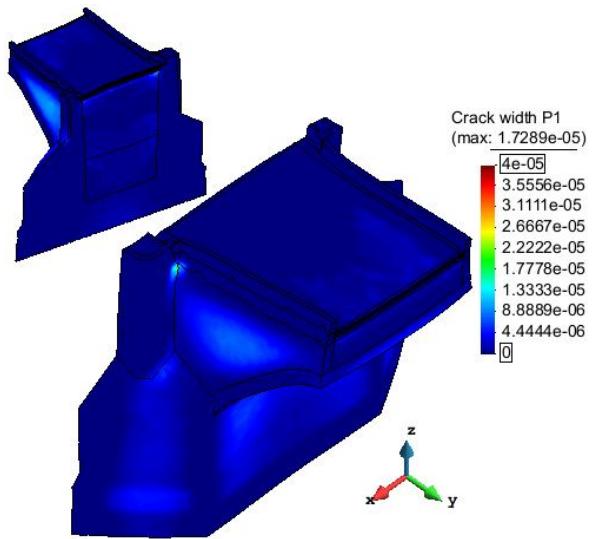
Figure 4.104 – Crack width P1, 2010 model (10/11/11)

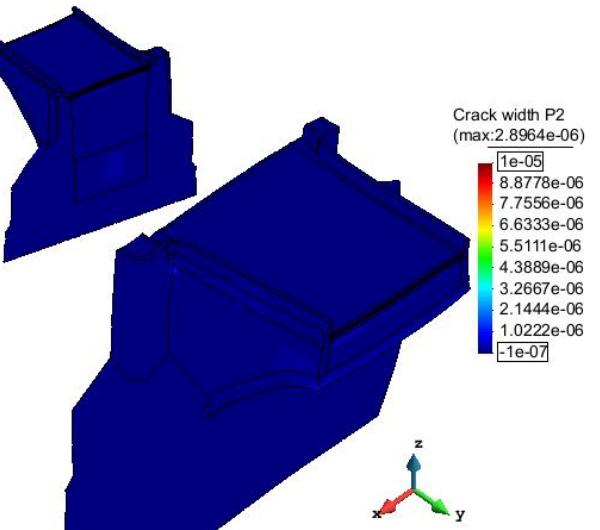
Figure 4.108 – Crack width P2, 2010 model (10/11/11)

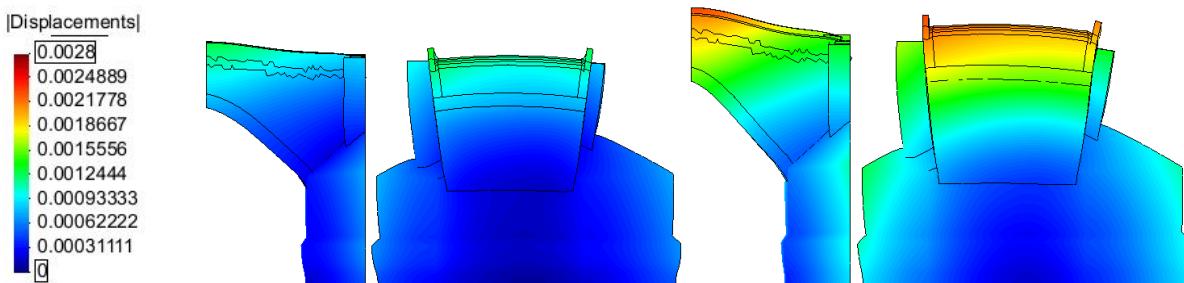
Figure 4.111 – Displacements on 10/06/2011 and 30/07/2011

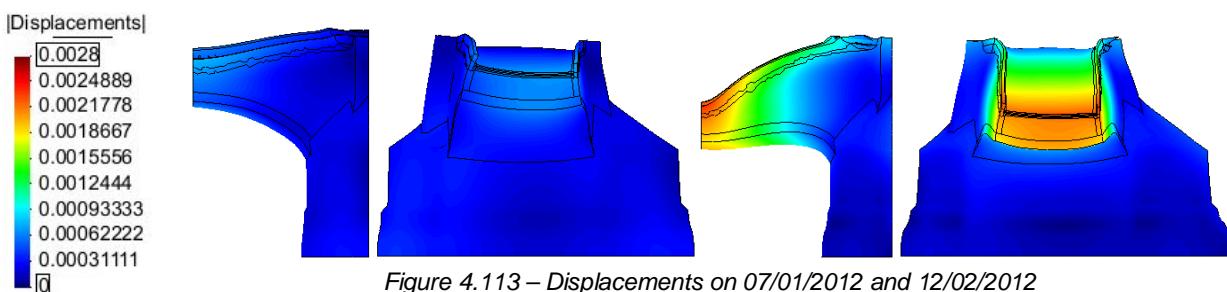
Figure 4.113 – Displacements on 07/01/2012 and 12/02/2012

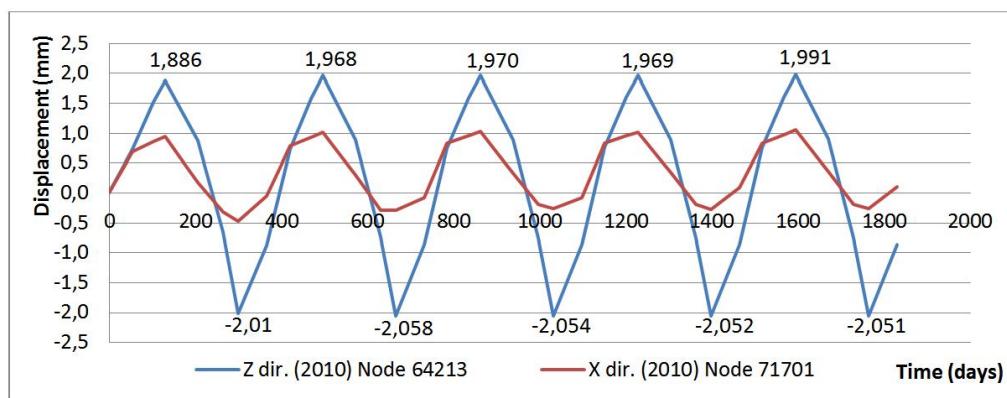
Figure 4.122 – Displacements on control nodes 64213 (Z direction) and 71701 (X direction)

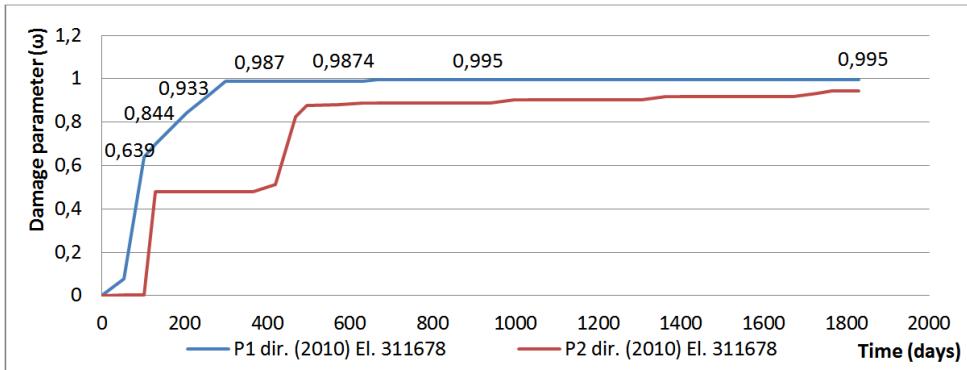
Figure 4.123 – Damage parameter evolution on control element 311678 in direction P1 and P2

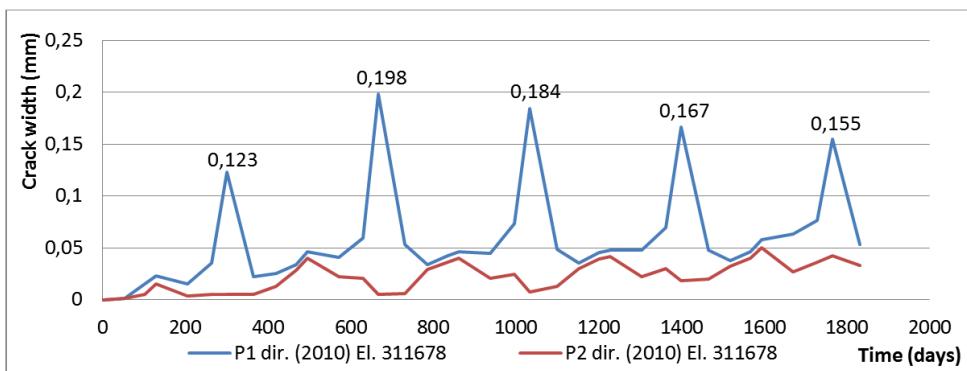
Figure 4.124 – Crack width evolution on control element 311678 in direction P1 and P2

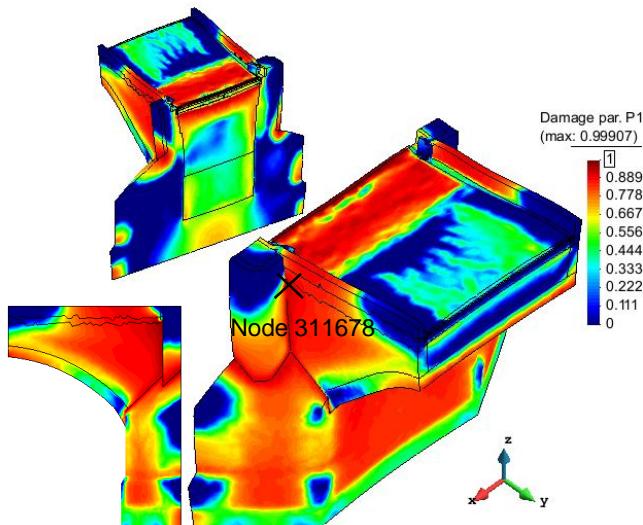
Figure 4.125 – Damage par.P1 (2010 mod.), 26/08/2012

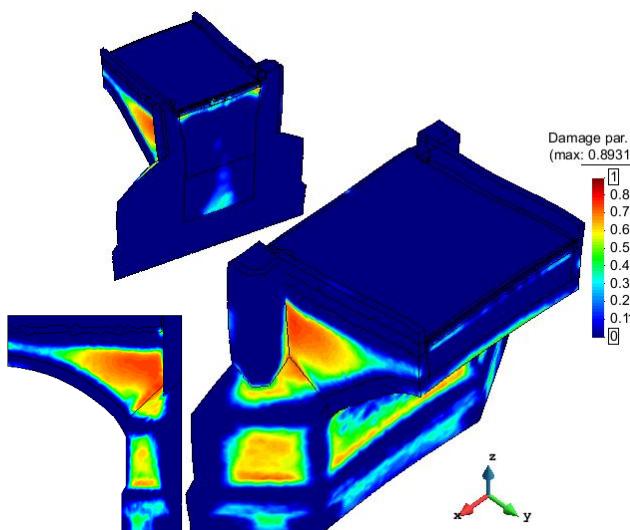
Figure 4.127 – Dam. par.P2 (2010 mod.), 26/08/2012

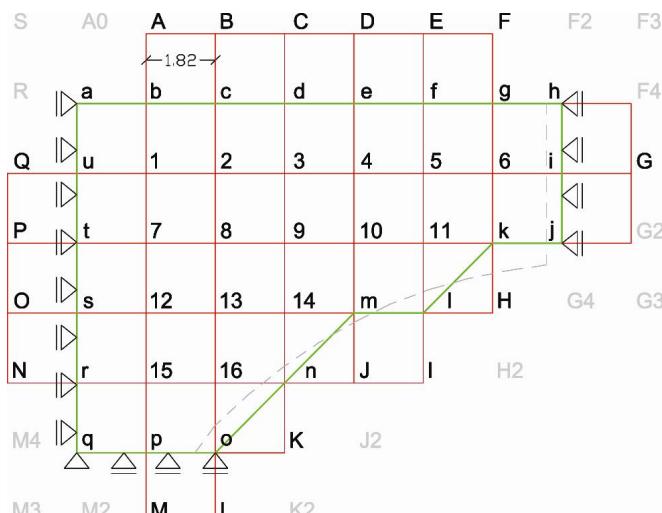
Figure 4.133 – Set up of boundary conditions and finite difference mesh
