ADVANCED MASTERS IN STRUCTURAL ANALYSIS
OF MONUMENTS AND HISTORICAL CONSTRUCTIONS

Master's Thesis

Thermo-Mechanical Analysis of Charles Bridge in Prague

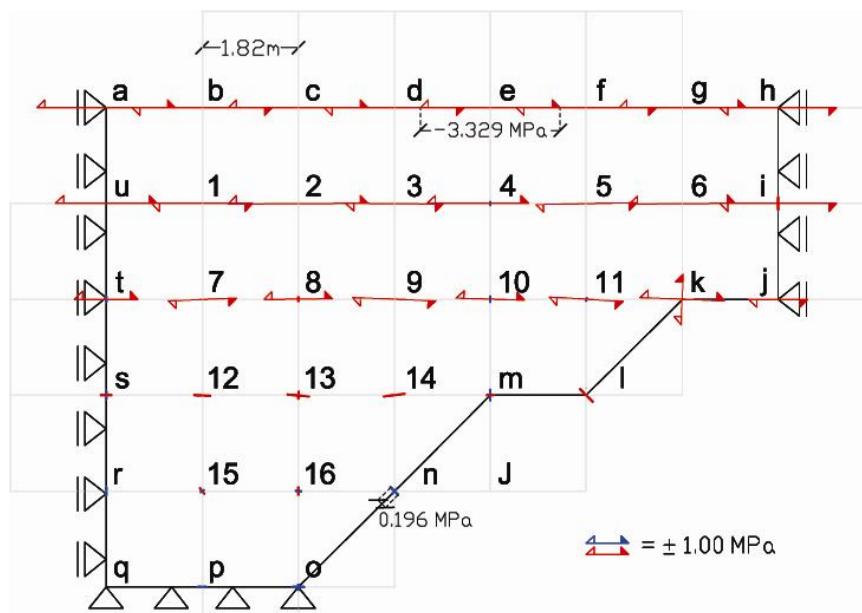
Figure 4.138 – Principal stresses direction (summer condition)

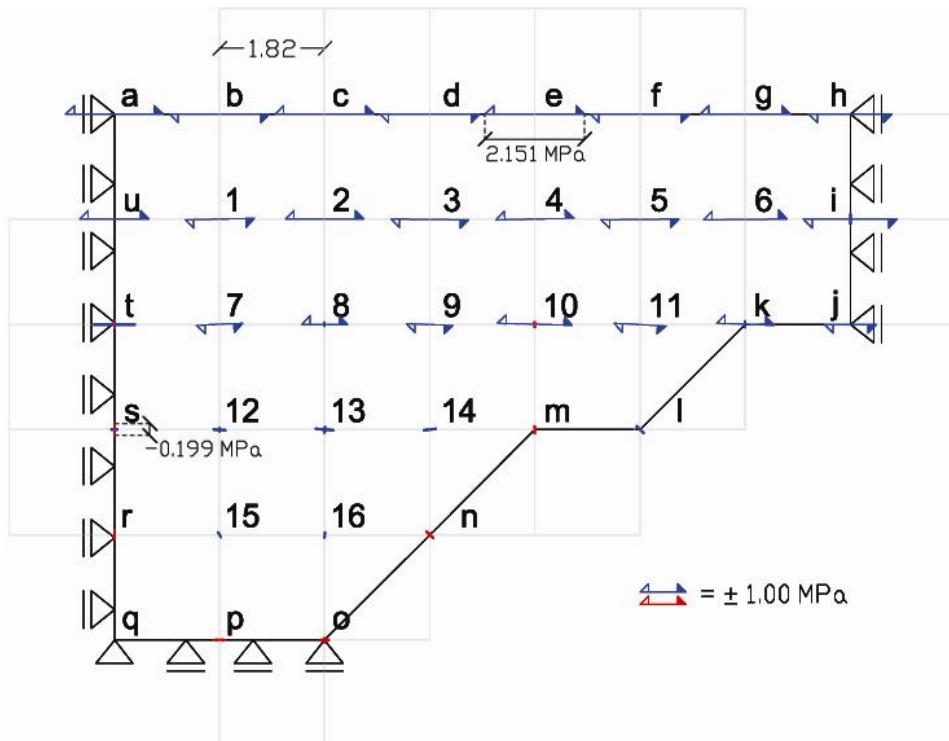
Figure 4.139 – Principal stresses direction (winter condition)

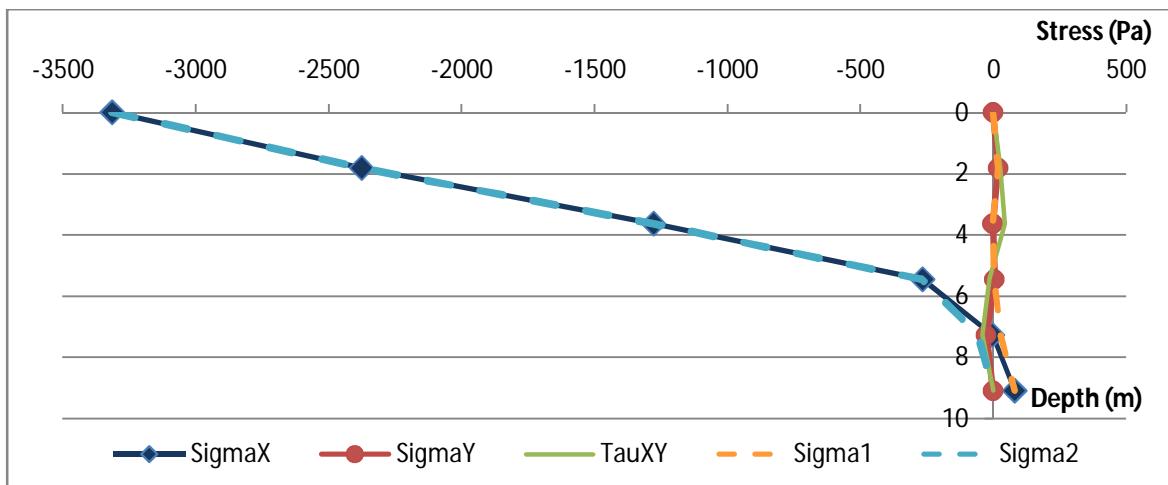
Figure 4.140 – Stresses in section line “b”-“p” (summer condition)

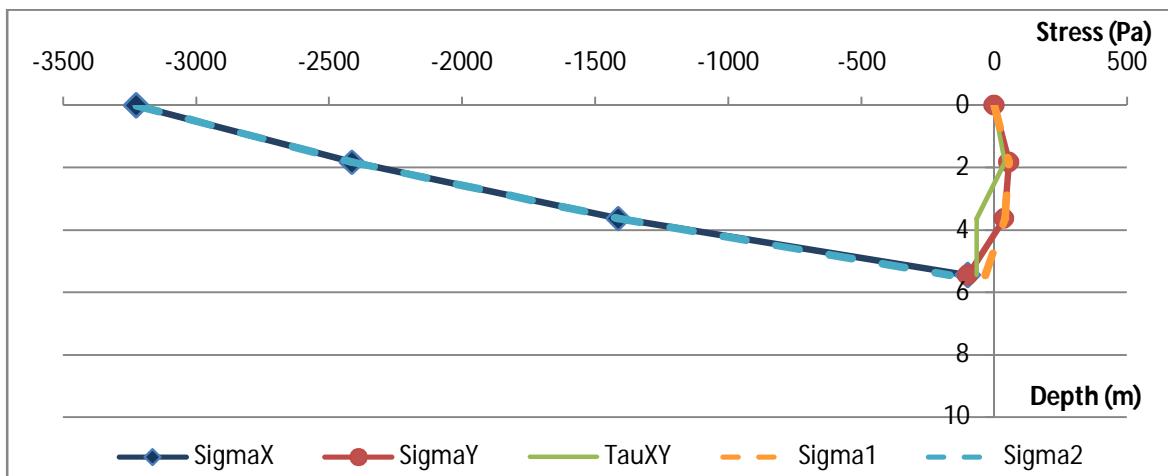
Figure 4.141 – Stresses in section line “f”-“l” (summer condition)

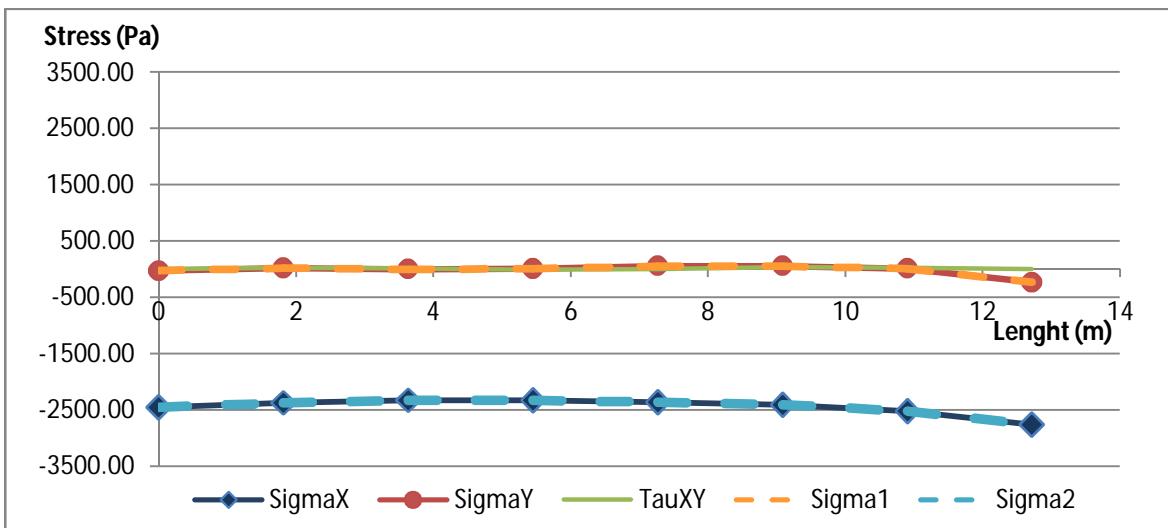
Figure 4.142 – Stresses in section line “u”-“i” (summer condition)

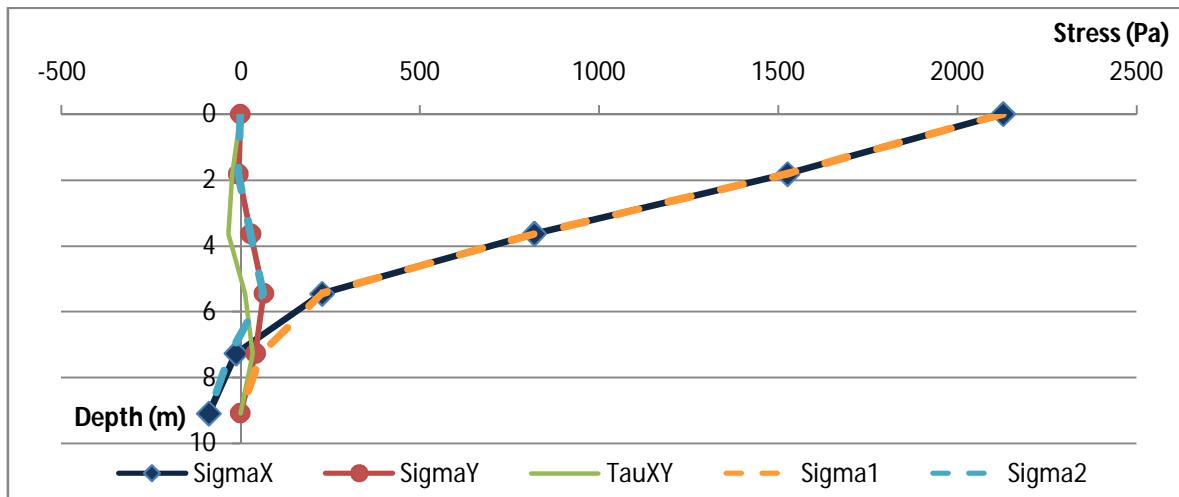
Figure 4.143 – Stresses in section line “b”-“p” (winter condition)

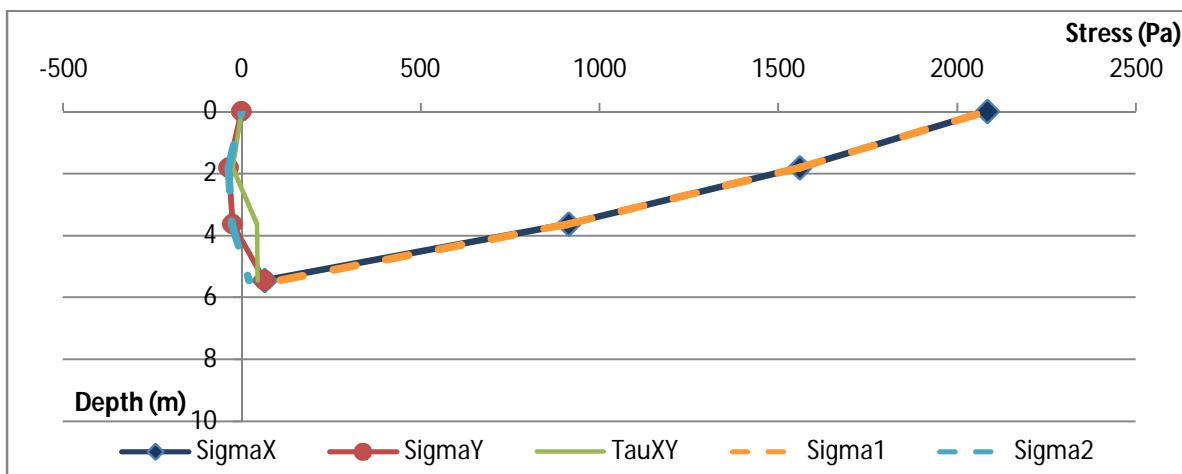
Figure 4.144 – Stresses in section line “f”-“l” (winter condition)

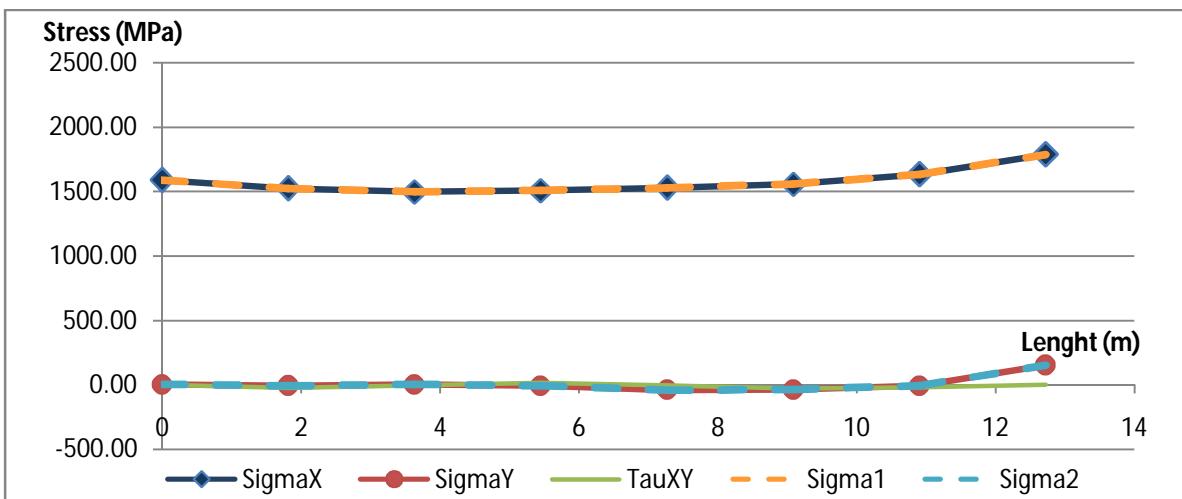
Figure 4.145 – Stresses in section line “u”-“i” (winter condition)

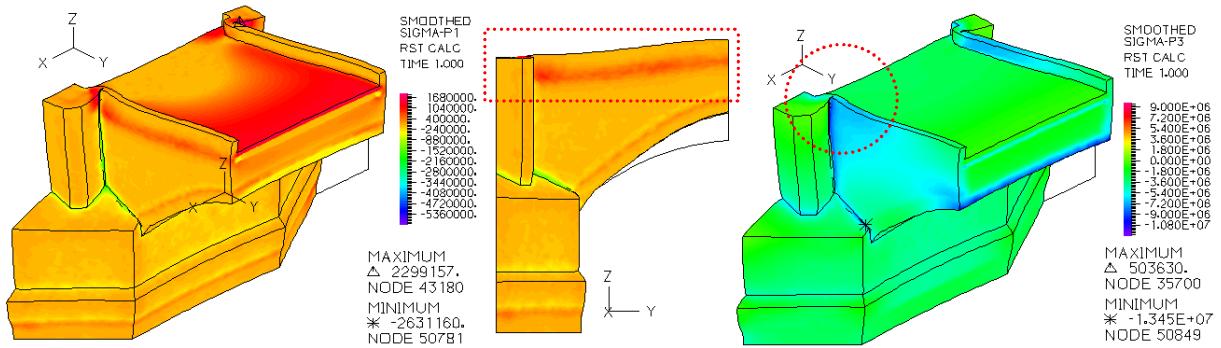
Figure 7.7 – 1975 model, Comb. C (from winter to summer), maximum and minimum principal stresses

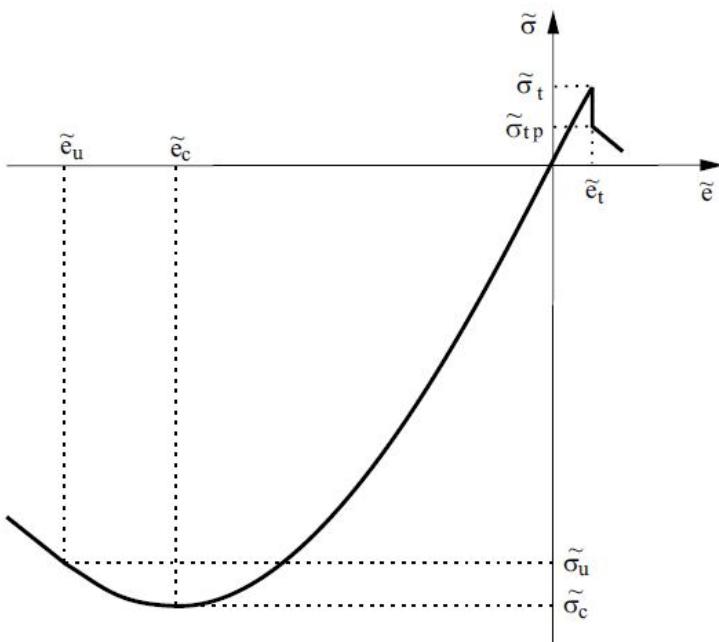
Figure 7.20 - Uniaxial stress-strain relation used in the concrete model (ADINA R & D, 2011)

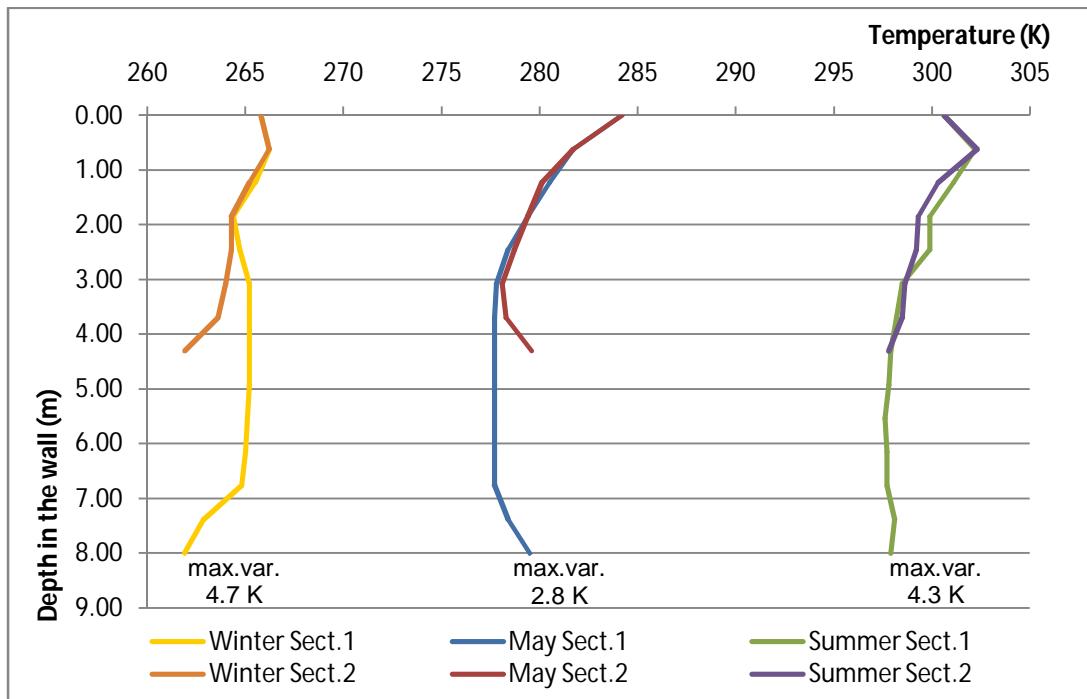
Figure 7.48 – Temperature distribution in April, August and February for 2 vertical sections

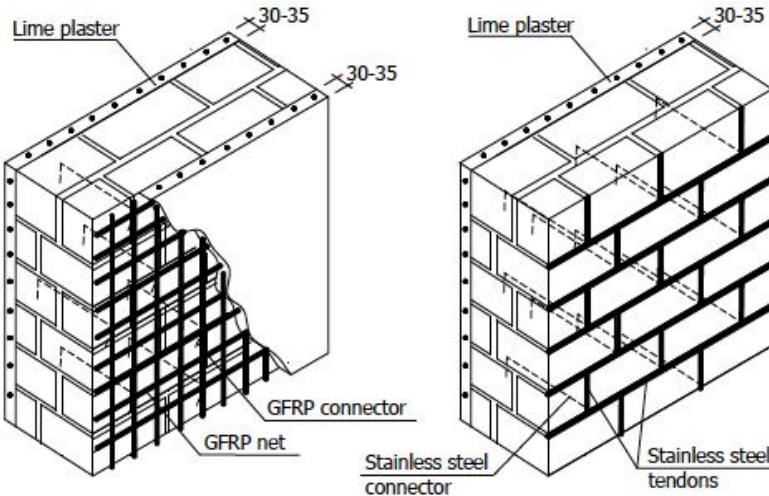
Figure 7.53 – Use of GFRP reinforced coating Figure 7.54 – Use of hybrid GFRP-stainless steel tendon net

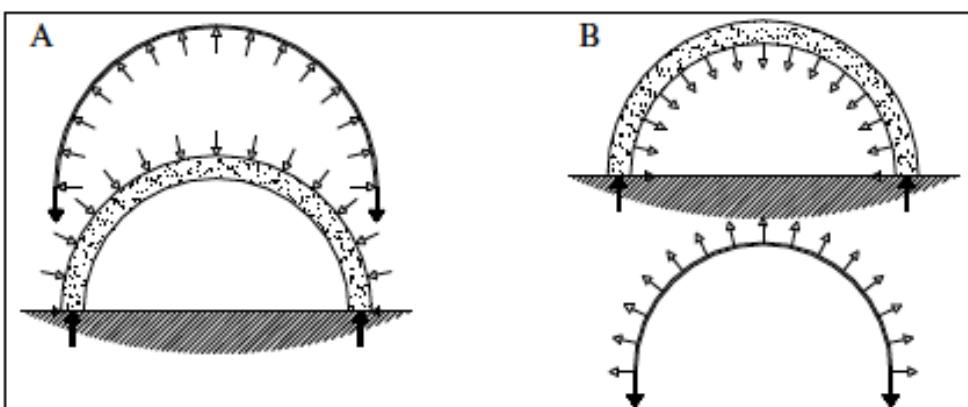
Figure 7.55 – Interaction forces between cable (in tension) and arch (in compression) when a post-tensioned cable is placed at extrados (A) or intrados (B) (Jurina, 2012)
