ADVANCED MASTERS IN STRUCTURAL ANALYSIS
OF MONUMENTS AND HISTORICAL CONSTRUCTIONS

Master's Thesis

Structural analysis of Palladio's timber bridge in Bassano del Grappa

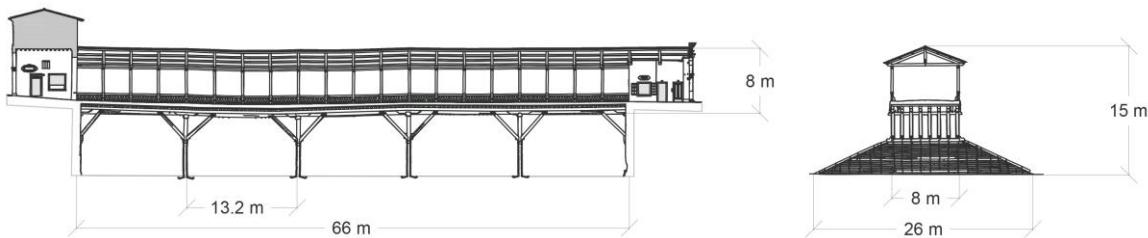
Figure 3 - Longitudinal and transversal sections of the bridge

The bridge present five spans of 13.2 m; the structure is loading on the two abutments and on four central piers.

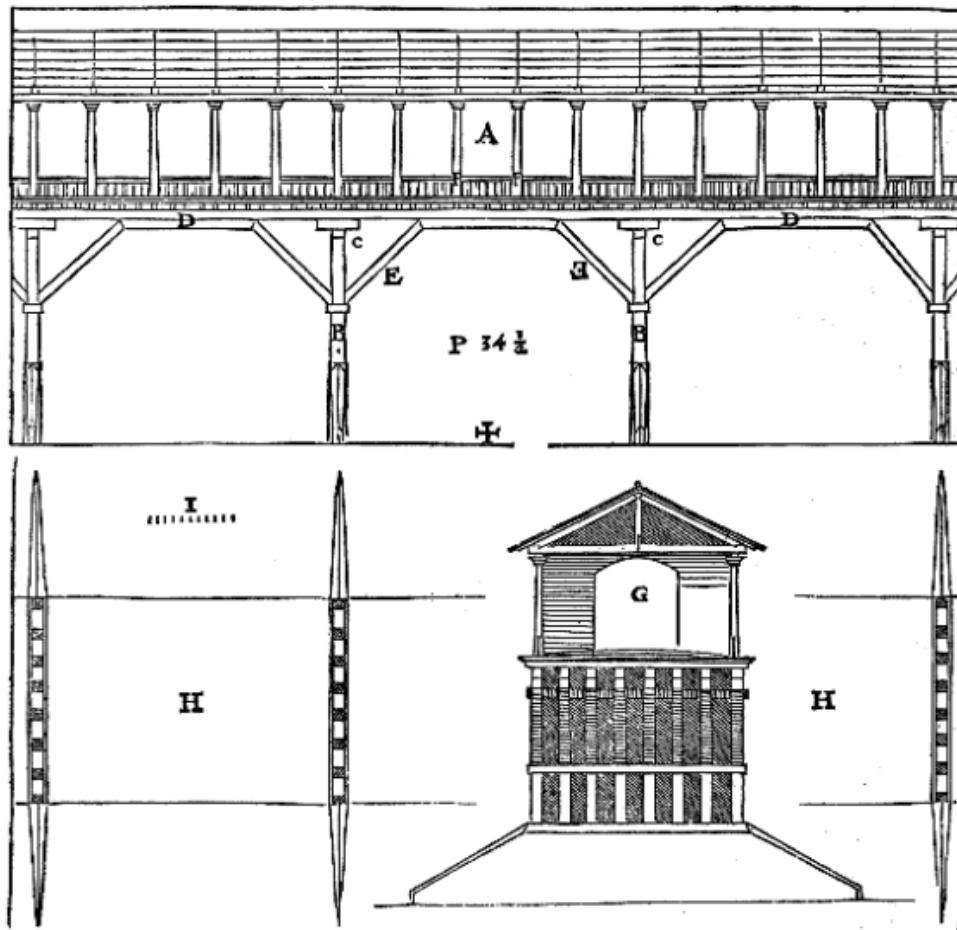
Figure 4 – A. Palladio, The Four Books of Architecture

- + is the water level*
- A is the longitudinal view of the bridge*
- B are the piles inserted in the river*
- C are the heads of the transversal beams*
- D are the beams posted in the longitudinal direction (supporting beam)*
- E are the oblique elements (strut)*
- F are the columns*
- G is the transversal section of the bridge*
- H is the plan*
- I is the referring measure of ten feet*

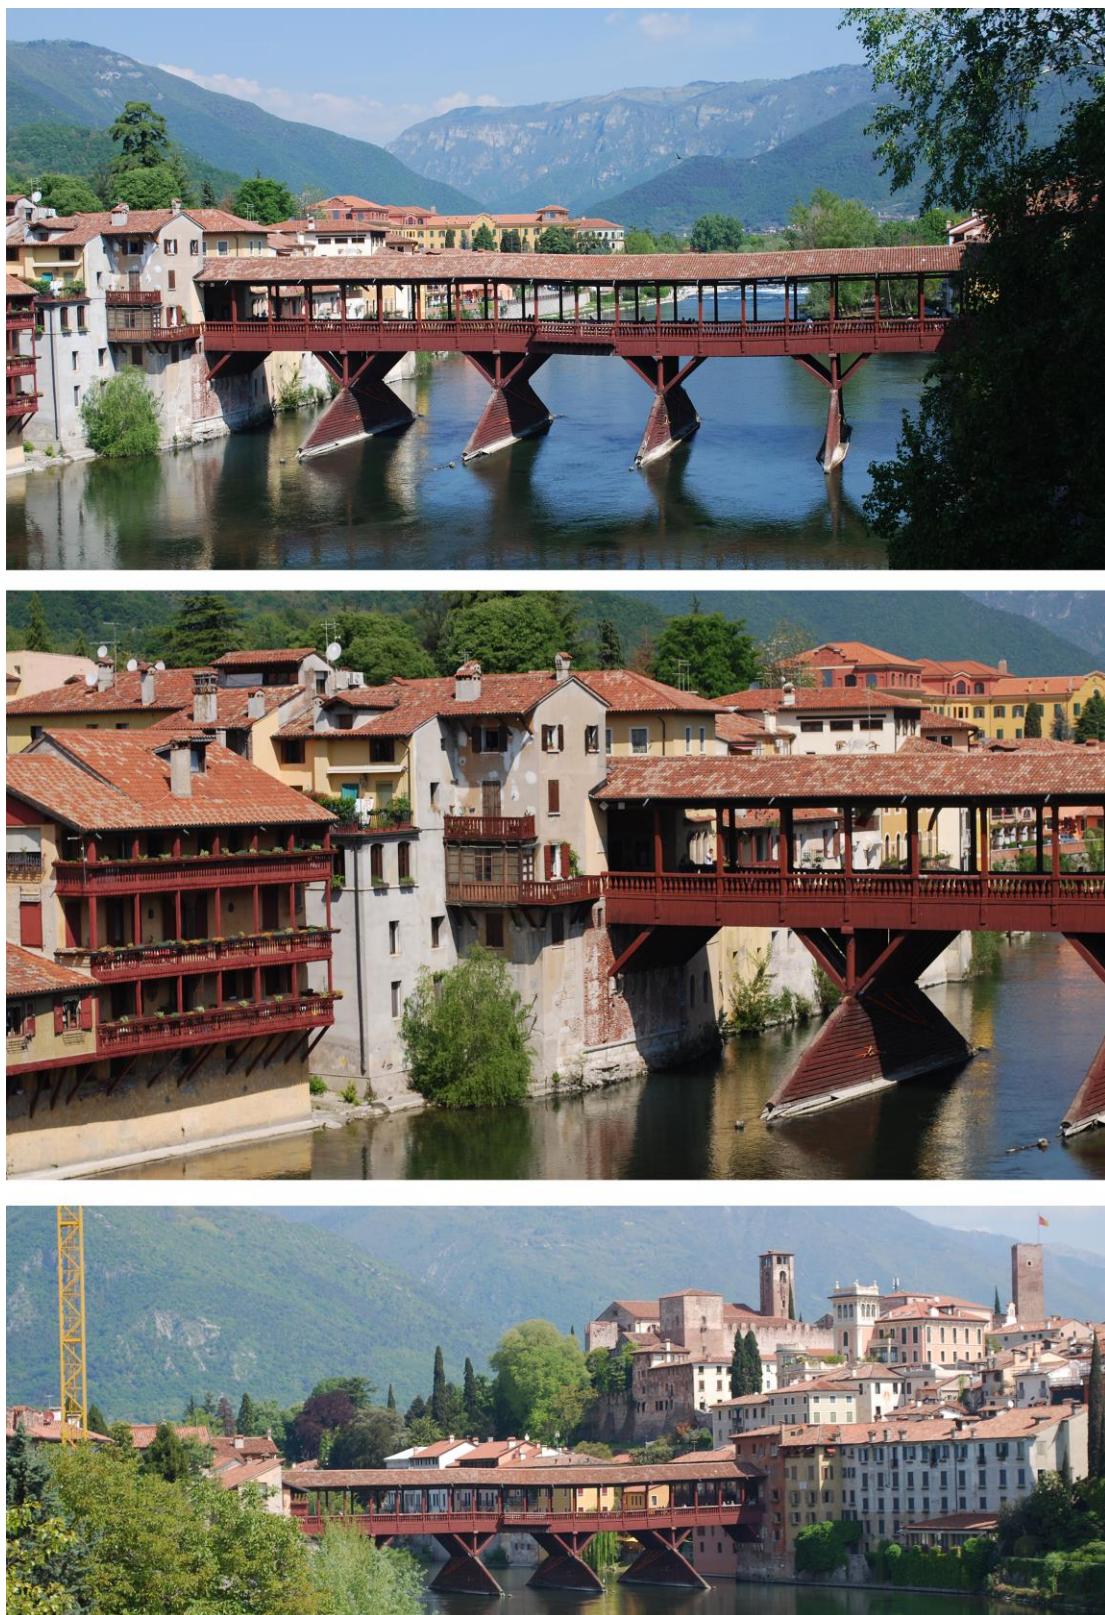
Figure 5 - Timber Bridge of Bassano del Grappa (2016)

The structure consists of five spans resting on four piers in the riverbed. Each pier has eight piles of the same length (1.1m) supporting the structure above, as well as 6 more columns of decreasing length on both sides, protecting the bearing columns; these triangular lateral elements are called *Rostri* in Italian. Two transversal beams connect the columns together on the top and at the base. The columns are covered by a planking structure with wooden elements (10x17cm) with a spacing of 25 cm. The connection between columns and beams is done by threaded bars of 16mm diameter; instead, the planks are not connected horizontally and their main aim is to protect the internal columns. In 1991 a survey was done by the engineer Ugo Bonato, his drawings are a great source of information. Each span presents the same type of structure: longitudinal beams loading on the cantilever beams which are supported by transversal continuous beams. The latter distribute the loads on the eight piles constituting each of the eight piers.

The oblique elements (struts), taking load from the longitudinal beams, are connected by the longitudinal supporting beams. The connection between those two elements is done by metallic plates 8mm thick and 9 bolts of 16 mm diameter. The other connections are made with bolts of 25 or 30 mm diameter with the use of Appel connectors.

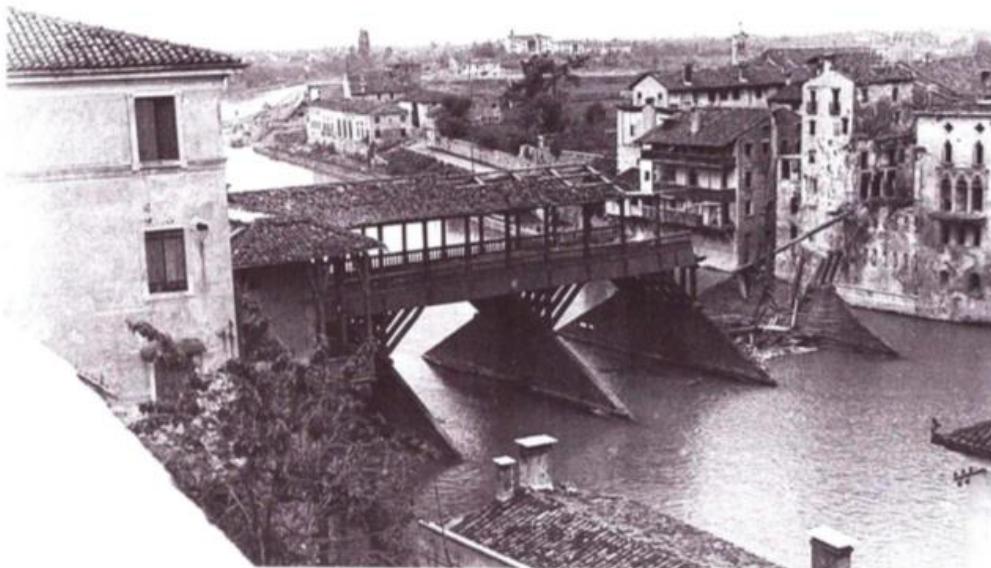
Figure 14 -The bridge after the German attack of April 1945

At the end of the Second World War, in the 1945, after the destruction of the new Bassano bridge the *Partigiani* blew up the bridge in order to stop the German invasion, but that was not too effective and it was still possible to pass. A few months later the German army destroy the occidental part the bridge as a revenge (Figure 14).

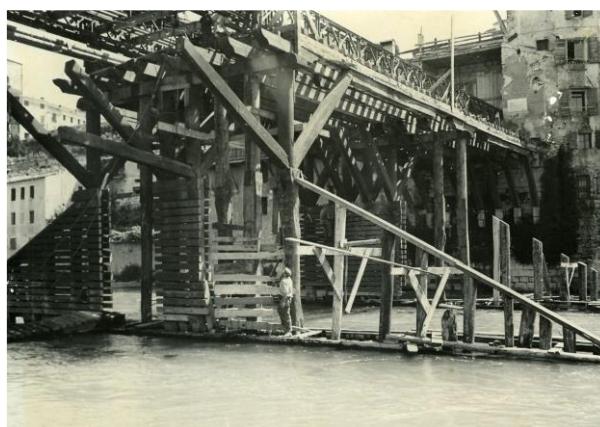
Figure 15 - Restoration of the 1948; third pier. Civic Museum of Bassano

The intervention of the 1948 was mainly focused on the fourth pier, it was reconstructed together with the foundation system. Looking at the picture of the time (Figure 15) it's clear that the last two spans (near Angarano) were destroyed, during this intervention they were rebuilt. It was necessary even to repair and reconstruct the roof and the entire part over the footing level (columns, balustrade, balconies); the pavement was done with a layer of rubble stones of 5 cm thickness. Moreover, the stone gate was damaged during the war and the reconstruction was necessary.

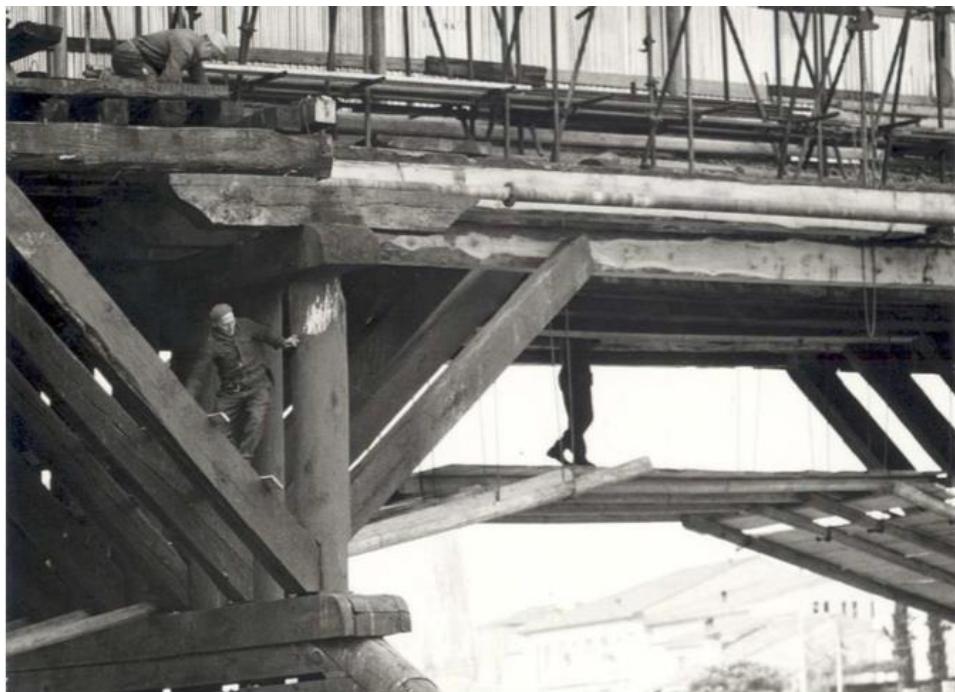
Figure 17 - Repair of the damaged elements (1965)

There are not fully information about this intervention, however it is known that the second span (from Angarano) was restored. The cantilever beam on the east side was substituted together with the first and second longitudinal beam on the north side.

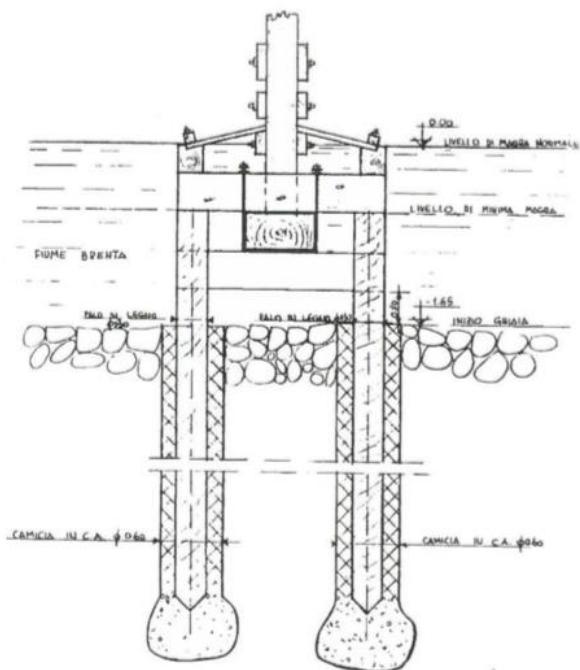
Figure 18 - Scheme of the new foundation system, Benetti 1968

A new foundation structure was designed, moving from one central line of piles to several not aligned piles connected by a new beam called "Cavezzale". Four new *cavezzali* for each pier were added in order to support the foundation structure. These supporting beams are located in different positions along the threshold; they have two piles each one as a support, the piles are in timber encapsulated in a concrete sheet and they stand for 7 m depth from the end of the concrete layer. The addition of these piles, other than increasing the stability, strengthened the soil foundation.

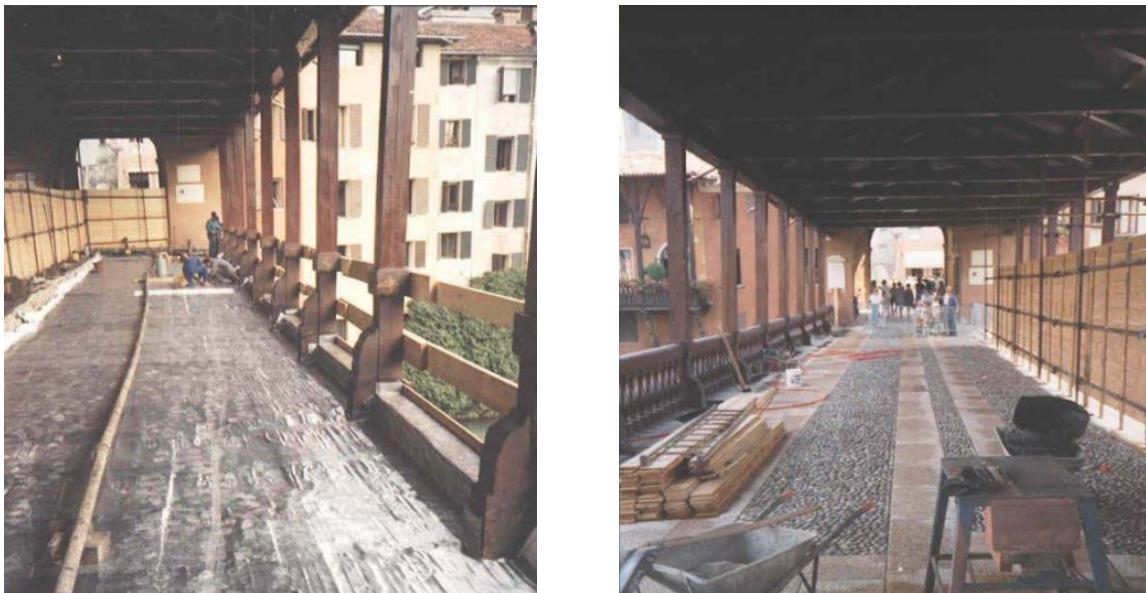
Figure 19 -Realization of the new pavement, 1991

The car passing on the bridge caused vibrations and, consequently, damages; for this reason the pavement was substituted and the bridge became pedestrian. A lead planking was placed to insulate the timber beams from the water. A new "massicciata" was realized on the base of the previous pavements; the stones used are verdello, chiarofonte and a hard limestone from Asiago.

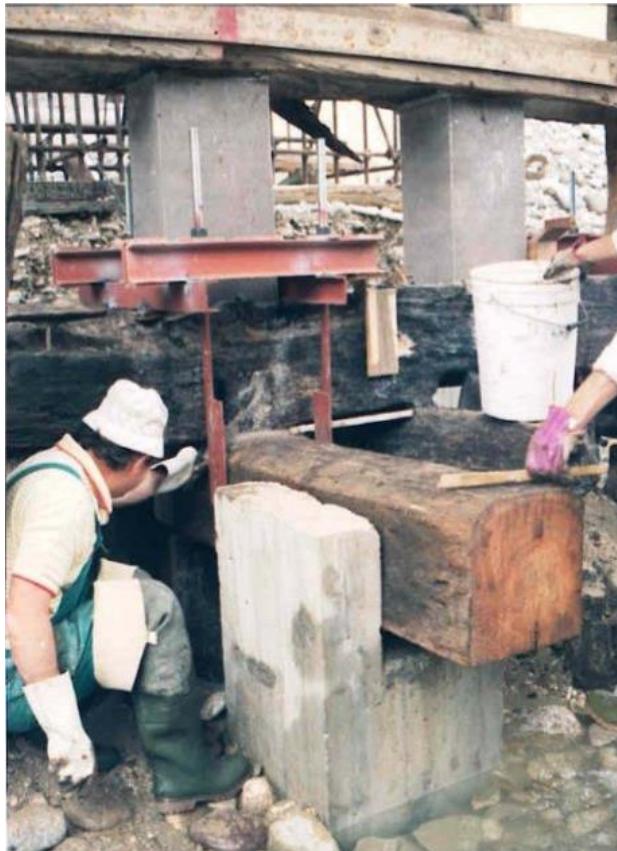
Figure 20 - The new foundation system, the cavezzali and the piles in RC

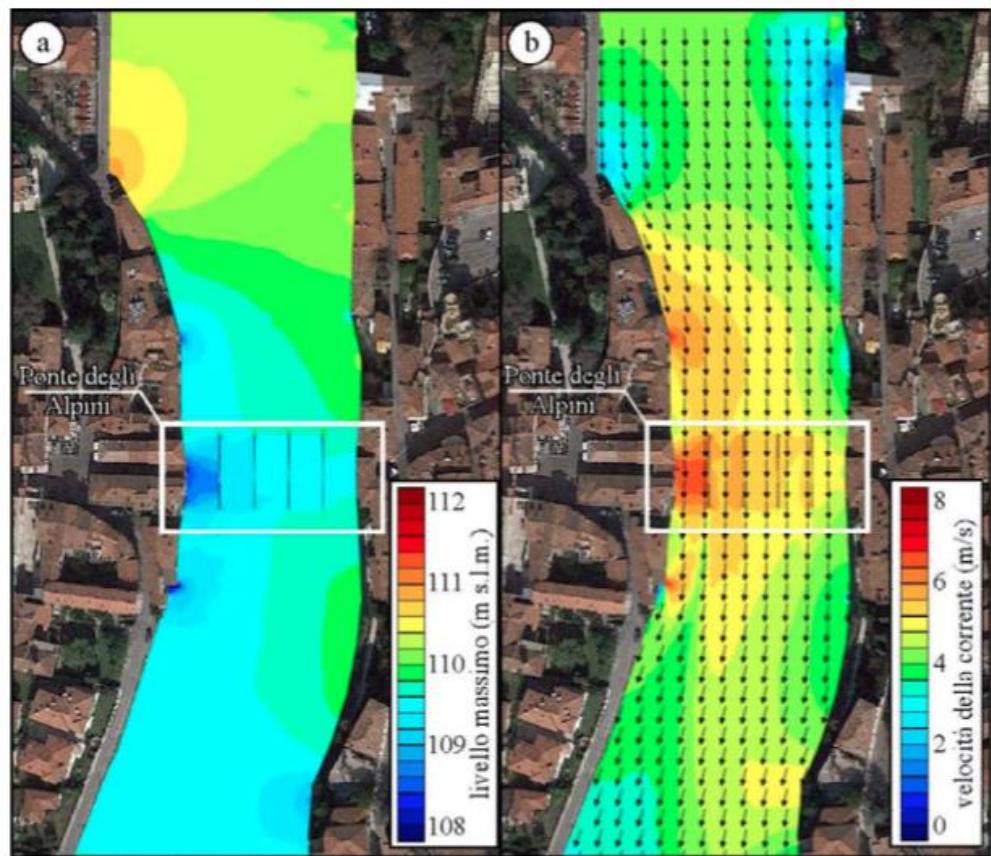
Figure 24 - a) water level, b) flow velocity (ES.R.IDR.01, October 2015)

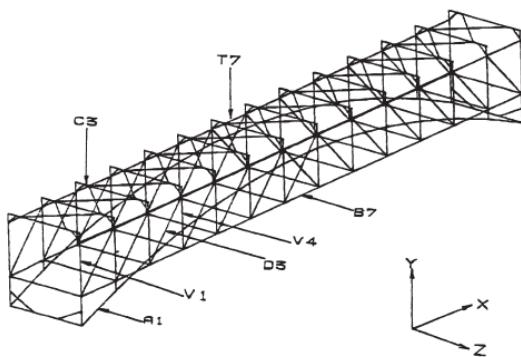
In the literature, just a few examples of assessment of historical timber bridges are present. One of those is the Barrackville Bridge in West Virginia (Spyrakos 1999), during this assessment, a geometrical survey and non-destructive test were proceeded and once all the data were collected, linear static analysis and seismic analysis were done. According to the AASHTO, a detailed seismic analysis is not required for simple span bridges; however, because of the historical significance of the bridge a multimode spectral analysis was applied to obtain the bridge response to four different spectra. In this case, a finite element analysis was employed to study the response of the structure. The Barrackville Bridge was modelled with three-dimensional beam elements; end-moment releases were specified at diagonal and vertical elements to simulate pinned joints.

Figure 26 - Fem model of the Barrackville Bridge
(Spyrakos 1999)

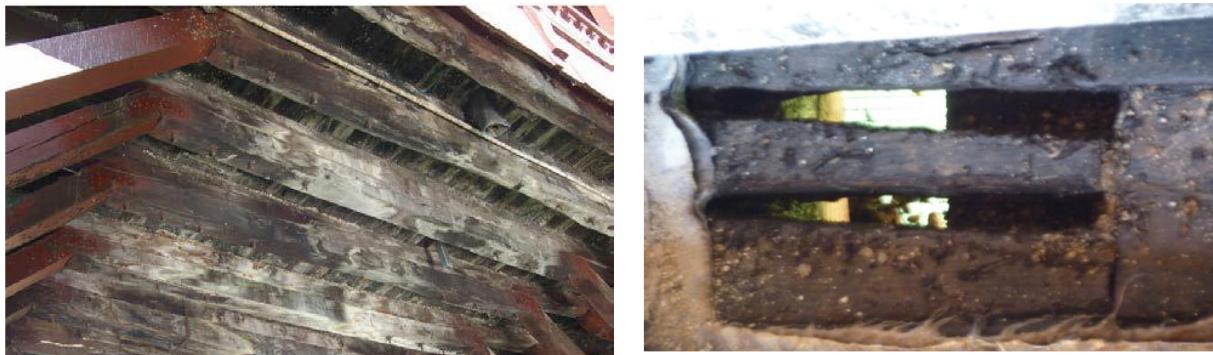
The deck shows high levels of deformation in the horizontal direction. The supporting and longitudinal beams show high levels of degradation and the consistence of the timber is really weak.

Figure 30 - Degradation of the timber beams

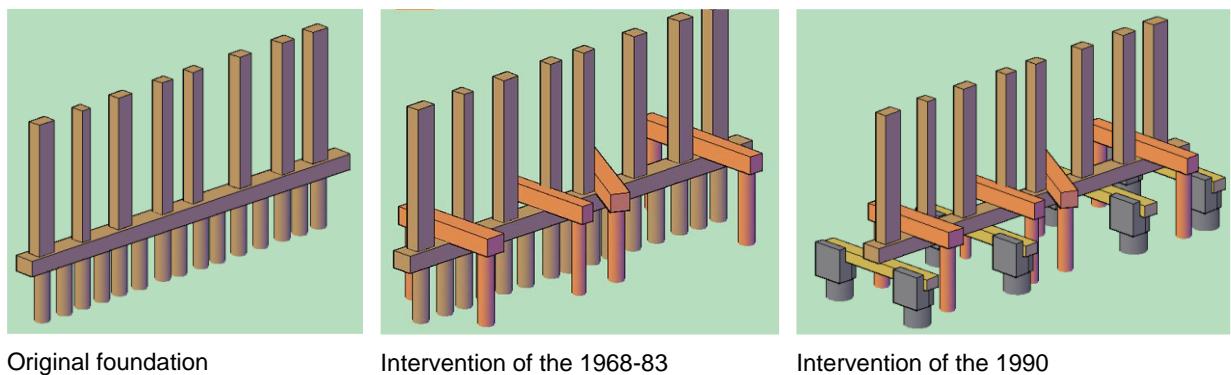
elements are supporting the wooden beams. From the assessment of 2014 it comes out that the 90's structure is nowadays the only supporting, the wooden piles are suffering from erosion and they are no more effective.

Figure 31 - Fonudation interventions (ES.R.RIL.04, 2015)

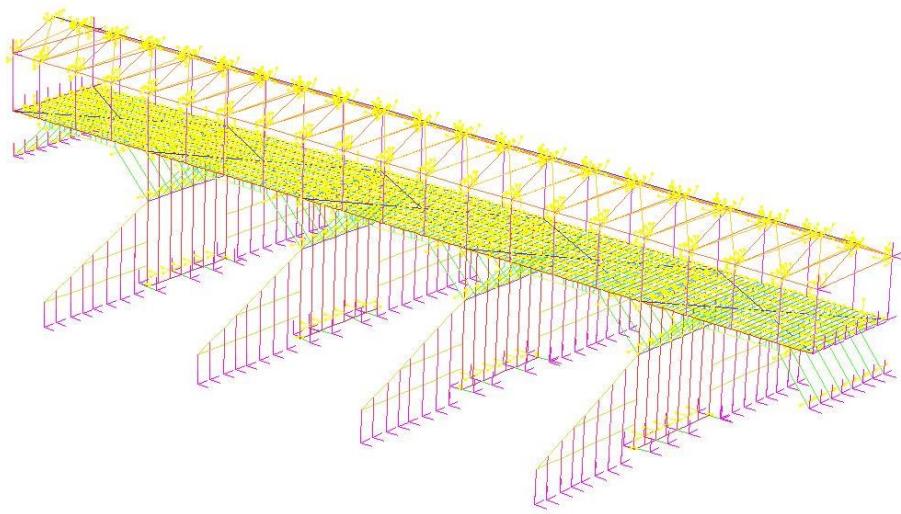
It is proposed a numerical model with "beam 2" elements in accordance with the geometrical survey. In order to use beam elements the dimensions perpendicular to the axis of the bar have to be small in relation to the bar's length. Beam elements may have axial deformation, shear deformation, curvature torsion; therefore they can describe axial force, shear force and moment.

Figure 32 - FEM model of the bridge, linear elements

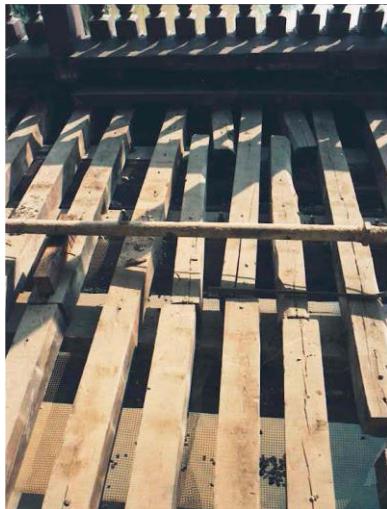
Figure 34 - Connection between longitudinal beams and secondary ones.

Analysing a timber structure, it is fundamental a good understanding of the joints and of the connections between the timber elements (Spyrakos 1999). End-moment releases were specified at diagonal, vertical and horizontal elements to simulate pinned joints. In the historic timber structure is hard to find a fix joint but it is most probable to have hinges between the elements. As an example, at the connection between the primary and secondary beams and at the one between the supporting beams and the struts the two main moments are released (Figure 34 and Figure 37).

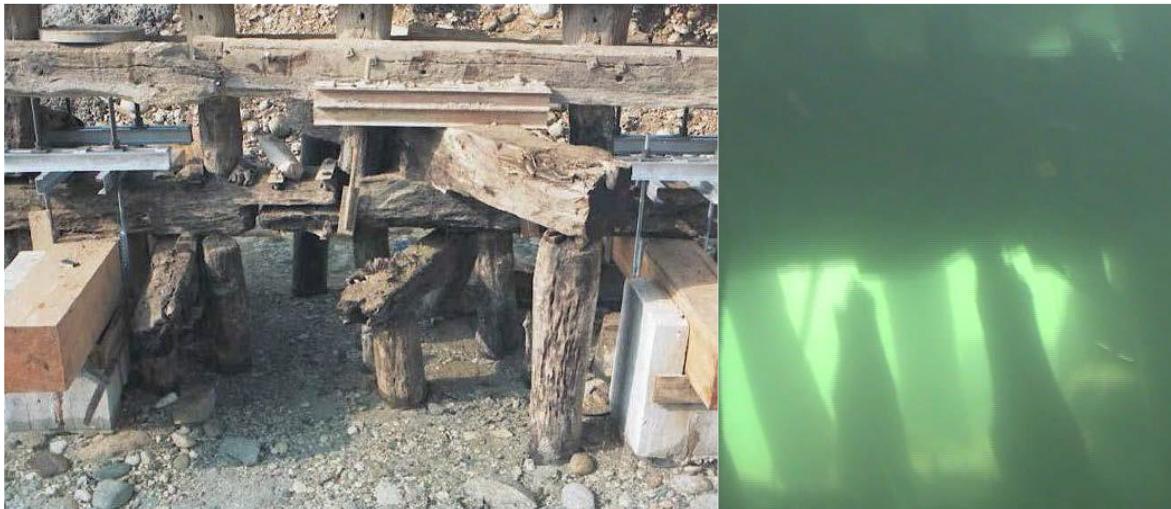
The damage level is considered in the FEM model mainly in the mechanical parameters. However, concerning the foundation system, the "cavezzali" are modelled but not the original poles under the longitudinal beams, this choice is due to the high level of degradation: many of those poles are no more effective.

Figure 38 - Damage of the foundation, the elements "Cavezzal" are visibly new

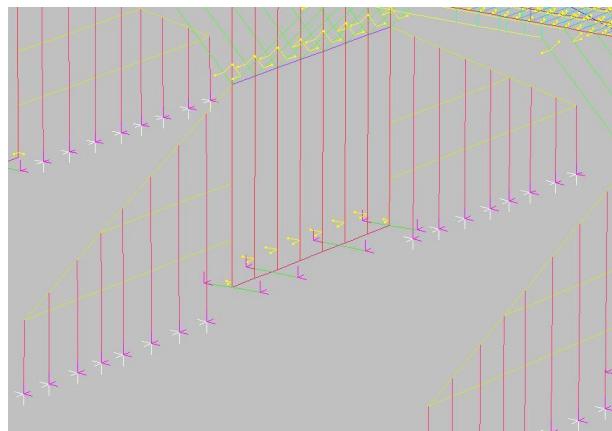
Truss elements are used in the piers, to connect vertical elements and to simulate the planking action.

Figure 40 - Truss elements (in yellow)

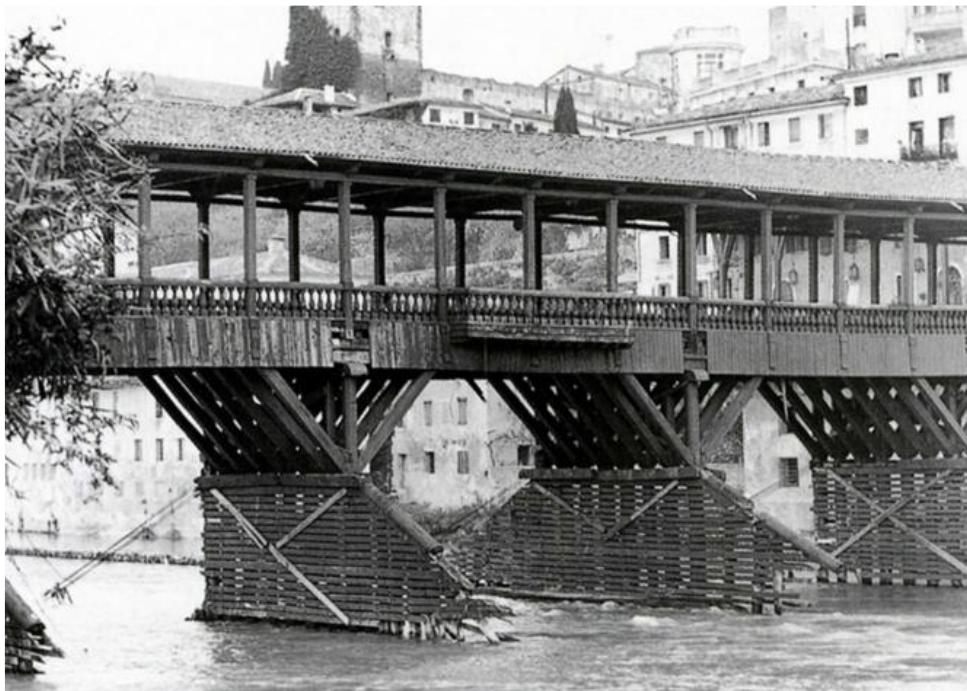
Figure 46 - Damaged structure after the overflow of the 1966

The lateral elements at the foundation, called “*Rostri*” in Italian, have been damaged during the floods of the past, especially during the 1966. They are the element most exposed to the water flow and therefore vulnerable.

Those parts of the structure are protecting the main central poles against the river. In case of out-of-plane behaviour, those elements make a strong difference in the overall behaviour. Working as

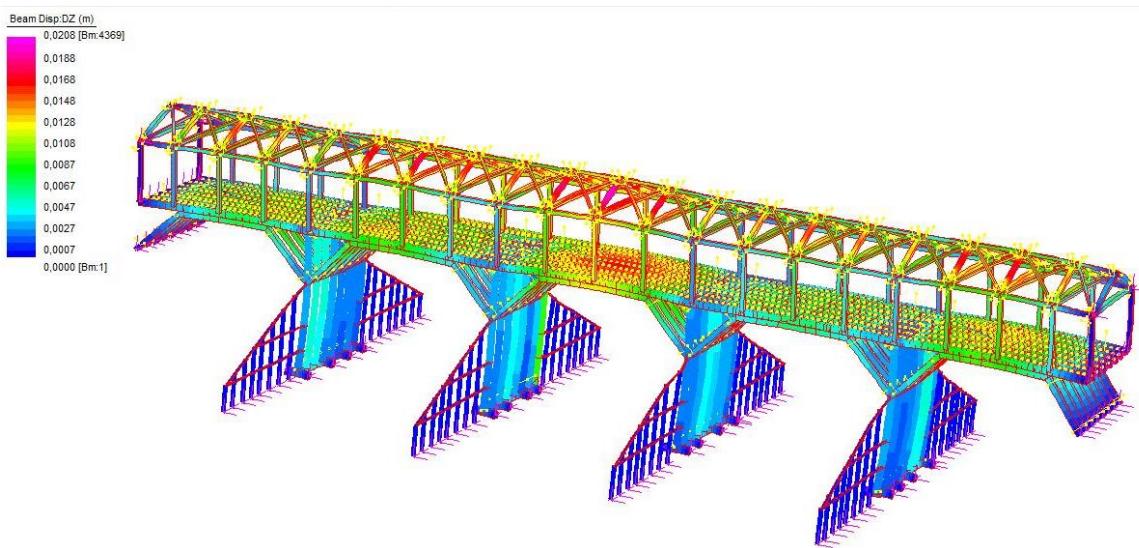
Figure 49 - FEM model, Static analysis (Envelope of the combinations). Displacement in Z direction (solid view of the linear elements).

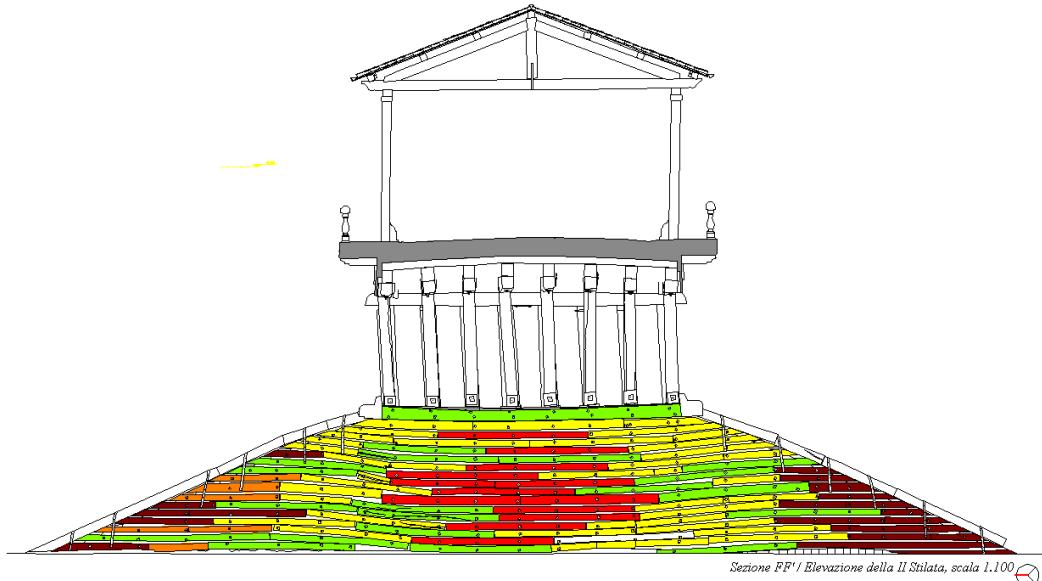
Figure 50 - Deformation survey (only the unsubmerged part is visible)

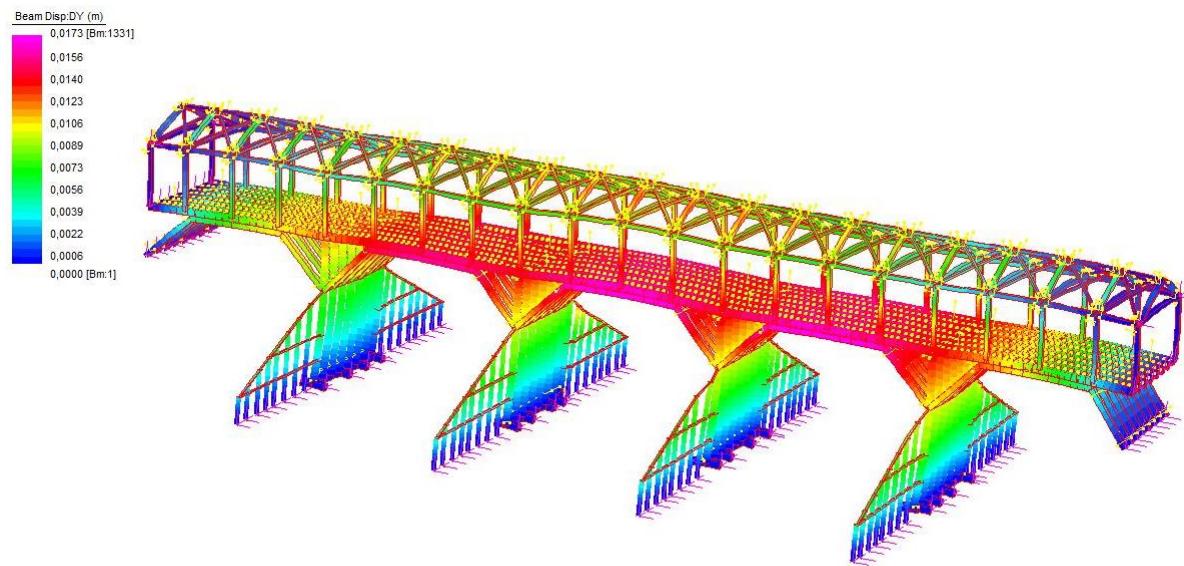
Figure 51 - FEM model, Static analysis (Combination 9). Displacement in Y direction.

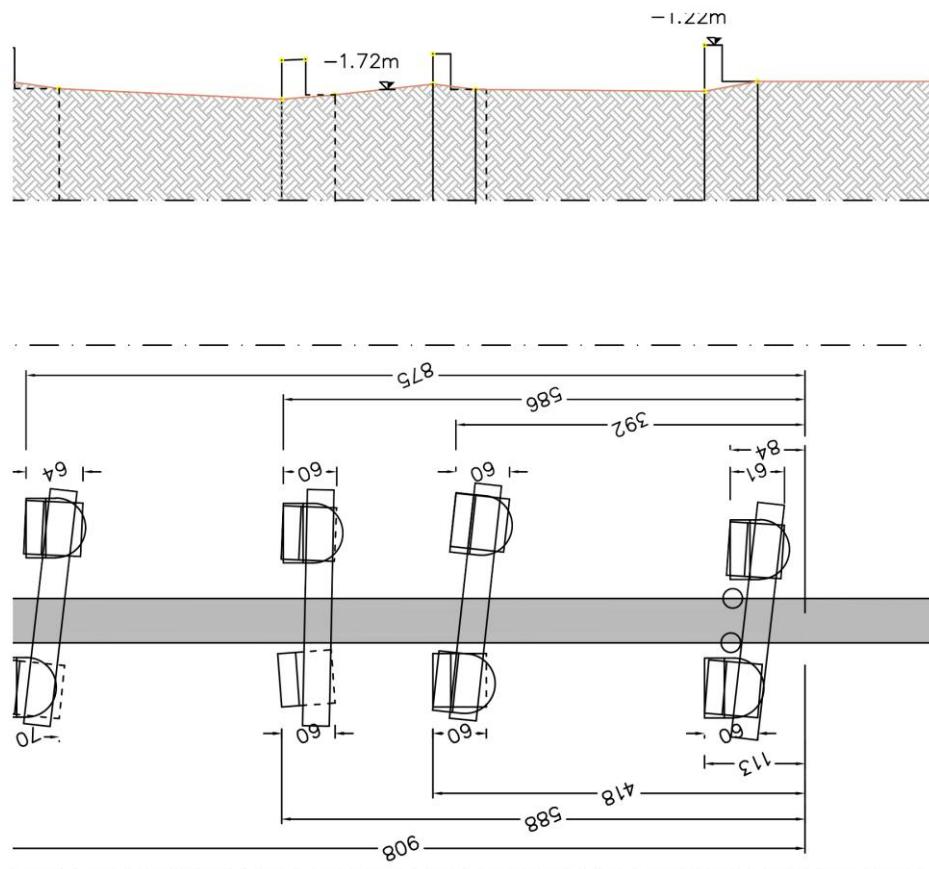
Figure 52 - Geometry of the foundation system

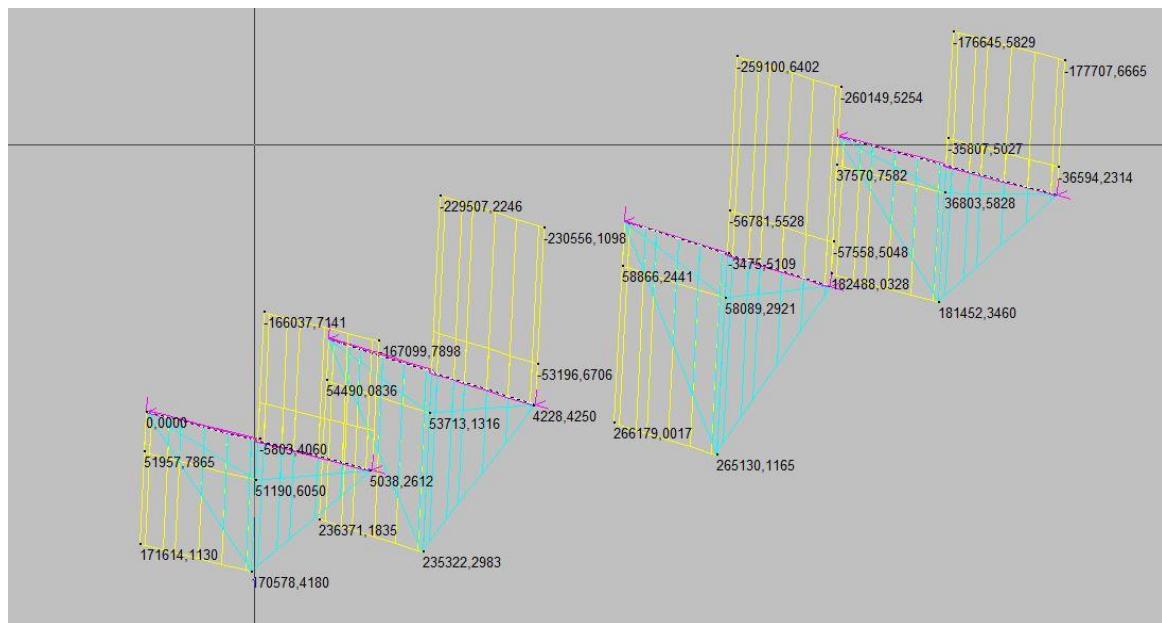
Figure 53 - Cavezzali of the third pier, shear and bending moment in direction z (action in N,m)

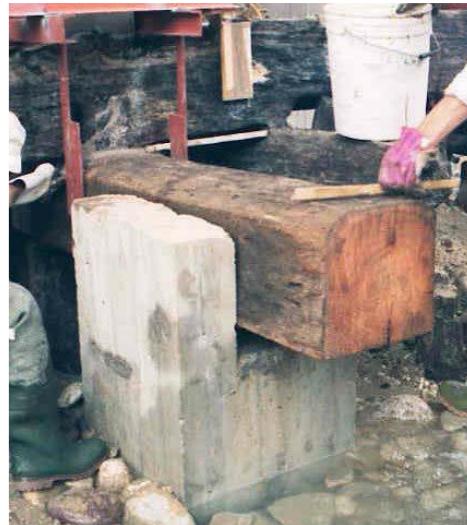
Figure 54 - Localized compressive stress on the Cavezzali beams

The Cavazzali elements are sustained at the extremities by concrete short poles and at the middle span they present the central load given by the vertical timber poles of the pier. This type of structure generates localized pressure perpendicular to the direction of the fibres. This type of stress may be dangerous in timber elements because of their orthotropic characteristics, timber presents a low resistance in the direction perpendicular to the fibres. Therefore, in addition to the verification of the

stress levels of the entire element, it is necessary to control the localized stress; the forces are almost punctual and they generate high level of compression at the extremities of the beam and in the middle. The concrete elements are not part of the FEM model because of their high level of stiffness respect to the timber ones. Their presence is simplified with the external restraints.

At the ends of the beam the stress distribution is considered triangular, instead at the central part the distribution is constant. In the following table it is possible to see the result of this analysis, in red the stress levels higher than the maximum acceptable.

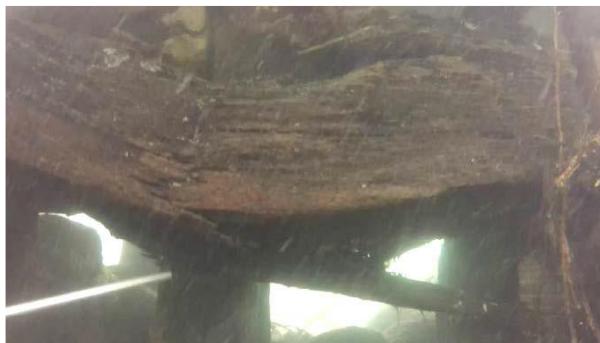
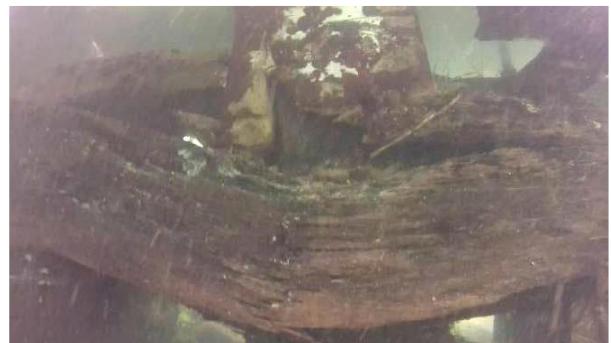
Examples of actual state of damage are visible in Figure 55 and Figure 56; the poles loading on the threshold create high levels of shear stress. The numerical results are compatible with the survey information.

Figure 55 - First Pier, threshold (UNIPD 2015)

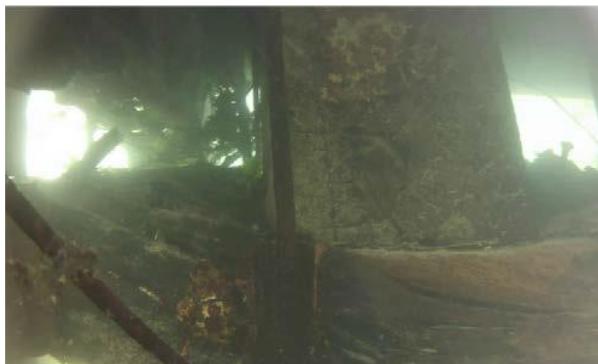
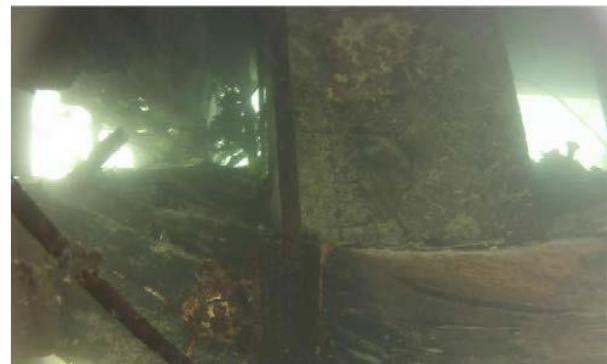
Figure 56 - Second pier, threshold (UNIPD 2015)

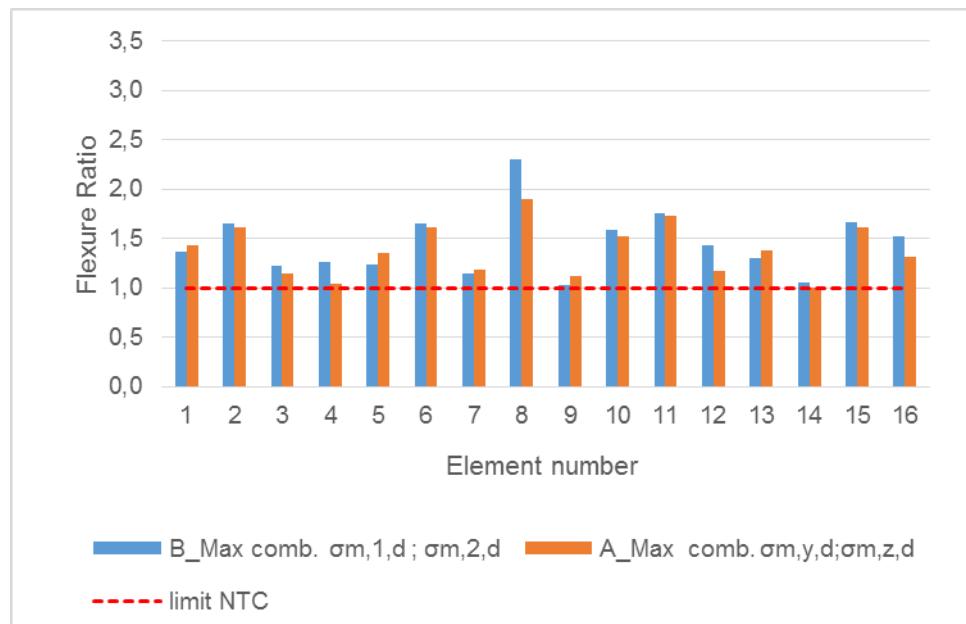
Figure 57 - Comparison between the Flexure ratios of model A and B

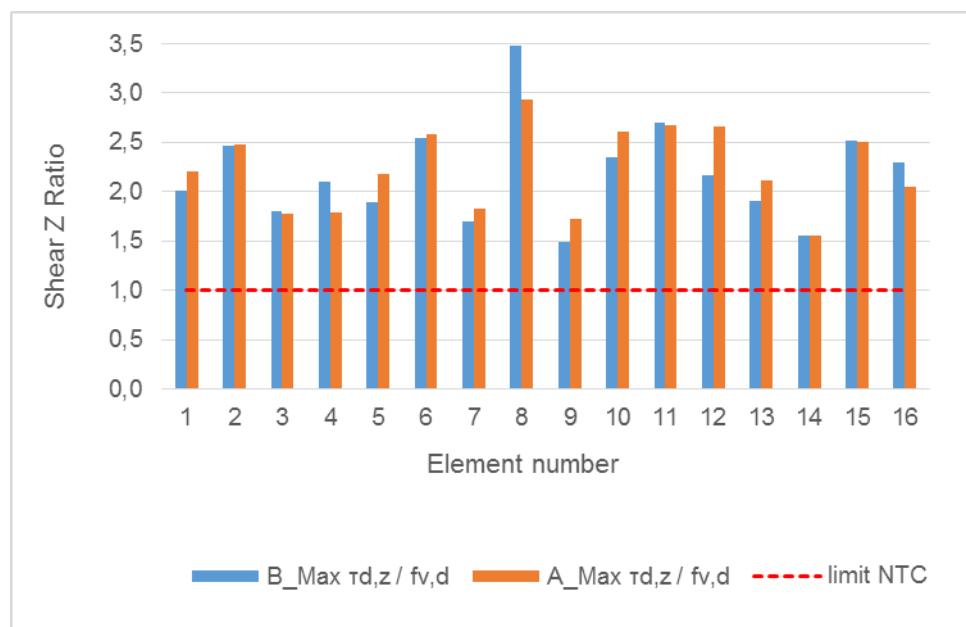
Figure 58 - Comparison between the Shear Z ratios of model A and B

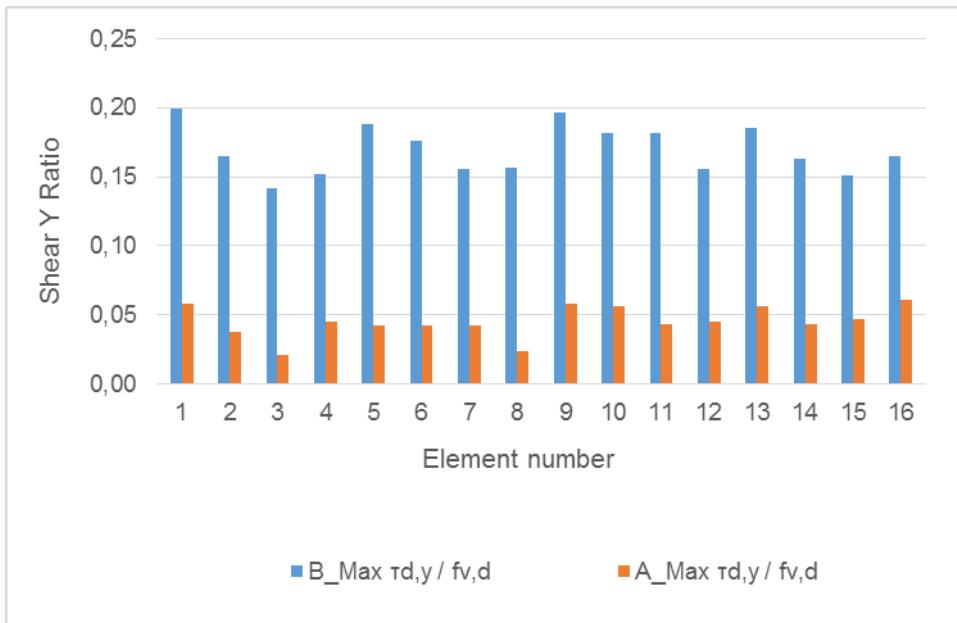
Figure 59 - Comparison between the Shear Y ratios of model A and B

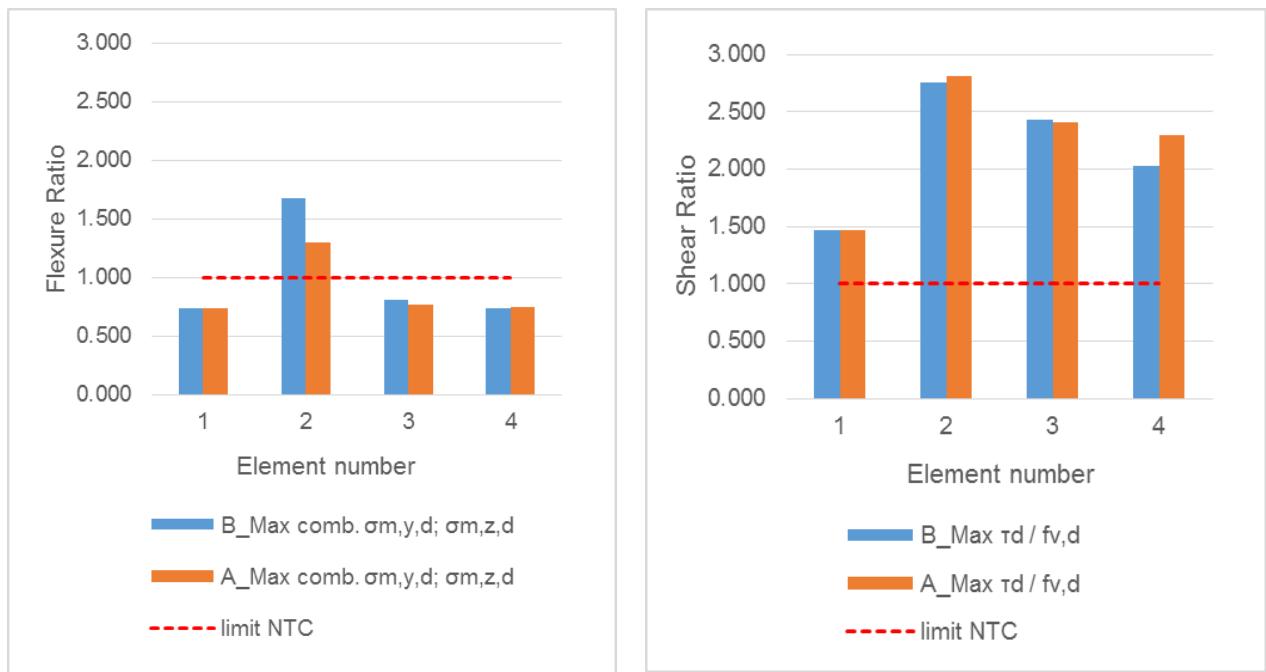
Figure 60 - Threshold beams, comparison of flexure and shear ration in the model A and B

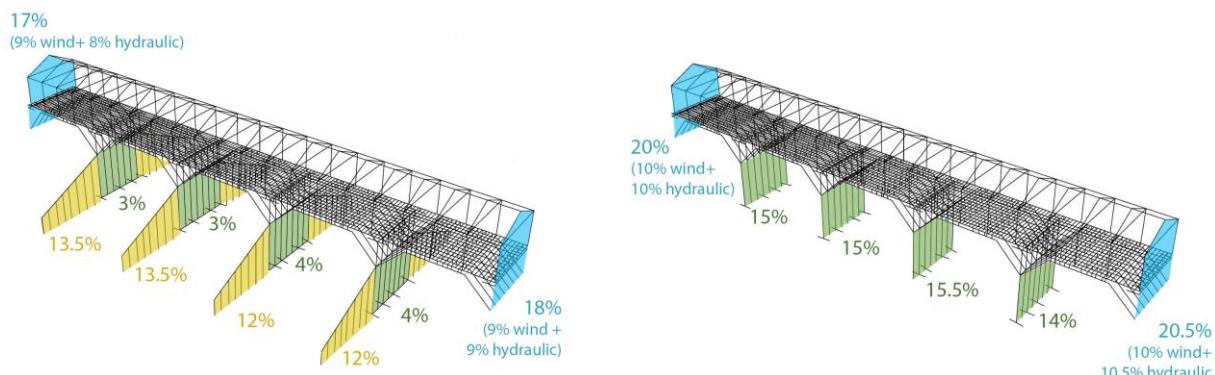
Figure 61 - Distribution of the reactions in Y direction model A (left) and model B (right).

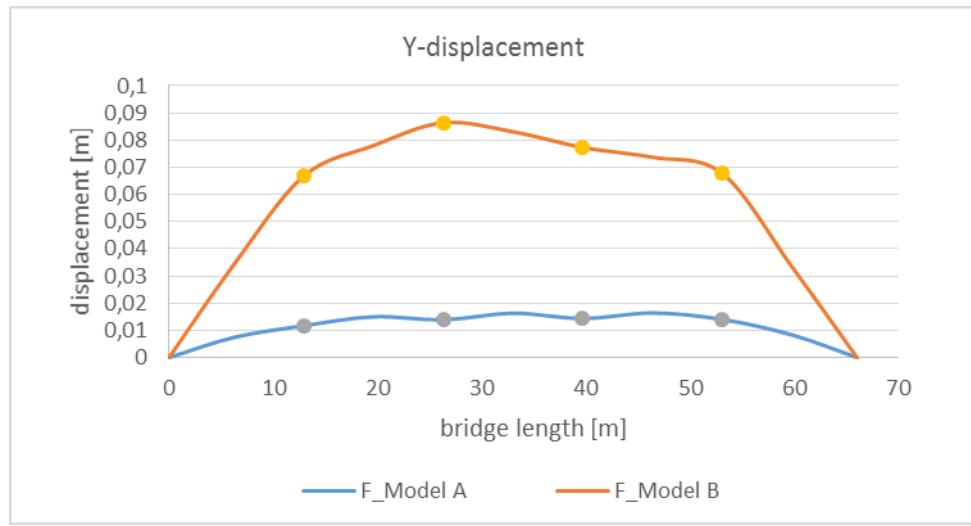
Figure 62 - Displacement of the bridge deck in the out of plane direction

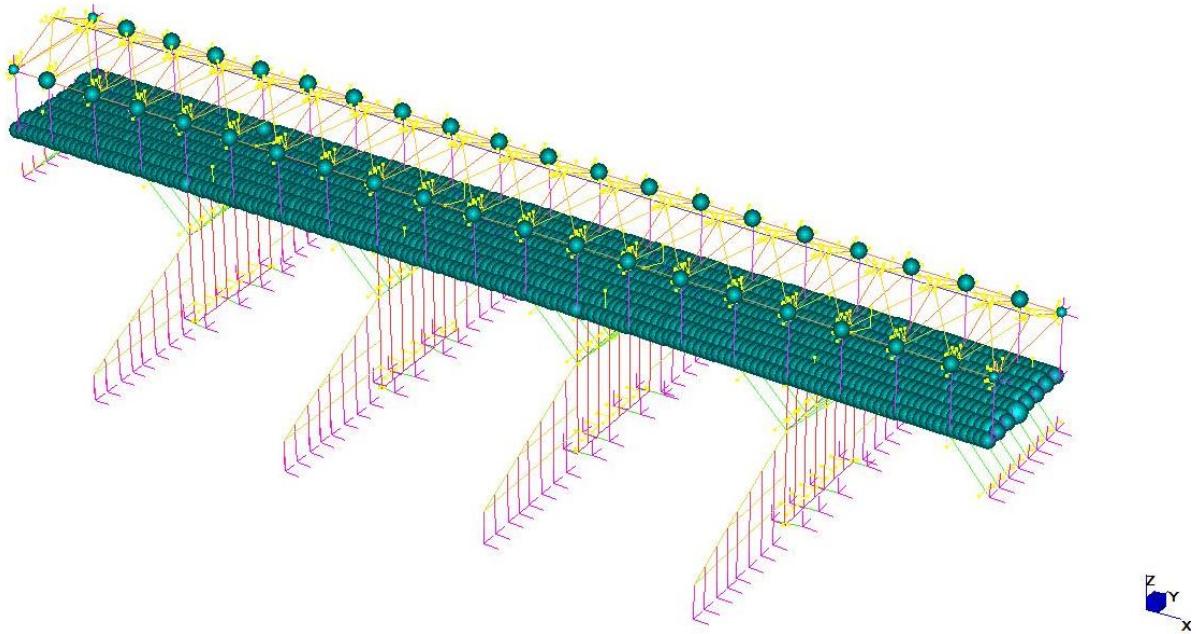
Figure 64 - FEM model, lumped masses

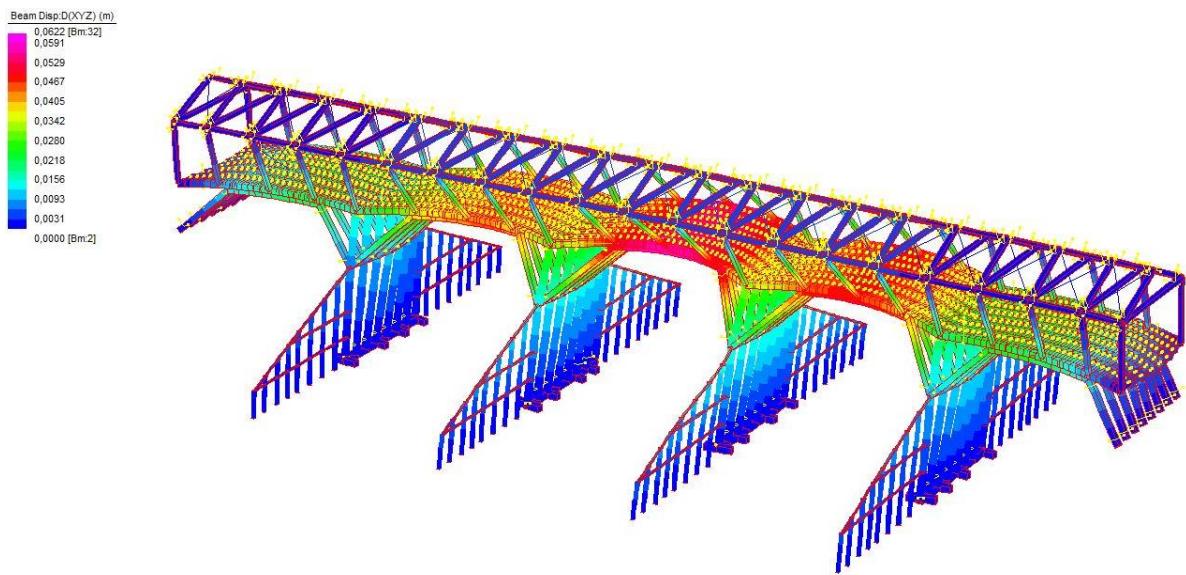
Figure 65 - Model A, displacement (XYZ), combination EQ.1 (solid view of the linear elements).
