ADVANCED MASTERS IN STRUCTURAL ANALYSIS
OF MONUMENTS AND HISTORICAL CONSTRUCTIONS

Master's Thesis

Structural analysis of Palladio's timber bridge in Bassano del Grappa

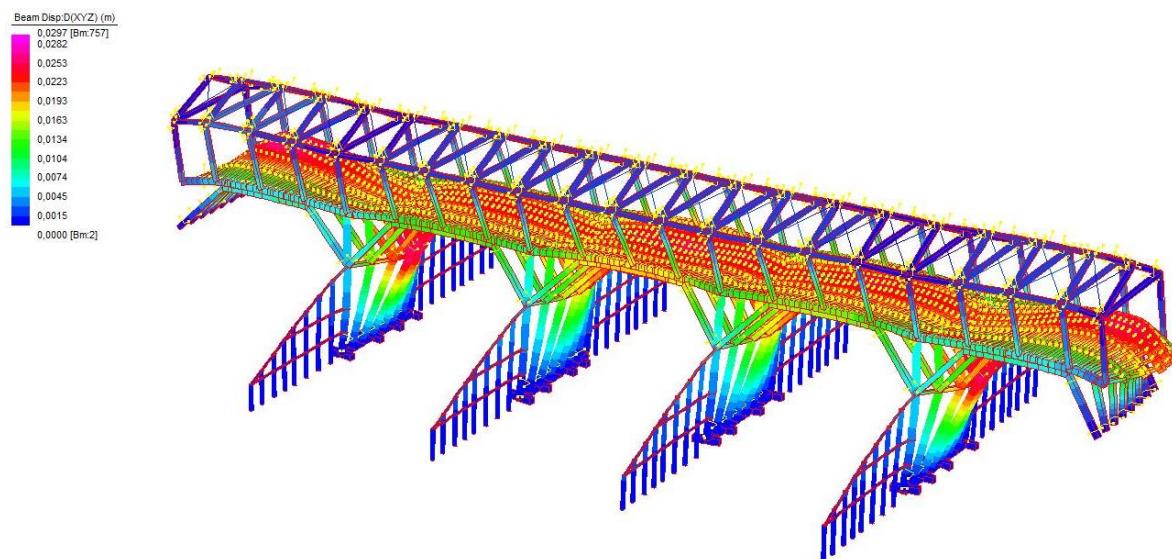
Figure 66 - Model A, displacement (XYZ), combination EQ.2 (solid view of the linear elements).

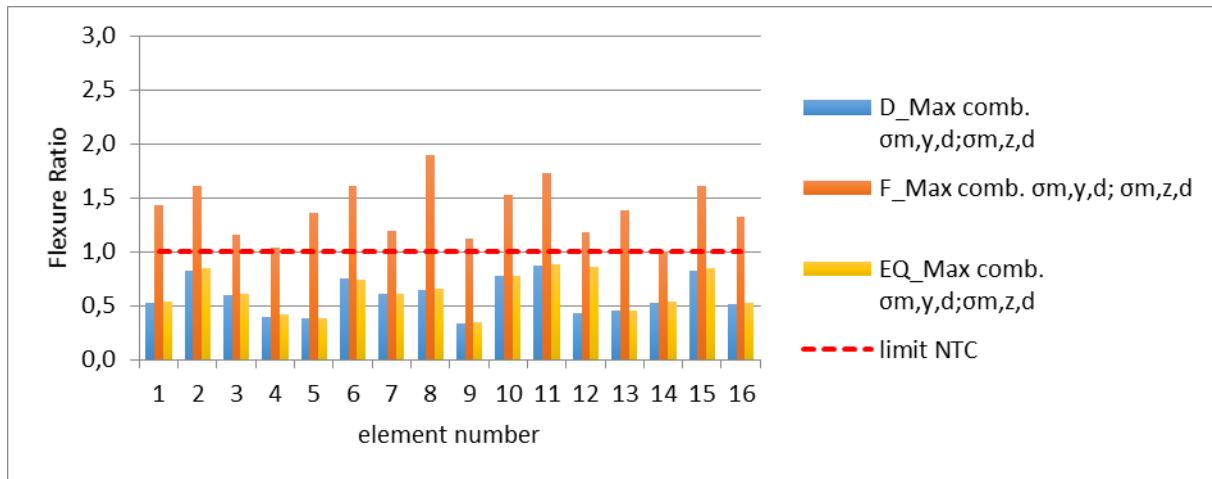
Figure 67 - Comparison of the results between daily, over flow and earthquake state. Flexure Ratio of Cavezzali (model A).

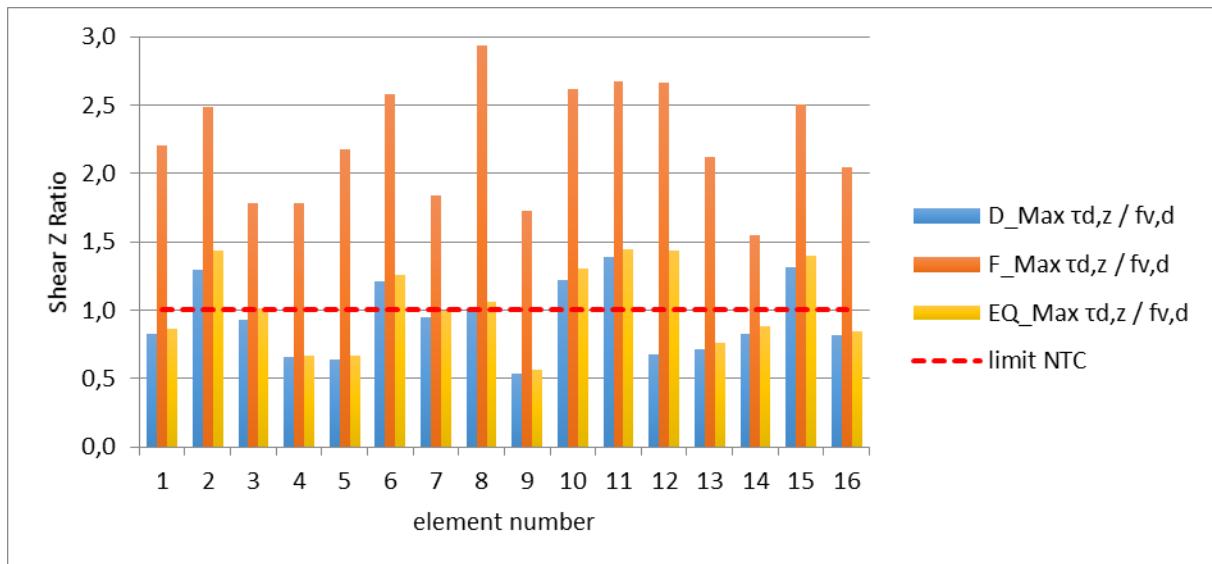
Figure 68 - Comparison of the results between daily, over flow and earthquake state. Shear Z Ratio of Cavezzali (model A).

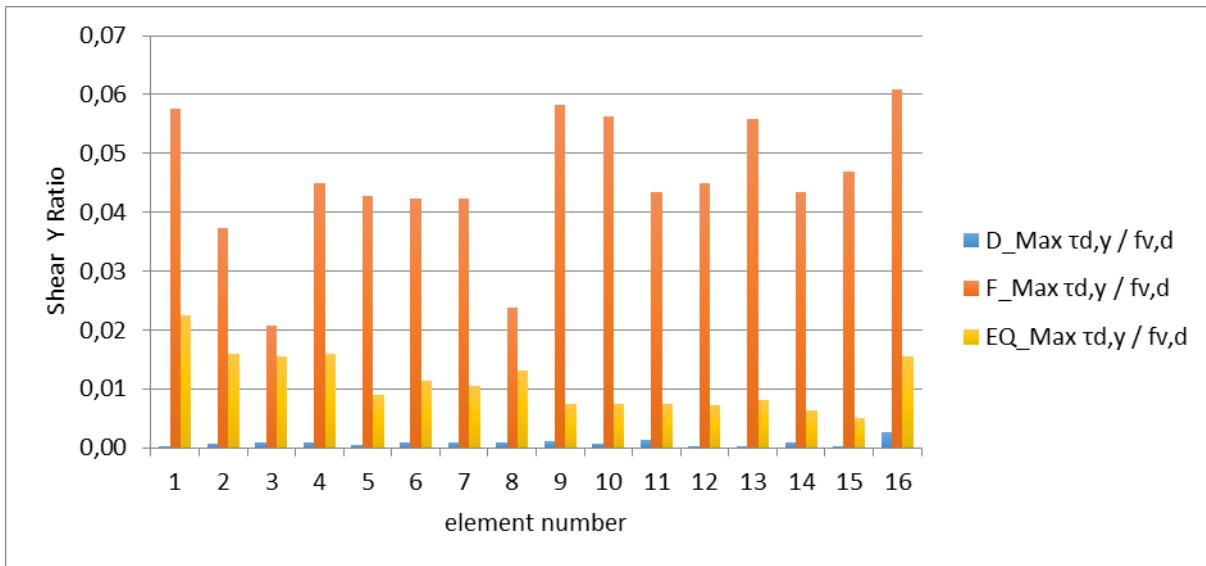
Figure 69 - Comparison of the results between daily, over flow and earthquake state. Shear Y Ratio of Cavezzali (model A).

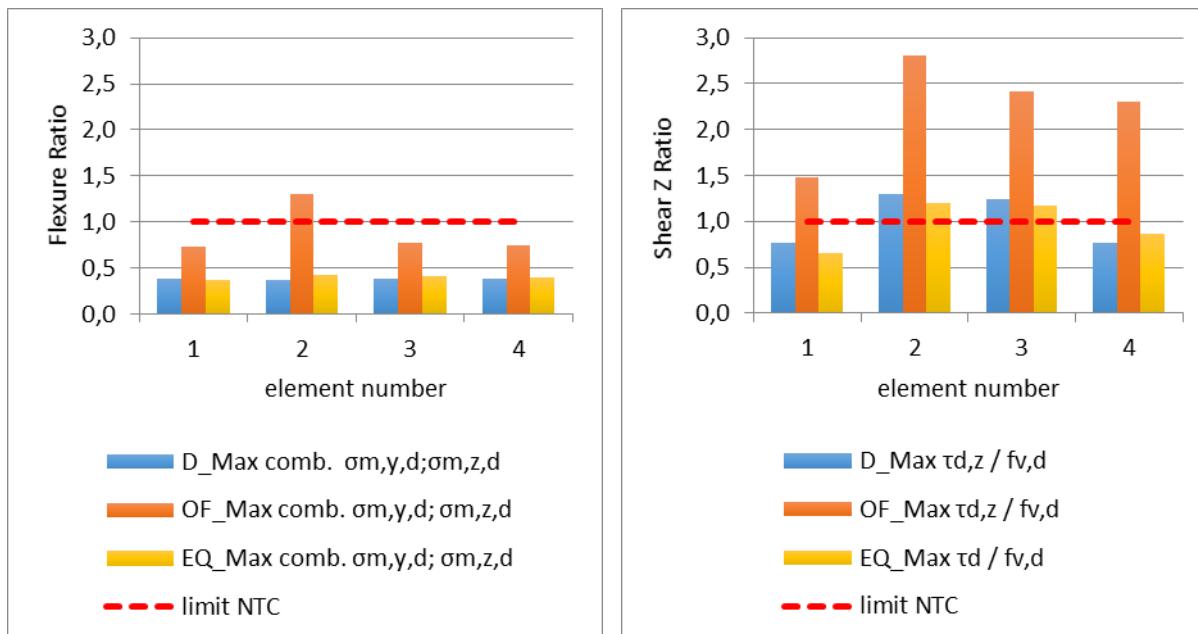
Figure 70 - Comparison of the results between daily, over flow and earthquake state. Flexure Ratio of the thresholds (model A).

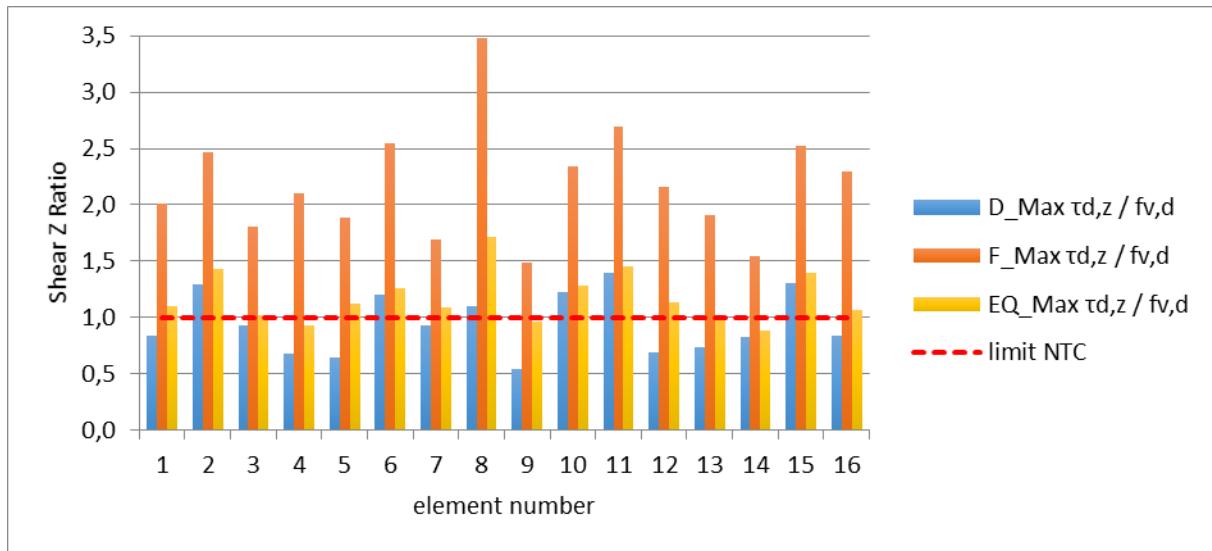
Figure 73 - Comparison of the results between daily, over flow and earthquake state. Shear Ratio Z of Cavezzali (model B).

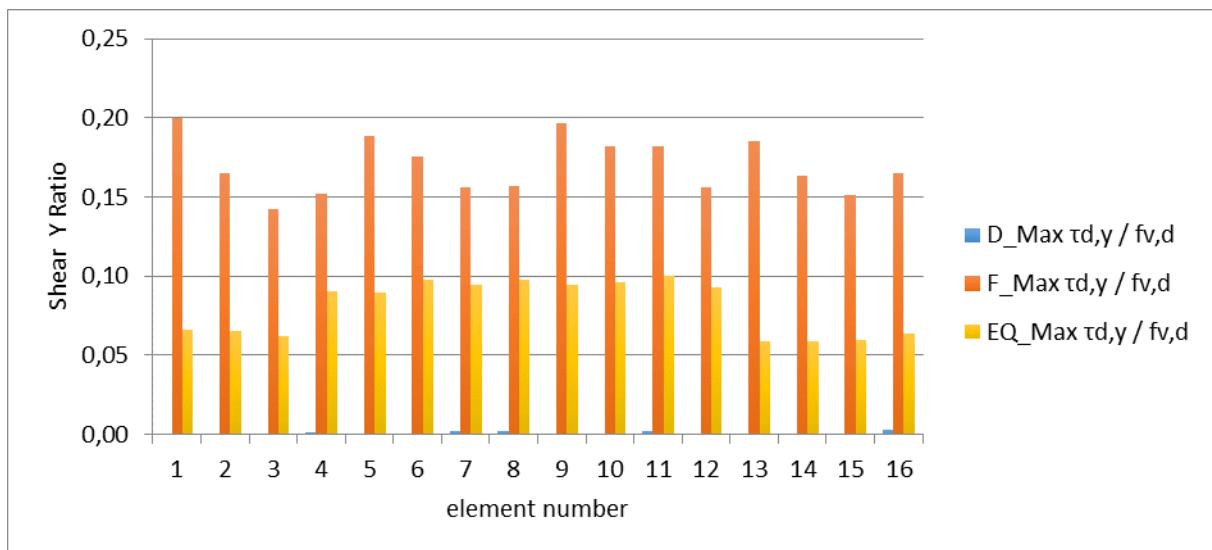
Figure 74 - Comparison of the results between daily, over flow and earthquake state. Shear Ratio Y of Cavezzali (model B).

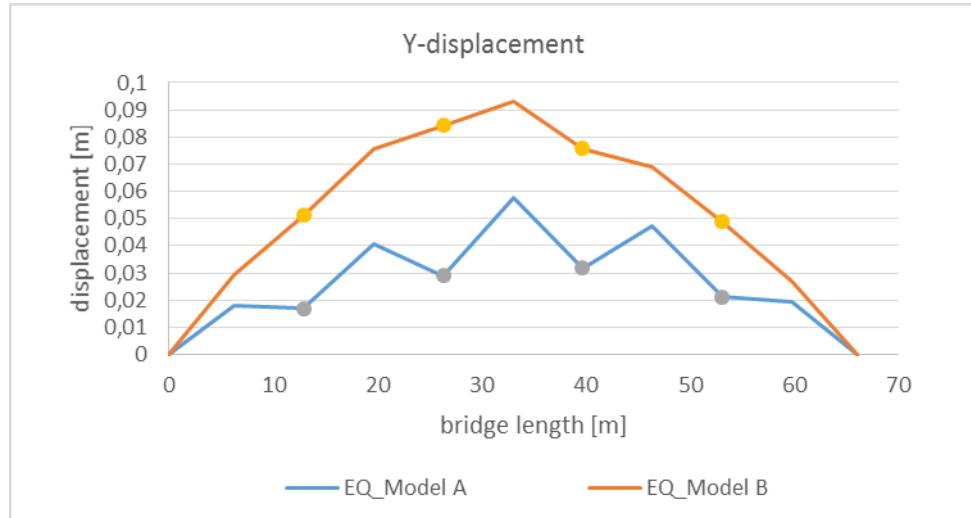
Figure 77 - Displacement in the out of plane direction (Y), Earthquake action (dots represent piers)

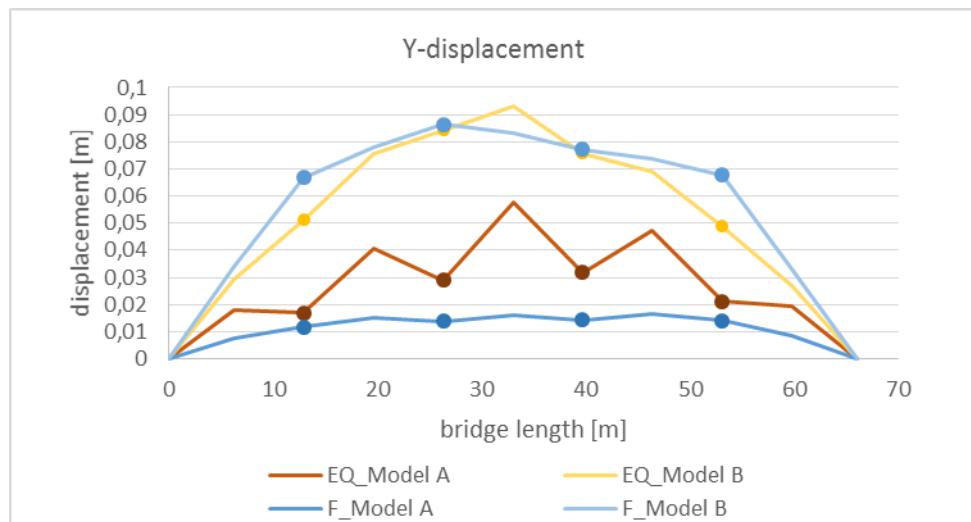
Figure 78 - Comparison between the displacement in the case of Floods (F) and Earthquake (EQ) (dots represent piers)

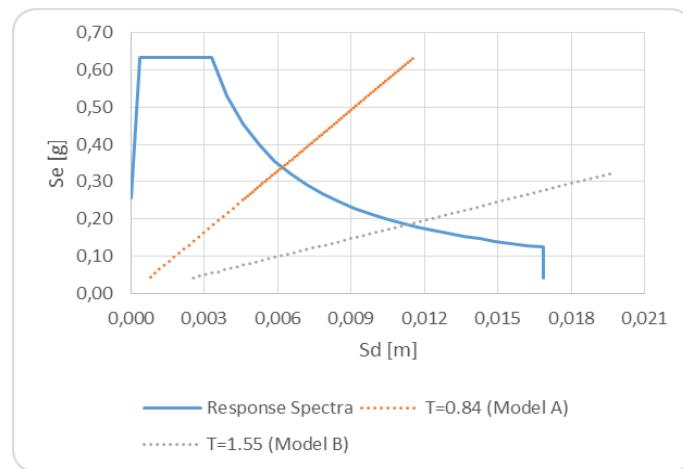
Figure 79 - First mode of model A and model B compared to the response spectra

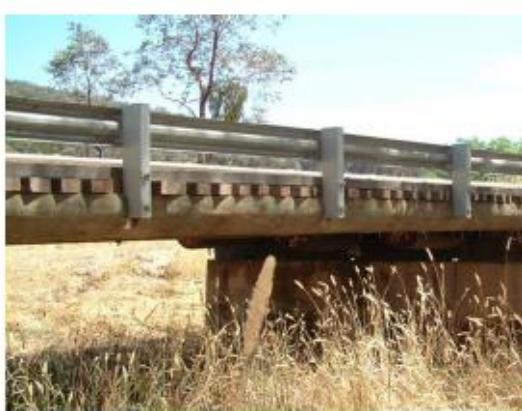
Figure 80 - Crews 2004, example of tested bridge

The University of Sydney has done a study of several timber bridges in Australia (Crews 2004), those bridges were in excess of 50 years old and many are in degraded conditions but they are highly valued, not just for economic reasons but also for social and historical value placed on them by the rural community. A campaign of dynamic frequency analysis was done, 69 bridges were tested. The aim of the project was to research and develop a cost – effective and accurate method for assessing the structural condition and predicting the load capacity of timber bridges, based on analysis of fundamental frequency of the superstructure to determine the global stiffness of a bridge deck.

Accelerometers were attached underneath the bridge girders and the vibration response and natural frequency of the bridge superstructure is measured when a calibrated sledgehammer is used to hit the unloaded deck and, than again with a relatively small mass applied at the middle span. The difference in response allows the load carrying capacity of the bridge to then be calculated, using a reliability based strength model, derived from extensive testing of aged timber girders. Thanks to these test campaign, some considerations were possible regarding the degradation effects. The increase of the traffic volume and loading intensity can cause cumulative incremental damage. The influence of these effects on the rate of deterioration of timber bridges can be particularly significant. Such damage to the strength and stiffness, in general, may not be identifiable from visual inspections, even by experienced staff. It is important not only the discovery of any damage but also the determination of the effects that such damage have on the structural integrity of the bridge.
