ADVANCED MASTERS IN STRUCTURAL ANALYSIS
OF MONUMENTS AND HISTORICAL CONSTRUCTIONS

Master's Thesis

Historical Case Study: The Frari's Basilica in Venice

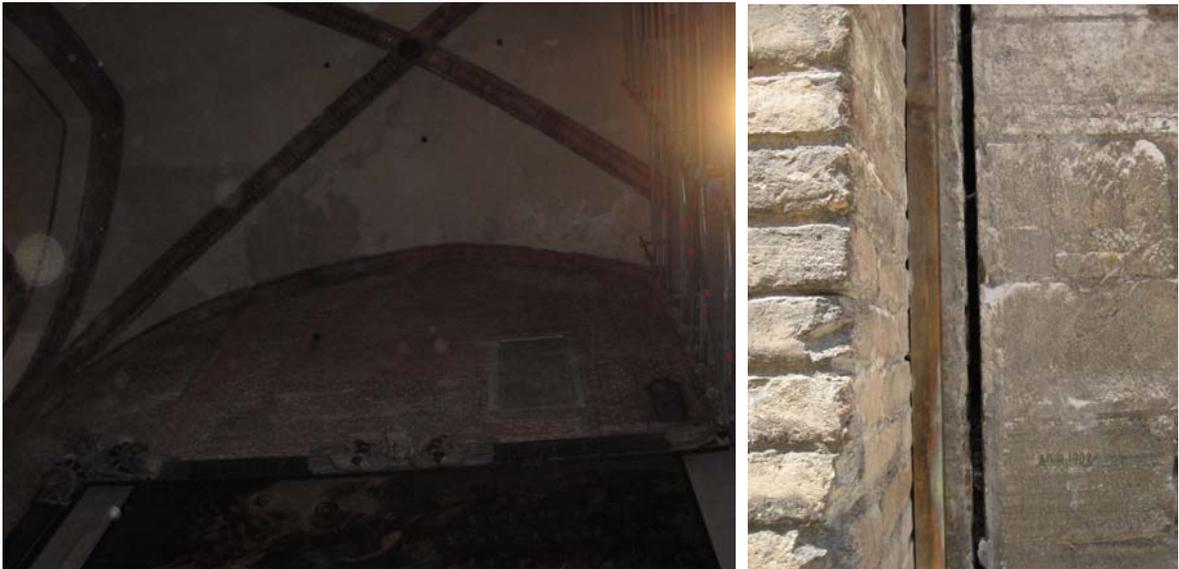
Figure 2-8: Cross vault set on the tower wall a) and structural joint between chapel and bell tower b)

The second construction phase took place between 1340 and 1432 and corresponds to the reconstruction of the church in its current form with the partial joining of the bell tower where the transept is. The creation of the church proceeded from West to East, namely by apses from the transept to the main façade at which insisted, until 1415, the structures of the primitive Franciscan church, with opposite orientation. The vertical walls of the church and bell tower, born completely released from each other to allow differentials movements between the two buildings, were locally joined together: both brick cross vaults of the left aisle and of the transept set directly on the walls of the tower (Figure 2-8a).

The third construction phase was set during the early mid-fifteenth century. In 1432 by the will of the bishop of Vicenza *Pietro Emiliani*, the chapel of St. Peter was built, between the wall of the bell tower and the church in the south-eastern corner. The new construction incorporated part of the east wall of the bell tower and was structurally released from the Basilica and the tower (Figure 2-8b).

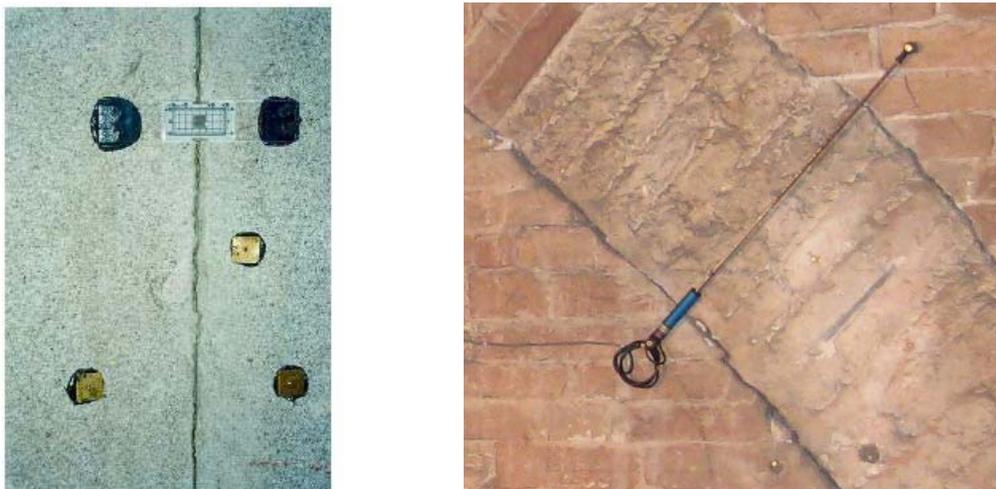
Figure 3-3: Removable a) and fixed b) crack meters

Crack-meters are used for crack measurements and are installed across joints or cracks by installing a pair of anchor stems. Pre-positioned holes are then drilled on each side of the crack or joint. The expected resolution was up to 0.005 mm (5 μ m) and measured up to 25 mm (\pm 12.5mm). During the first phase of the work, in 1995, the outdated glass indicator instruments were replaced (they were used at the beginning of the XX century), and some of the damages were controlled by installing removable mechanical strain gauges basis (Figure 3-3a).

Crack-meters, located on 7 different locations, determined that the cracks were active (Figure 3-3b).

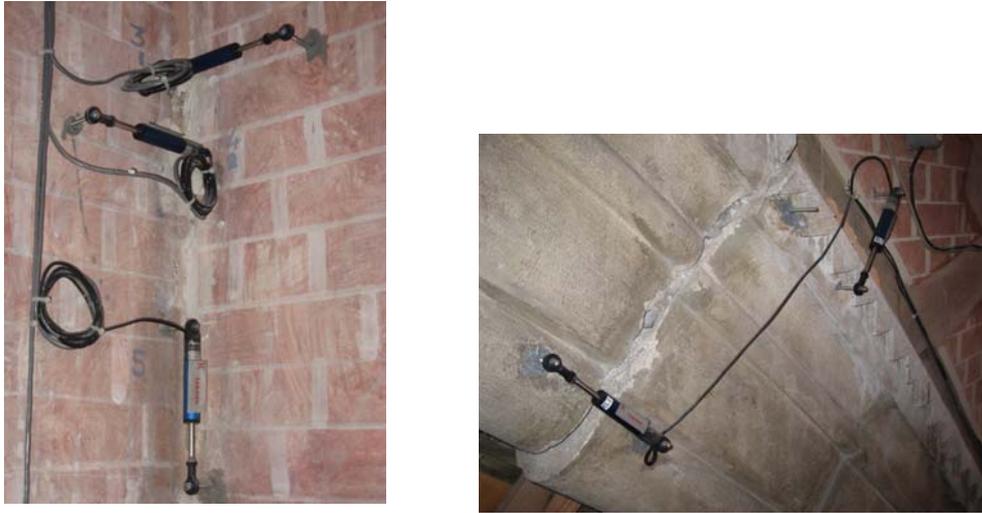
Figure 3-5: Crack meters

- Two crack meters along the major fractures present in the stone arch that connected the tower to a pillar of the Basilica;
- Four crack meters between the tower and the perimeter wall of Basilica, close to the lateral portal;
- One crack meter on a large fracture among the wall above the arch that connected the tower to the adjacent pillar;
- Four electrical gauges on the provisional tie rod.

These were tied to two stainless steel pins on both sides of the crack were checked and secured to the wall by epoxy resin. The connection of the devices with metal pins were executed through

spherical junctions that allowed the movement of the instrument in three orthogonal axes thus avoiding arising of flexural components in the transducers (Figure 3-5).

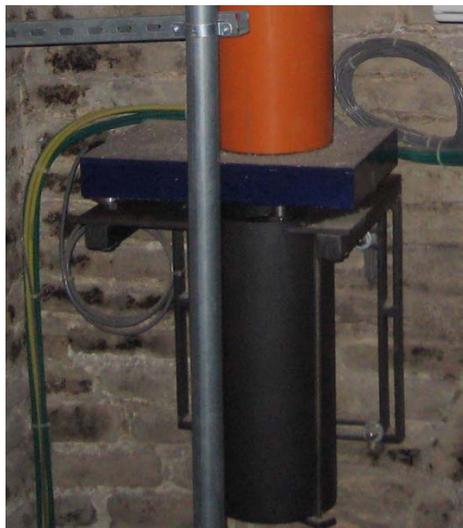
Figure 3-6: Direct Pendulum

In particular, a direct pendulum (PD1), able to detect the two horizontal components of the displacement of the top of the tower was installed in the inner tube of the bell tower. (Figure 3-6)

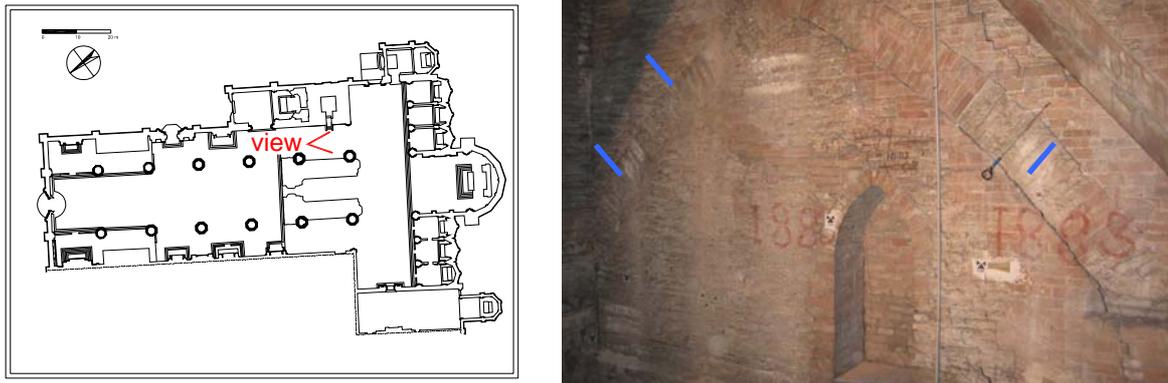
Figure 3-18: Relieving arch and position of the flat jack slots

Climbing the belfry gives access to the extrados of the cross vaults; from here it is possible to inspect the relieving arch (Figure 3-18) that had been constructed in the past centuries and for which purpose and reasons are still not clear. Apparently this relieving arch had not been built for the entire thickness of the wall and to better investigate its behavior, a certain amount of flat jack tests have been conducted among its length.

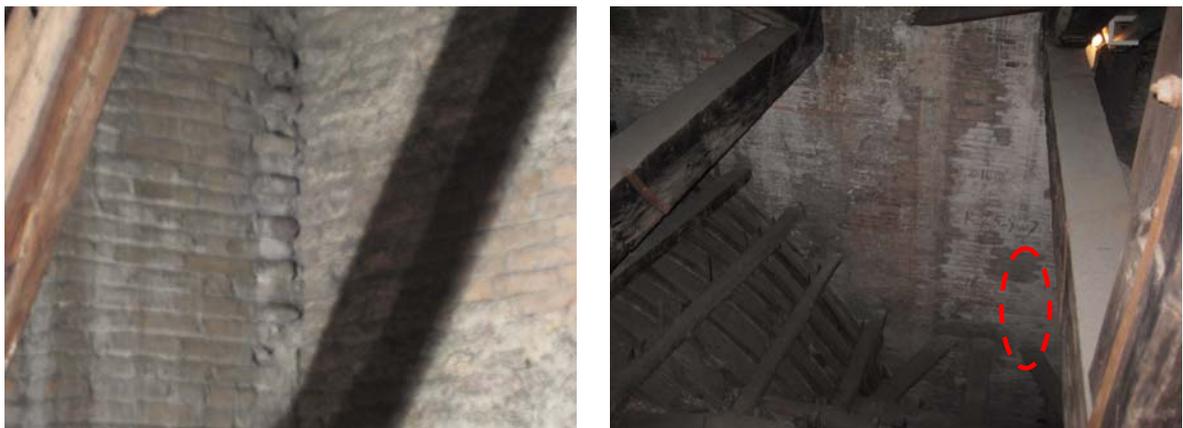
Figure 3-19: Scarf among the structures

From the same room it can be noticed as well the attempt to scarf together the wall of the transept of the Basilica and the South-West wall of the tower; as it can be seen with a closer view, the scarfing bricks are not connected at all with the orthogonal wall. This ancient effort of connecting the two structures is a clear indication that they were built independently (Figure 3-19).

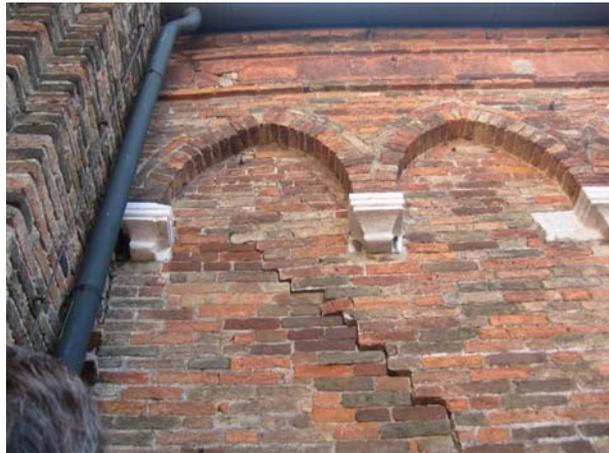
Figure 3-24: External transept wall crack pattern

A further hazardous aspect inferred from the damage survey is the one depicted in Figure 3-20. It is the external crack that matches the red cracks depicted in Figure 3-17.

These cracks, which follow the trend of the tensile isostatics in the part of the wall that connects the bell tower to the Basilica, explain the formation of inclined struts (between the main cracks) capable of transmitting relevant components of vertical and horizontal forces from tower to church and vice versa. Even if the amount of forces enrolled in the exchange between the structures is difficult to define (cause of high non linear components) their pattern is undoubtedly clear, as depicted in Figure 3-21.

Moreover the stronger stiffness of the left hand side of the transept wall (blue, Figure 3-23), compared to the remaining part on which the horizontal force of the tower acts (cyan, Figure 3-23), let the weaker part of the masonry wall, already fractured, become even more seriously compressed. This phenomenon induces a state of *bulging*, which is namely a deformation of a wall consisting in a deviation from its original form, which the shape of deviation is roughly a curve, as can be noticed in Figure 3-24.

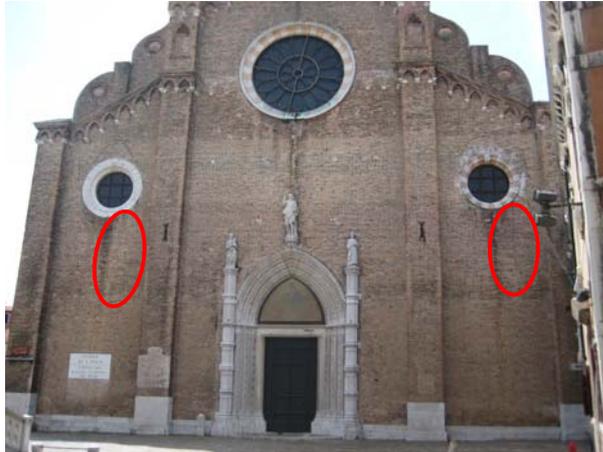
Figure 3-28: Mortar seepage marks

At many points along the masonry joint of the external walls one could see dark seepage marks (Figure 3-28).

This could be the dissolution and leaching of the components of hydrated mortars.

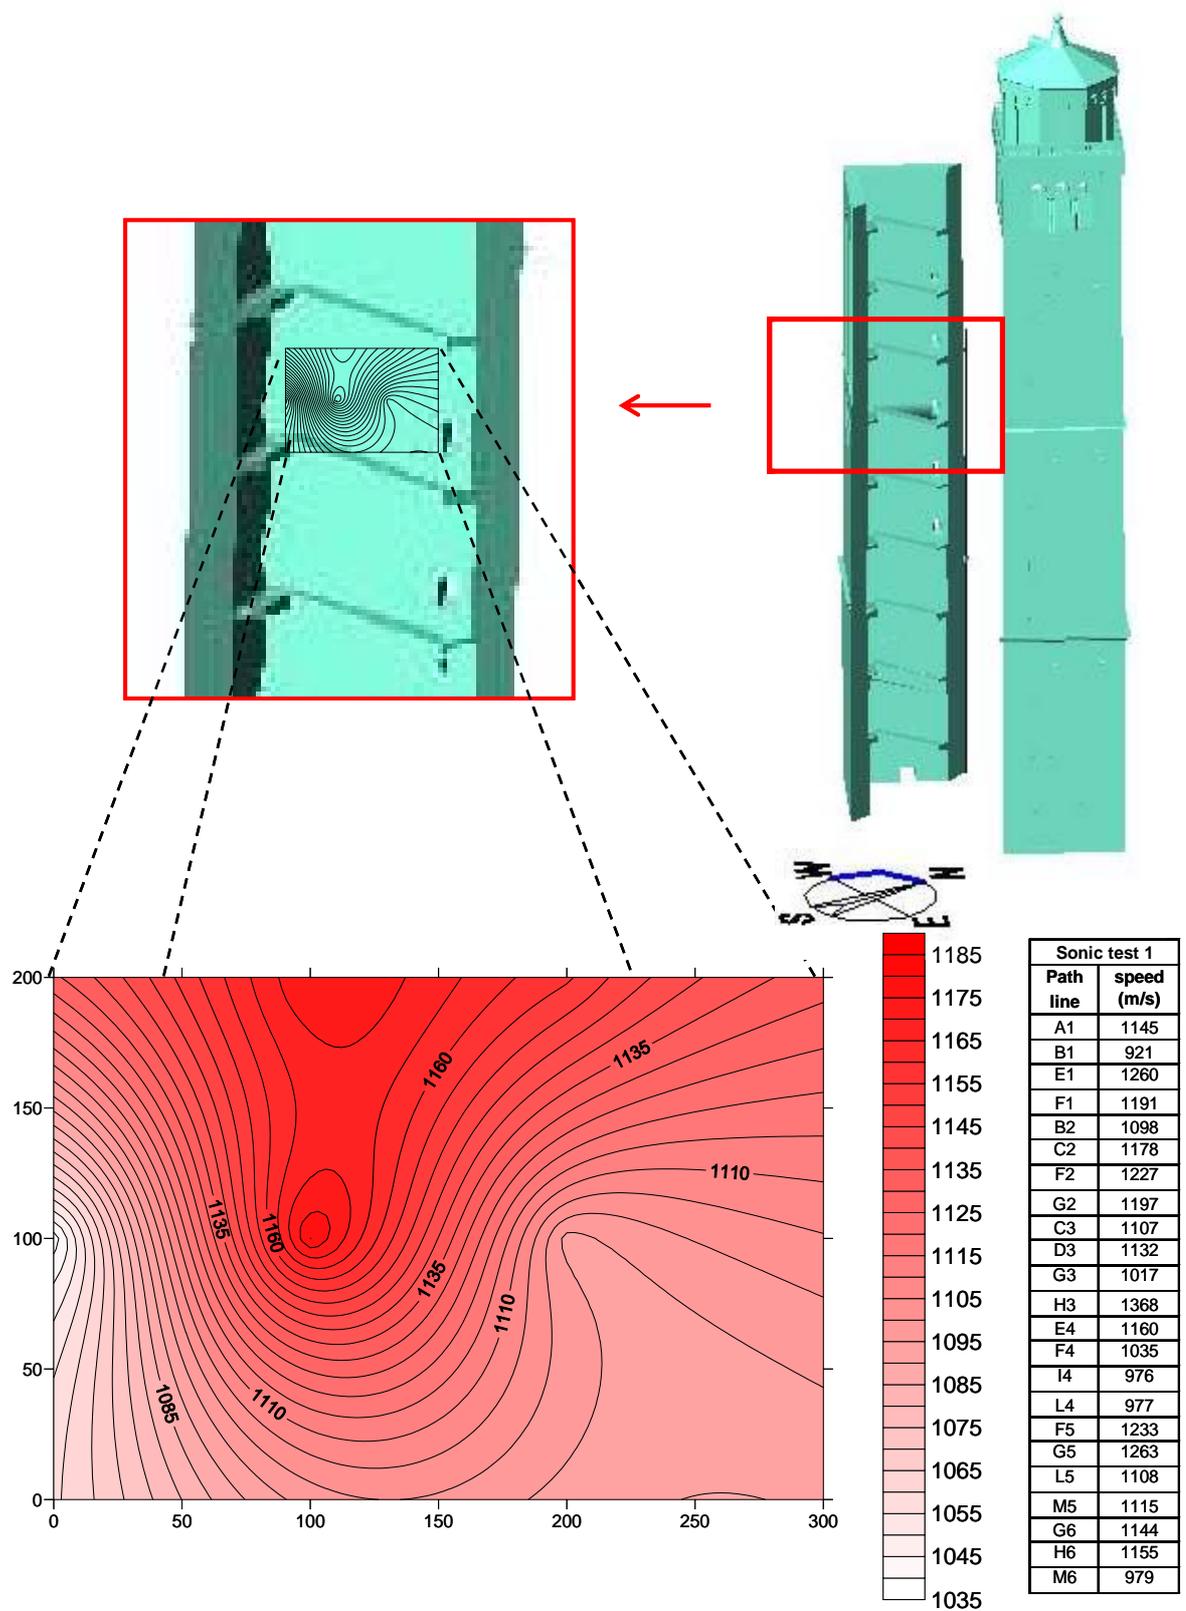
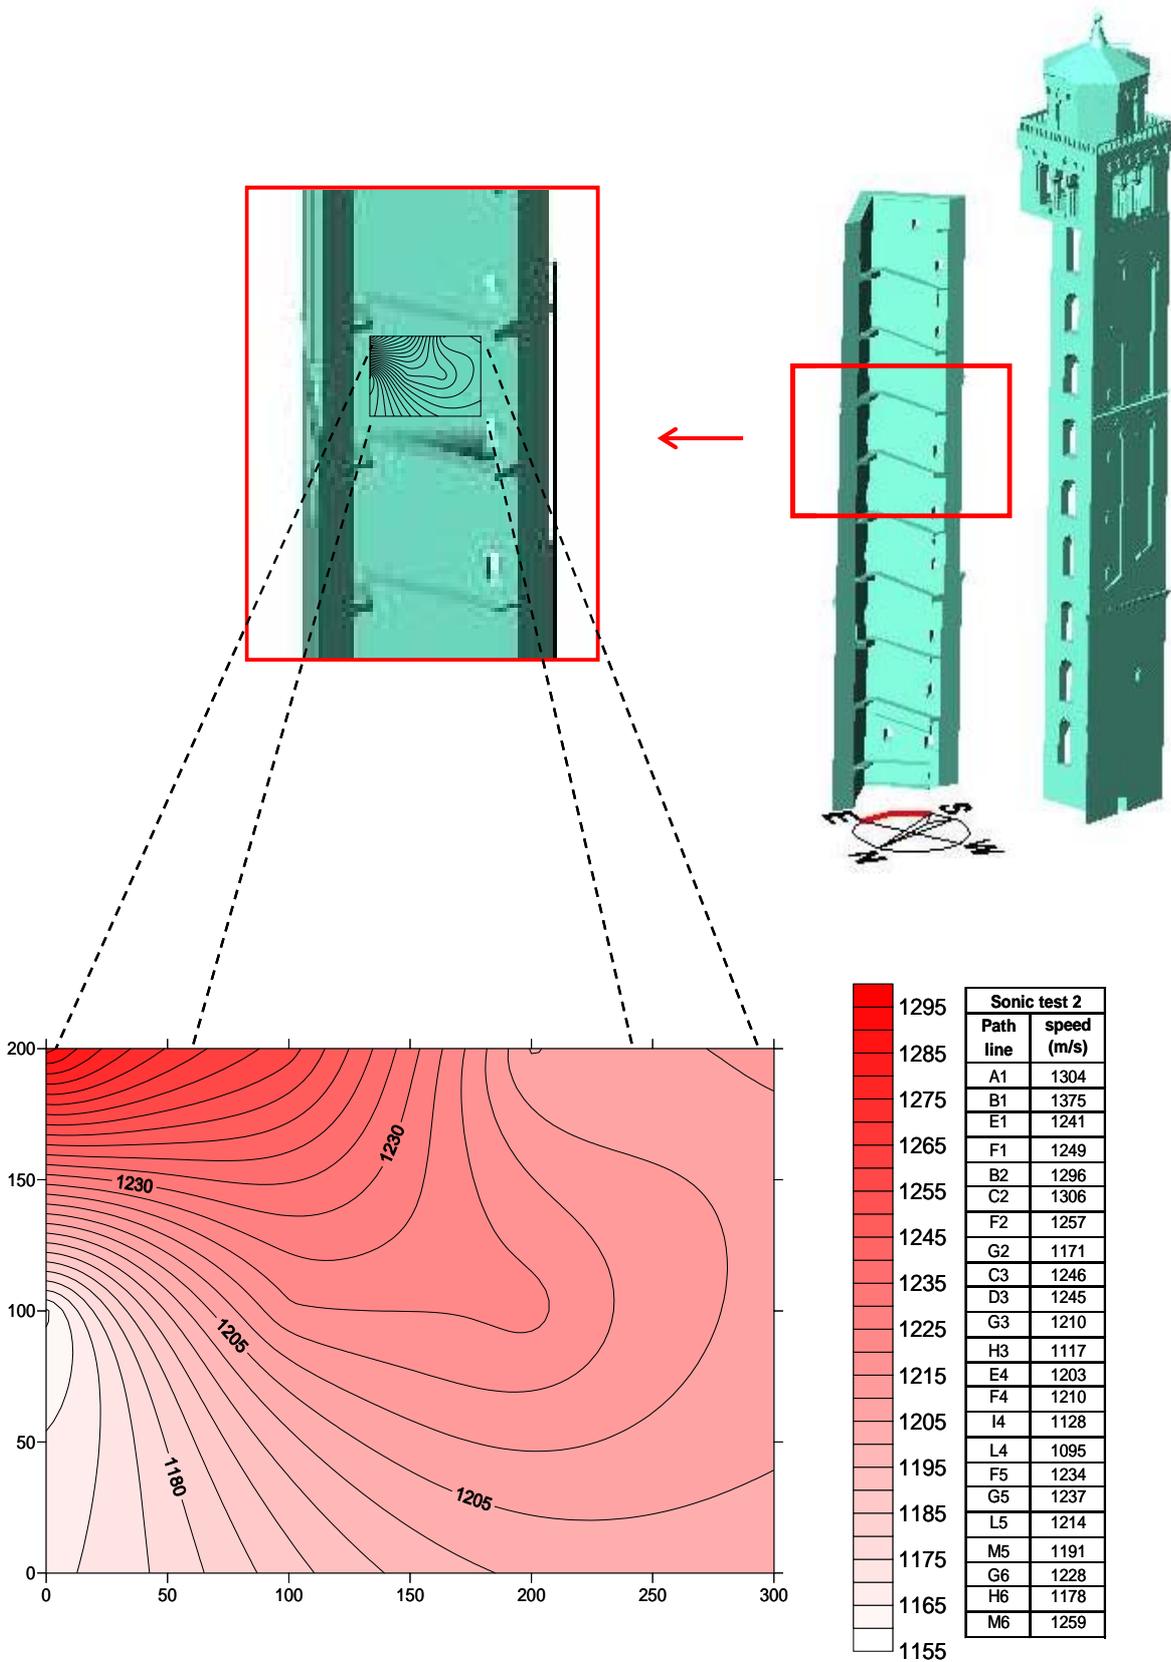
By referring to Table 4-1 it can be seen that masonry constituting the bell tower is in relatively poor condition. Both tests gave an average value of velocity of the sonic wave of above 1000 m/s with a uniform distribution among the masonry samples. Visual inspection indeed revealed that the masonry of the belfry suffered from the phenomenon of expulsion of the outer layer of the masonry giving a first hint on the overall condition of the walls. Furthermore, such a low value of wave speed may indicate the presence of voids or, most likely in this case, irregular joint patterns or the inadequate filling of mortar.

Figure 4-4: Sonic 1, NW wall (unit: m/s)

Figure 4-5: Sonic 2, SE wall (unit: m/s)

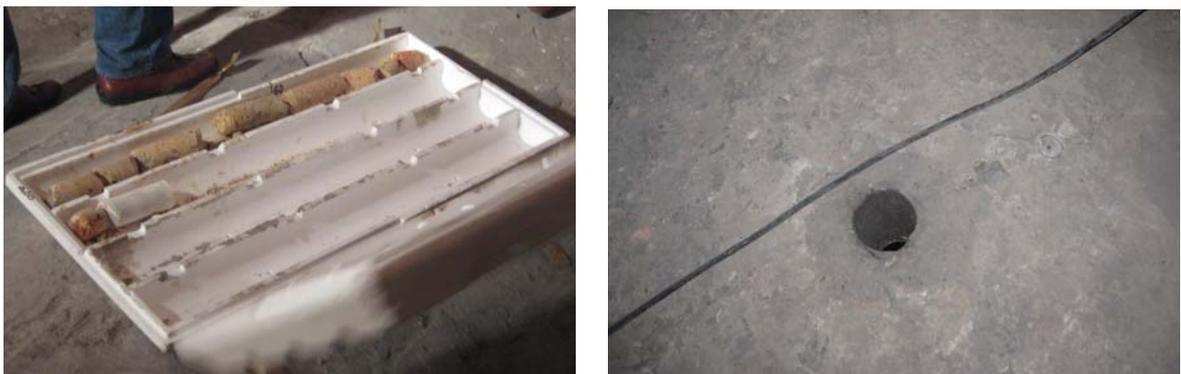
Figure 4-6: Masonry core sample

This very sample had been removed from the West corner above the last cross vault of the left aisle. Therefore it is a direct view of the properties of the masonry wall above the deflected column which divides the main nave from the transept.

At first sight, the collected sample looks to be of pretty good quality: the masonry appears to be in a good conservation state and the mortar seems to be of decent quality and high strength. However, in order to have abundant data to compare, a laboratory test campaign could be carried out to chemically and mechanically describe both bricks and mortar.

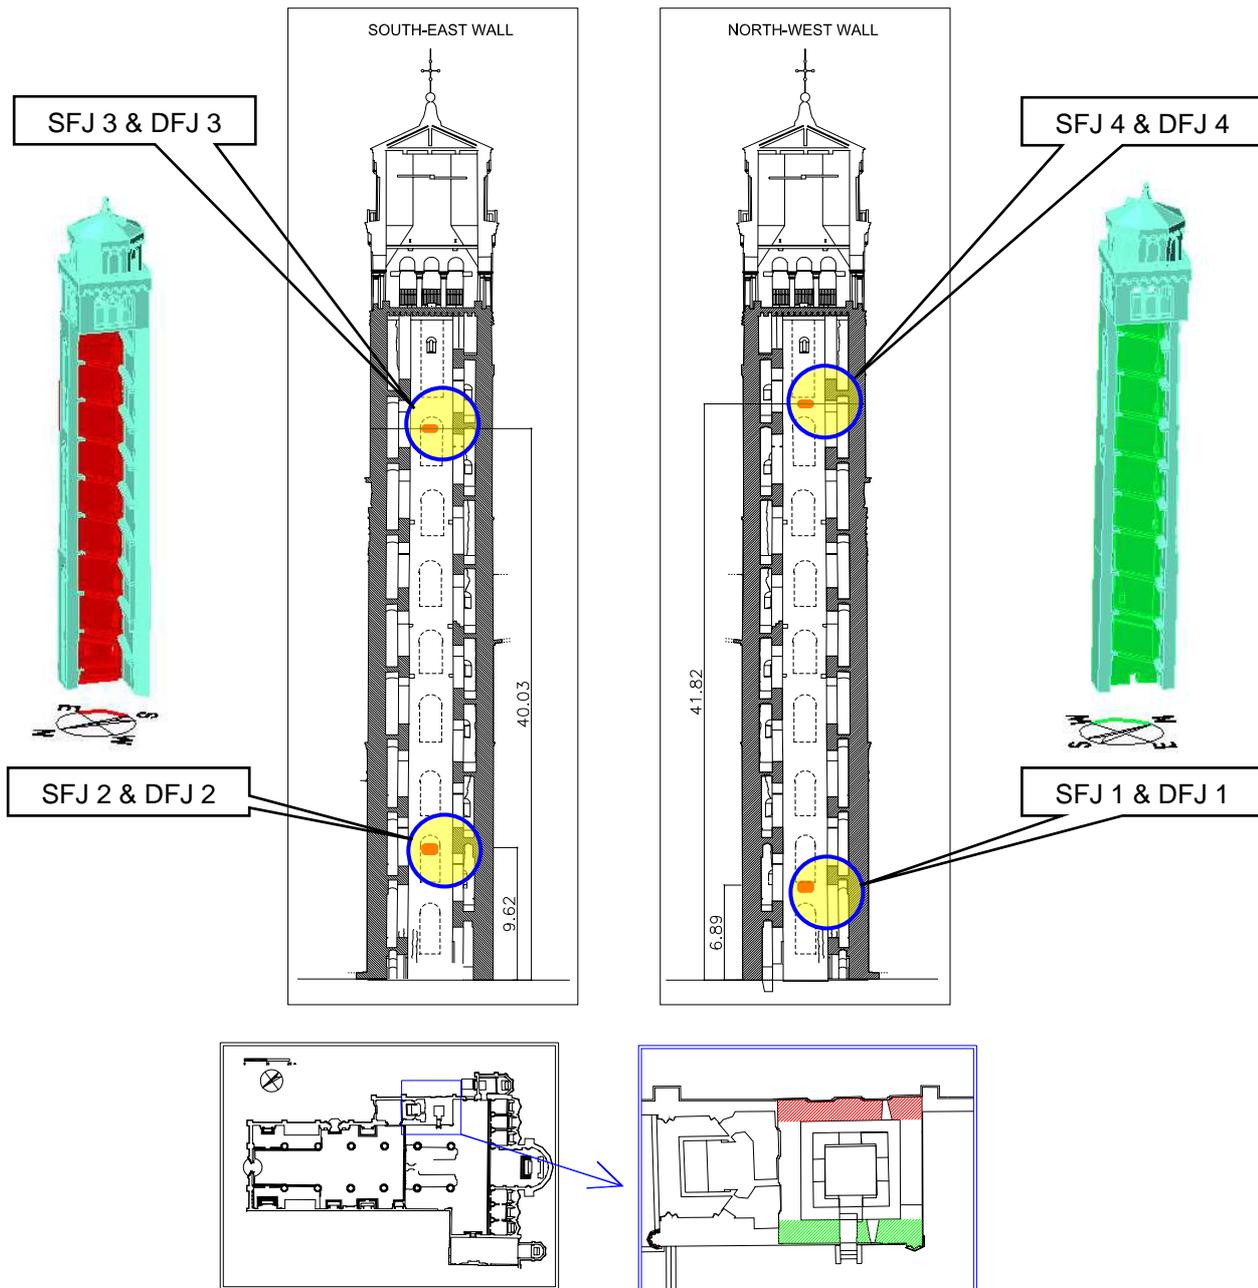
Figure 4-11: First Flat-Jack campaign layout

The tests were performed in the opposite SE and NW walls in order to gain a better knowledge of the out-of-plumb of the tower. As it can be inferred from the results, both single flat-jack test pairs #1 and #2 (SFJ1 and SFJ2) and #3 and #4 (SFJ3 and SFJ4) present a common explanation: the higher value within the couples lie in SFJ2 and SFJ3 which confirms that the tower was leaning towards SE, that is, in the opposite direction of the Basilica. A higher compressive state found in those tests ascertain that there was more load on the SE wall or simply that the dead weight was no longer vertical, but the slight eccentricity of the bell tower created a moment force that enhance this behavior.

Different modulus of Elasticity has been found with double flat jack tests (DFJ). In particular DFJ1 and DFJ2 state complete different values among the two walls. Comparing the output stress-strain diagrams of the two tests it is clearly legible that the first has a more elastic behavior than the latter in which, already at the second load cycle, showed a plastic behavior.

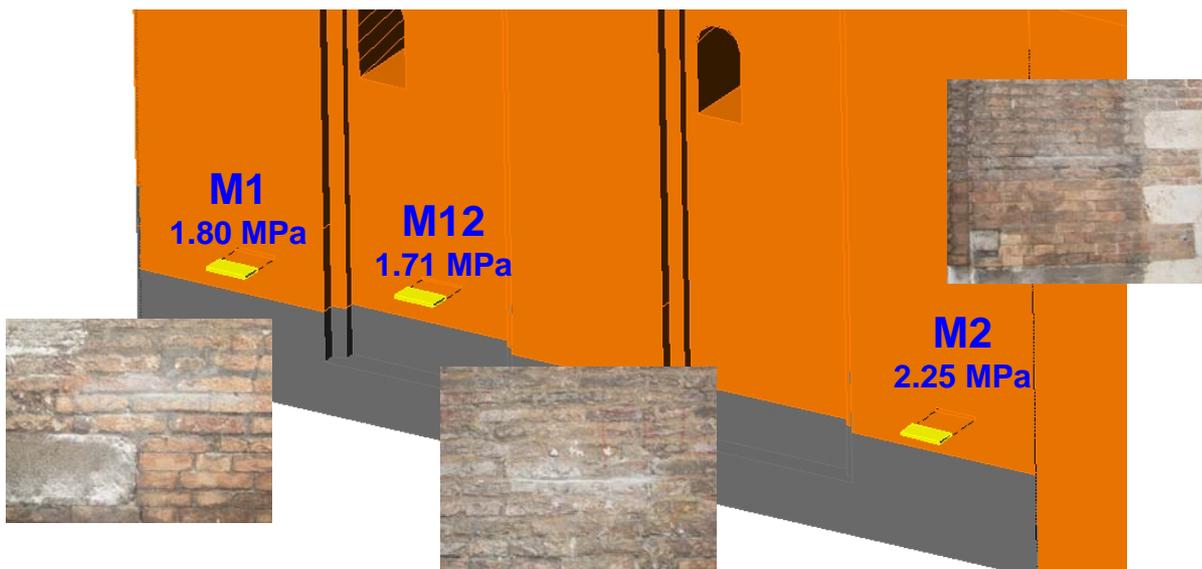
Figure 4-13: Single Rectangular Flat-Jack test M1, M2 and M12

The first M1 and M2 tests were performed on the SE wall overlooking *Campo dei Frari* (Figure 4-13). Values of these two tests highlighted a different distribution of stresses along the South-east wall, most likely cause of the out-of-plumb of the tower. Stress value of 2.25 MPa was recorded in the East corner (M2), higher than the one recorded at the South angle (M1 = 1.8 MPa).

These tests were performed on the pilasters present in the corners. Since the pilasters were affected by local phenomenon of bulging it was necessary to carry out an extra test (M12) just beside them. Therefore the test quoted a value very close to the one from the test next to it (1.71 MPa) confirming that the bulging phenomenon did not actually affect the previous test and its value was reliable.

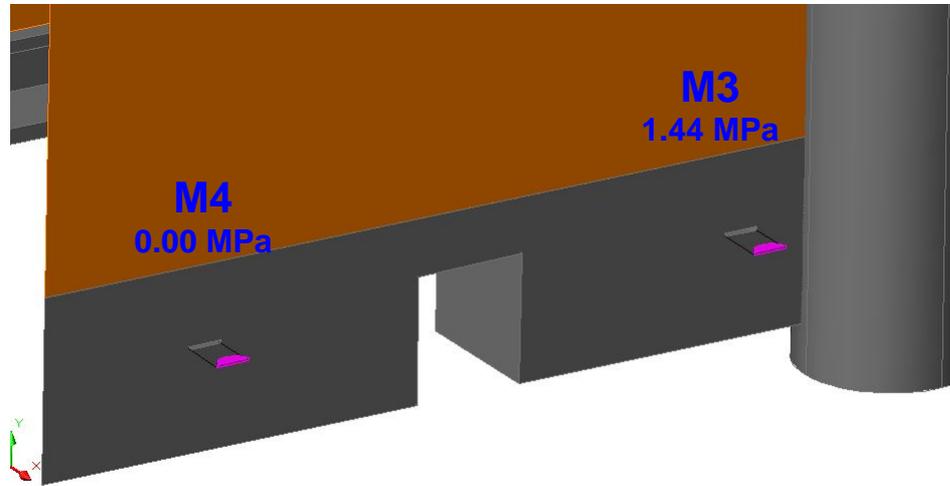
Figure 4-14: Single Semicircular Flat-Jack test M3 and M4

These tests emphasized another kind of behavior: M4 stated that the stone is unstressed, while M3 stated 1.44 MPa compressive strength. This could mean that, if the test has been correctly carried out, no stresses are transmitted in that portion of the wall, thus confirming an out-of-plumb of the bell tower. The same phenomenon can be explained by defining the composition of the wall in those areas: large stone blocks that may transfer vertical load in a non homogeneous way, but only through the areas of contact between the irregular surfaces of the stone blocks.

Therefore, the average compressive stress measured at the base of the tower was estimated at 1.92 MPa in the outer side and 1.44 MPa in the inner side of the Basilica. The lower compressive state found in the inner side of the Basilica was most likely due to the fact that within the Basilica, part of the dead load of the tower is transmitted to the column by the arch stone (Figure 4-15).

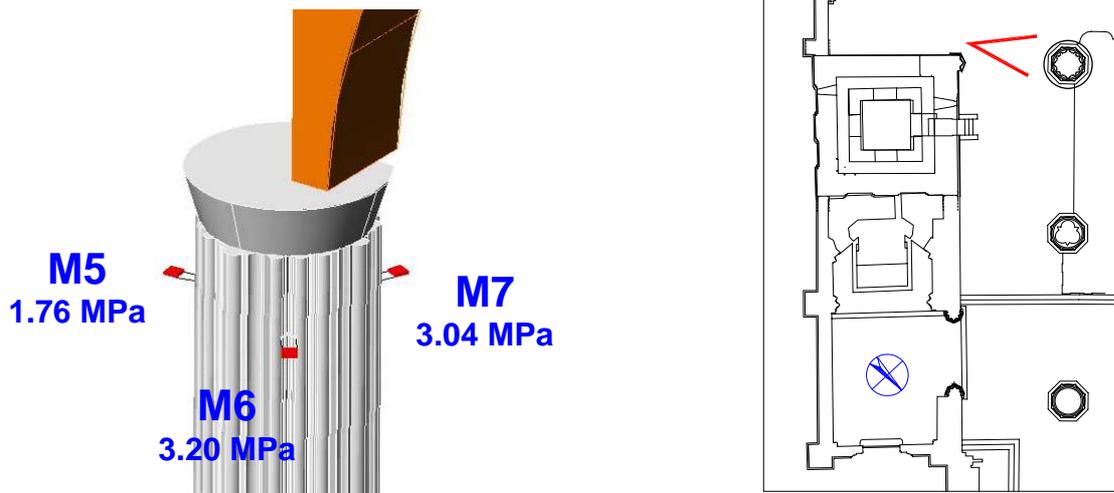
Figure 4-15: Single Square Flat-Jack test M5, M6 and M7

To confirm this theory, additional tests were carried out on the upper part of abovementioned column. Three tests were performed on the surface column shaft, just below the capital, arranged in three directions, 120° apart from each other (Figure 4-15). Not only was a higher load on the column found, but this load came with a high eccentricity that produced a bending moment on top of the column. The column tended to have a differential shift towards the main nave due to the eccentric horizontal load coming from the bell tower. Evidence of this phenomenon was given by the discovered values. Tests showed an uneven distribution of compressive stress, with a load concentration in the part of the column facing the tower. In this area, test M6 and M7 registered stress values of 3.20 and 3.04 MPa, in strong opposition with 1.76 MPa value registered by M5 test diametrically opposed.

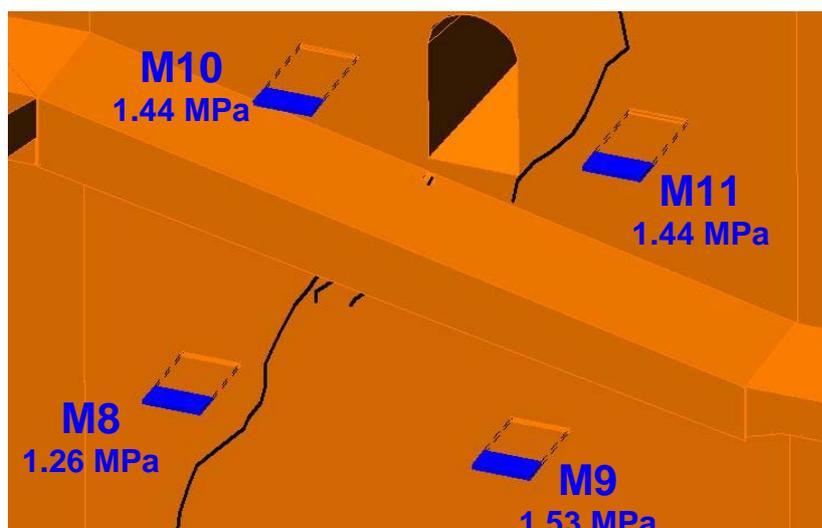
Figure 4-16: Single Rectangular Flat-Jack test M8, M9, M10 and M11

These tests were carried out among the two parts of the SW wall of the tower separated by the main oblique crack. Tests M10 and M11, performed close to the window facing the transept of the Basilica about 15 m high, show the same stress load between the two parts among the large diagonal crack (1.44 MPa). In a lower level (approximately 3 m below) M8 and M9 tests showed an uneven distribution of stress with a value of 1.53 MPa (the one closest to the relieving arch) and 1.26 MPa (opposite side). It is difficult to explain this stress distribution but the main reason can lie in the fact that M10 and M11 were carried out in a portion of the wall in which the crack may have been less deep through the thickness of the wall, thus no variation of loads can arise. On the other hand, the slightly different values recorded between test M8 and M9 can be linked to the more influence of the crack which can lead to separation or shift between the two portion of the walls. However, the average value between test M8 and M9 is 1.41 MPa which is very close to the value measured approximately 3 m above.

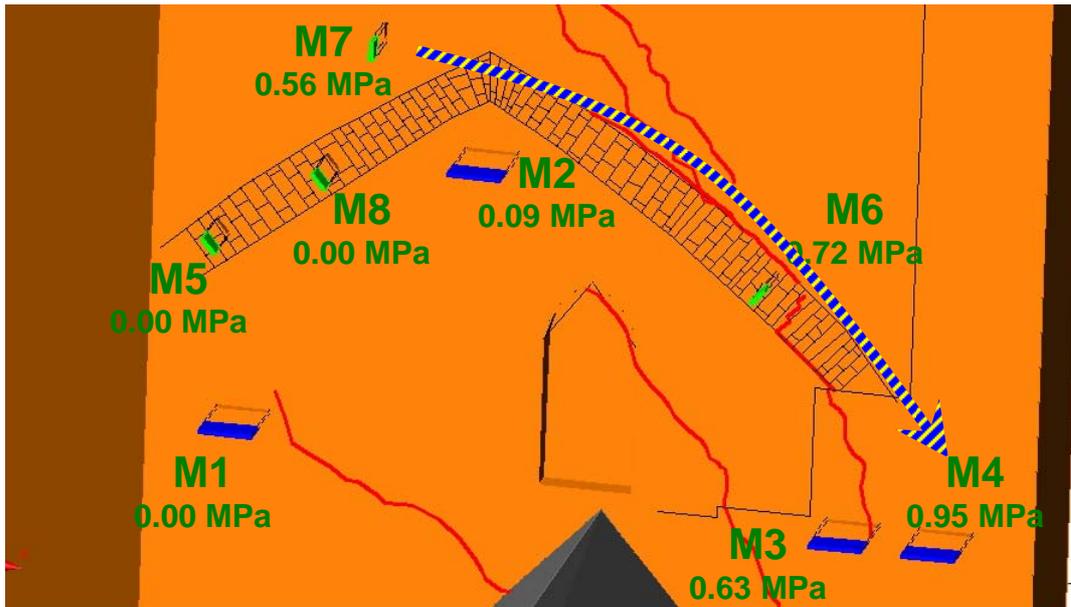
Figure 4-17: Summary of compressive state measured by the third single Flat-Jack campaign

Tests M1, M2, M3 and M4 were carried out with rectangular flat-jacks (blue in Figure 4-17) concerning the masonry wall, while tests M5, M6, M7 and M8 were performed with smaller square flat-jacks (green in Figure 4-17) involving the relieving arch. Each test was made for a purpose, in particular:

Regarding the effect of the large crack on the SW tower-transept wall, it can be observed that tensional states measured on two distinct levels and on opposed side of the wall are all very similar, which indicates that the fracture, although running through the entire thickness of the masonry wall, does not induce disruption of appreciable size on load distribution along this side of the tower.

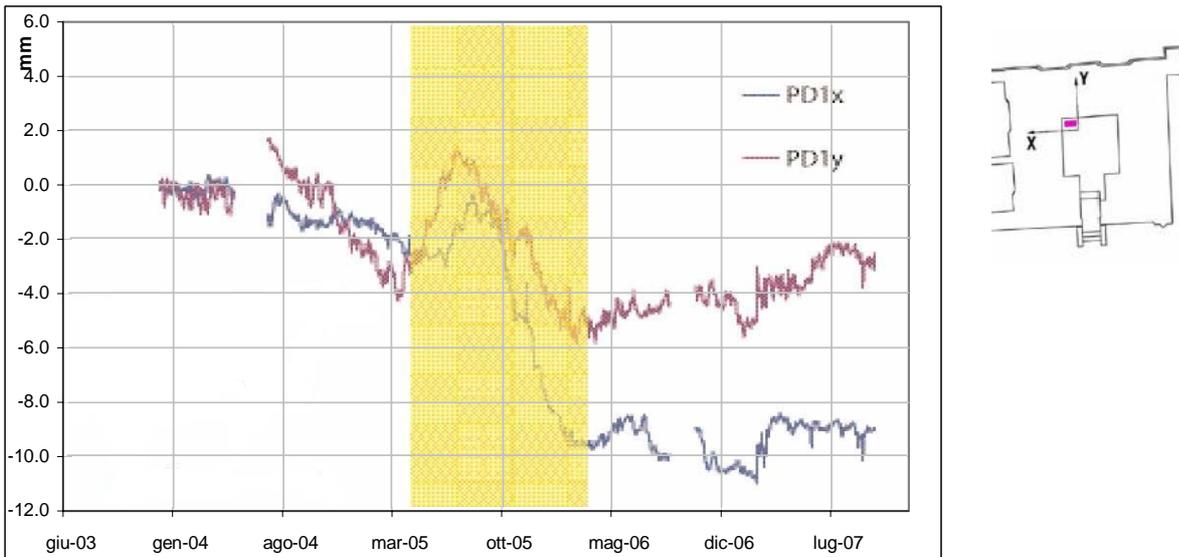
Figure 4-18: Direct pendulum measures

The results of the direct Pendulum are depicted in the following Figure 4-18. This image show the period from 17th December 2003 (date of installation of the monitoring system) to 30th August 2007. The yellow highlighted period is from July 2005 and March 2006 while the execution of the soil works occurred (boreholes, tests, injections). Injections were carried out strictly from September 2005 to January 2006, but it can be seen from this graph that their influence concerns a longer period.

The trend of measurements related to the X component of the displacement of the direct pendulum, shown as PDx, was observed during the period December 2003 and April 2005: a shift of the tower towards the apse with fluctuations related to seasonal thermal changes is noticed; however the displacement is not more than 2 mm. In this period, the velocity of movement of the X component of the pendulum can be estimated as approximately 1.5 mm / year.

There was however rapid increases in the displacement of the tower towards the apse of the Basilica from July 2005 until March 2006. This was due to the work of soil fracturing for the consolidation of the soil beneath the tower.

The shift measured on top of the tower was approximately 9 mm during the period mentioned above. After the completion of the work, the speed of deformation decreased significantly and between March 2006 and January 2007 showing a trend similar to the one found during the previous period.

less than 0.5 mm/year. This significant reduction of the shifting speed of the pendulum, if confirmed by future long term observations, seems to indicate that the consolidation of the soil with the technique of soil fracturing had achieved positive results.

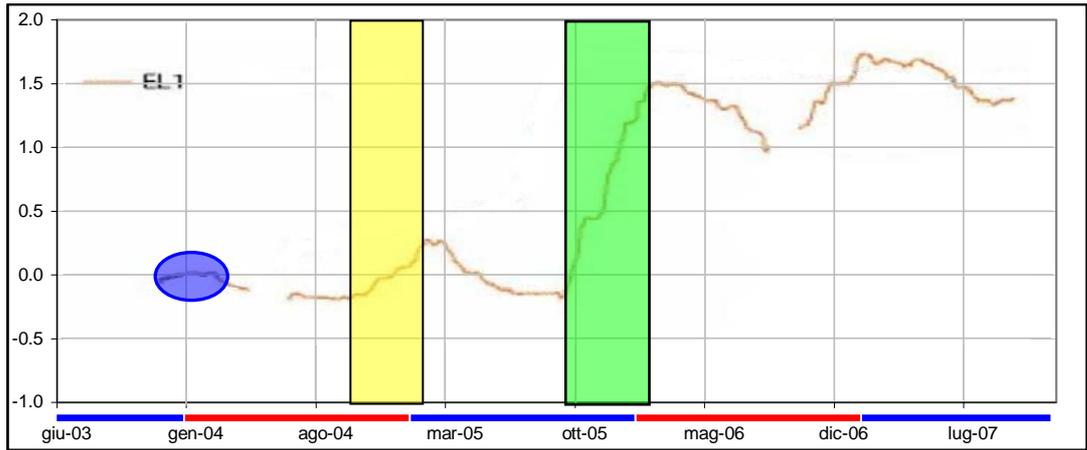
Figure 4-20: Crack meter EL1

Gauge EL1 (Figure 4-19) recorded a rapid increase of the opening of the crack of about 0.4 mm from November 2004 to mid February 2005 (Figure 4-20, yellow) with deformation speed of approximately 1.17 mm per month.

Such increase, occurred during winter time, seems not only related to thermal variations, as long as comparing the trends during the same period of the previous year (Figure 4-20, blue). Without considering thermal effects (very regular after all), the permanent opening increase was about 0.25 mm, by simply comparing the value recorded in the same month of January in 2004 and 2005.

EL1 recorded another rapid opening movement of the crack during September 2005 and January 2006 (green Figure 4-20). Those values (and related movements) are undoubtedly associated with the consolidation works of the soil and they are higher than the measurements correlated with thermal variations (which are of 0.5 mm as indicated by the diagram of openings detected after January 2006).

Hence the openings of the cracks are related, and happened simultaneously, to the movements of the bell tower which, in the same period, suffered an inward movement towards the Basilica, thus compressing the arch that separates it from the adjacent column.

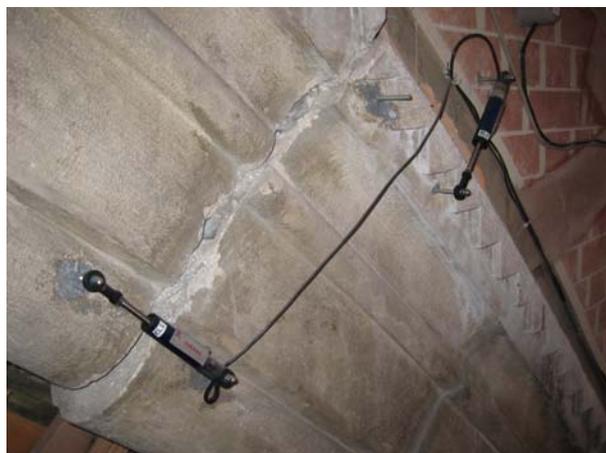
Figure 4-21: Position of gauges EL1 and EL2

Crack meter EL2 did not seem to be affected by thermal variations as its record indicates a smoother path compared with the results of crack meter EL1. As a matter of fact, this trend is clearly related to its position: despite EL1, crack meter EL2 is in a vertical direction and it was placed among the stone arch and the masonry wall. (Figure 4-21).

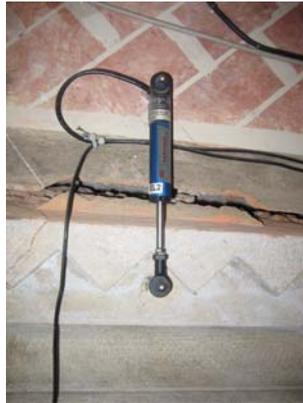
Figure 4-22: Gauge EL2

The path of EL2 crack meter (Figure 4-22) can be divided in three separate sections, each of them with the following speed per month characterization:

| speed = 0.03 mm/month crack width = 0.6 mm time = 555 days | speed = 0.30 mm/month crack width = 1.2 mm time = 120 days | speed = 0.01 mm/month crack width = 0.3 mm time = 750 days |

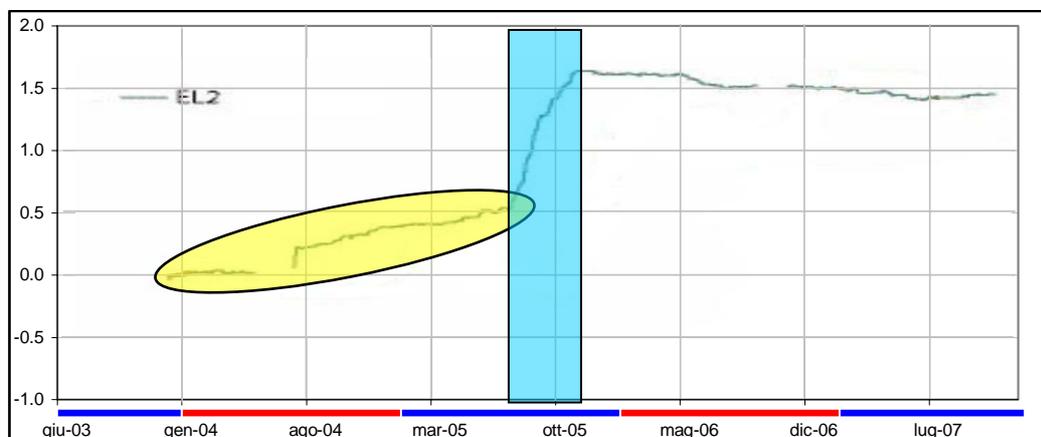
Figure 4-23: Crack meter EL2

By comparison of the widths recorded in December 2003 (0.05 mm) and the one recorded in September 2007 (1.55 mm) it can be stated that a significant deflection of a permanent nature, not linked to thermal variations, is about 1.5 mm. Subtracting the value of deformation caused by the earthquake (0.2 mm), the final permanent width of the crack is 1.3 mm in about forty-six months (Figure 4-23).

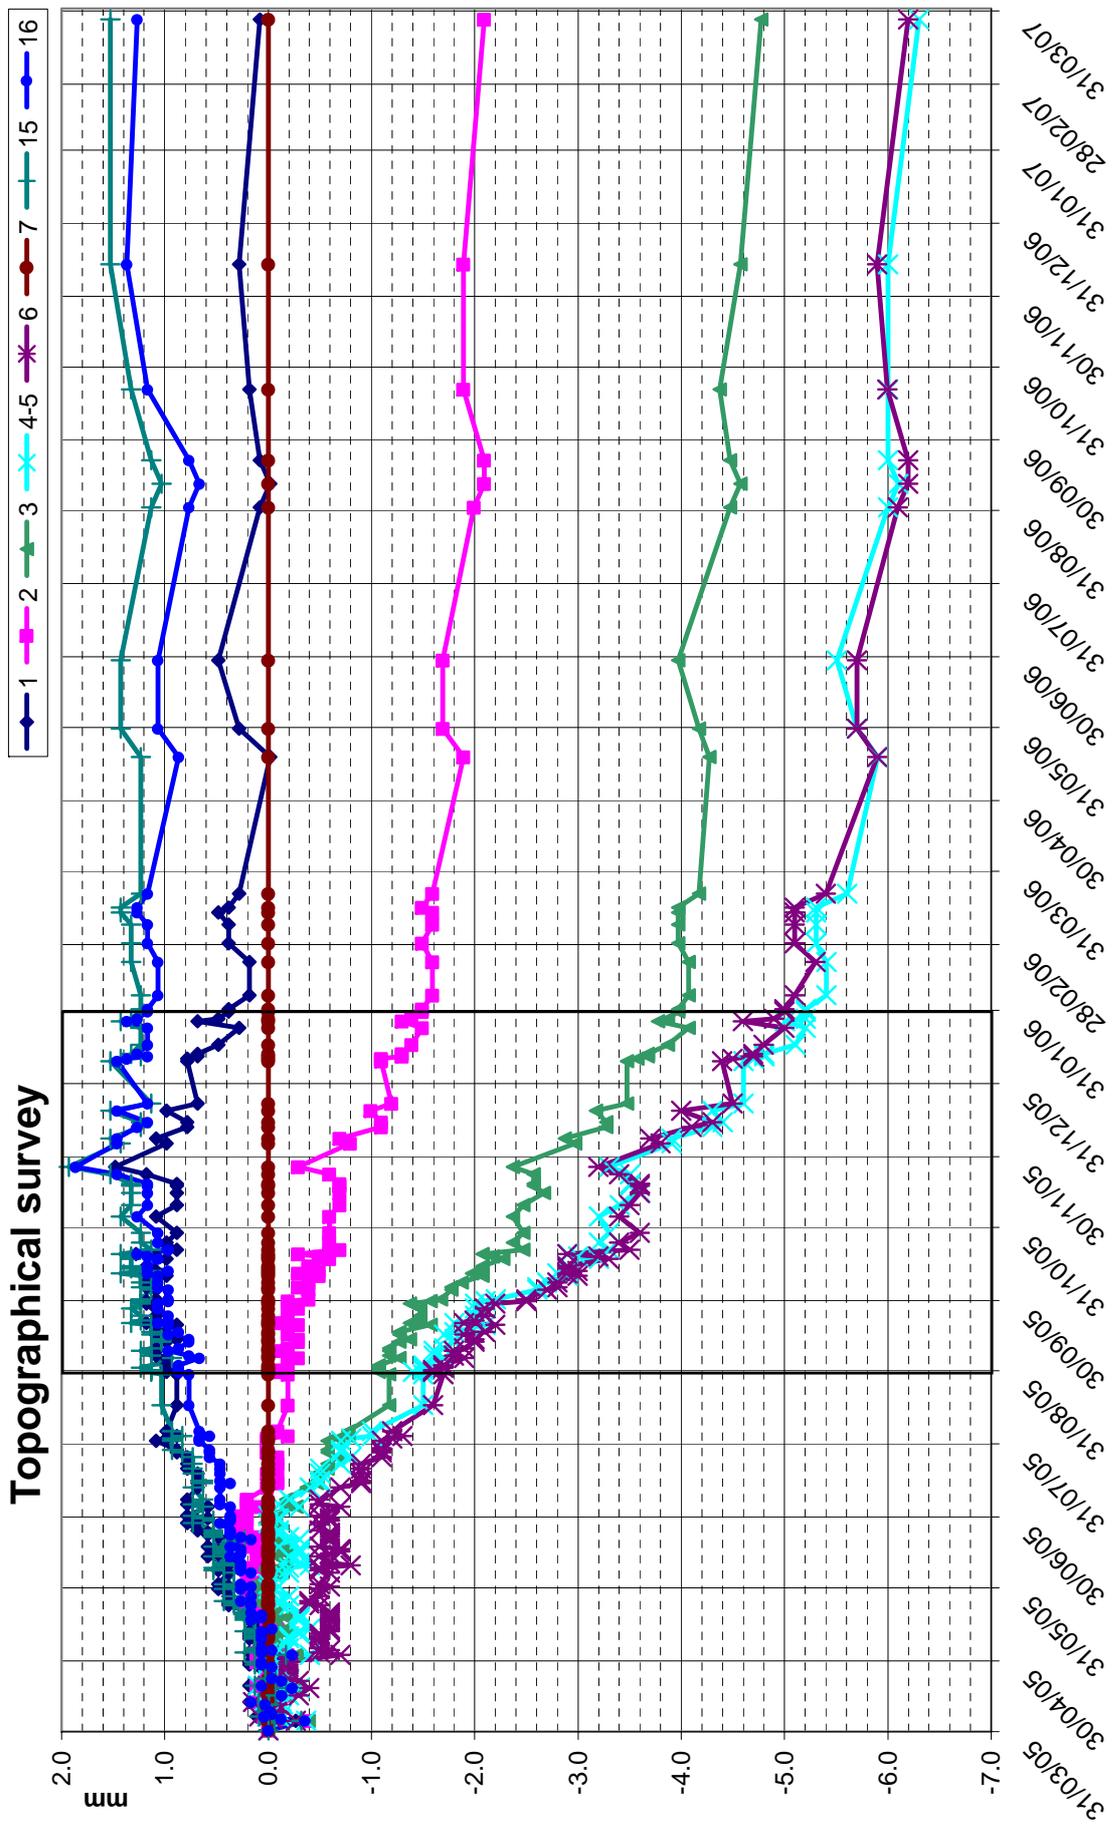
Figure 4-27: Data from the topographical survey

The yellow section in Figure 4-27 represents the period during which the work on the soil foundation occurred. The maximum reduction was always registered in points #4 and #5, located on the edge, toward the apse. The values of this settlement can be divided as follows and represent the periods of the start, the duration, and end of the work (Figure 4-28, Figure 4-29 and Figure 4-30):

A closer examination of Figure 4-27 allows the reader to notice the trend of the rotation of the tower towards the interior of the Basilica. Thanks to these measurements it is also clear that the phenomenon of differential settlements affects only a small portion of the Basilica as the survey clearly stated a negligible value (close to zero) of benchmark #1 placed on the pillars of the main nave. Furthermore, benchmarks #15 and #16, placed respectively on a pillar far from the tower and on the door of St. Peter's Chapel, show positives value, hence an upward movement.

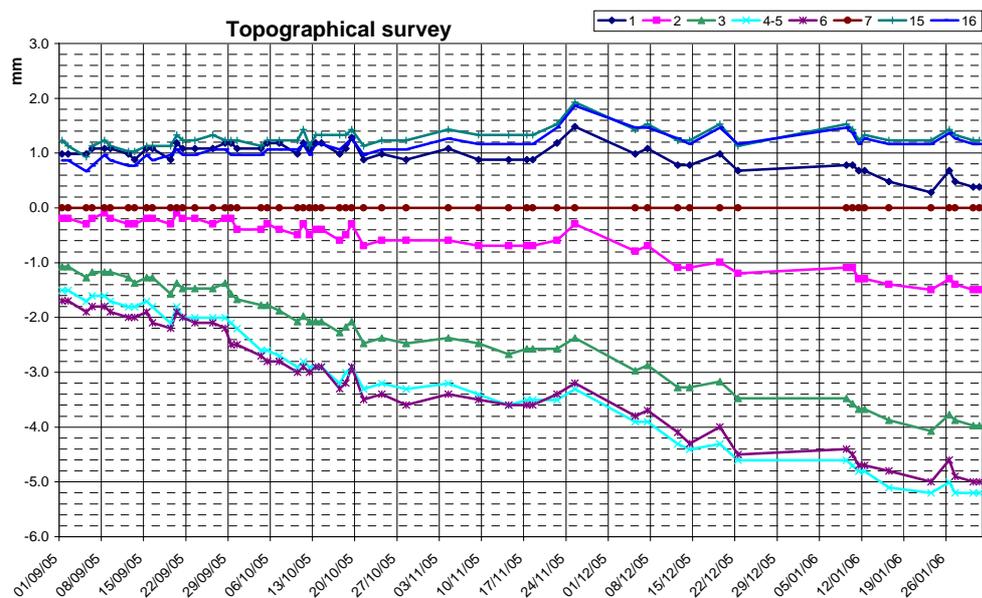
Figure 4-29: Settlements during execution of the work

The strong variations clearly visible in Figure 4-29 are without any doubt linked to the work of soil fracturing and are consistent with information provided by the direct pendulum. The maximum settlement was registered in benchmarks #4 and #5 located in the corner of the tower towards the apse, with maximum value of -11.94 mm. The next examination of the settlements in other cornerstones #3 and #10, respectively -9.28 and -8.59 mm, indicated that the direction of movement of the bell is facing the apse and towards the nave Figure 4-31. The same Figure illustrates the trend of settlements by means of vectors (arrows point toward the bigger settlement) and colors. In the latter the behavior of the surveyed structure is clearly visible: the largest settlement is around benchmarks #4 and #5 (blue zone), then the settlement decreases while moving out from the tower (red zones).
