ADVANCED MASTERS IN STRUCTURAL ANALYSIS
OF MONUMENTS AND HISTORICAL CONSTRUCTIONS

Master's Thesis

Historical Case Study: The Frari's Basilica in Venice

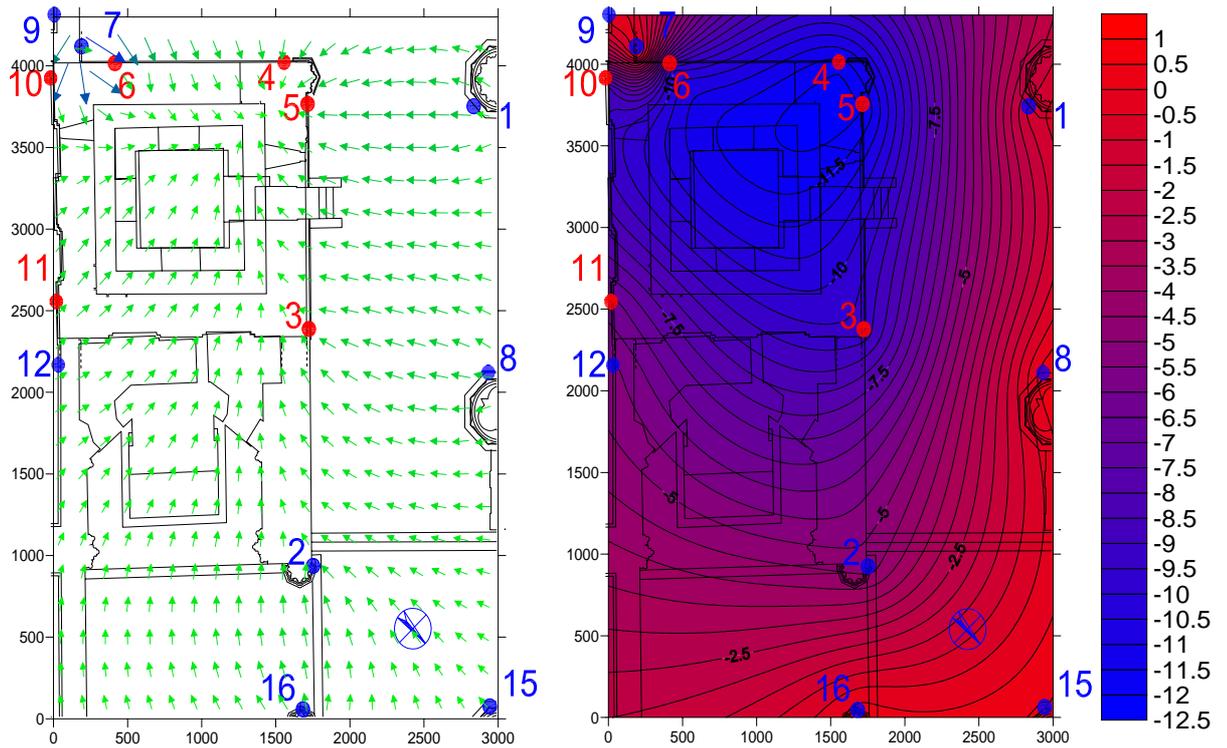
Figure 4-31: Settlement pattern [legend in mm]

The strong variations clearly visible in Figure 4-29 are without any doubt linked to the work of soil fracturing and are consistent with information provided by the direct pendulum. The maximum settlement was registered in benchmarks #4 and #5 located in the corner of the tower towards the apse, with maximum value of -11.94 mm. The next examination of the settlements in other cornerstones #3 and #10, respectively -9.28 and -8.59 mm, indicated that the direction of movement of the bell is facing the apse and towards the nave Figure 4-31. The same Figure illustrates the trend of settlements by means of vectors (arrows point toward the bigger settlement) and colors. In the latter the behavior of the surveyed structure is clearly visible: the largest settlement is around benchmarks #4 and #5 (blue zone), then the settlement decreases while moving out from the tower (red zones).

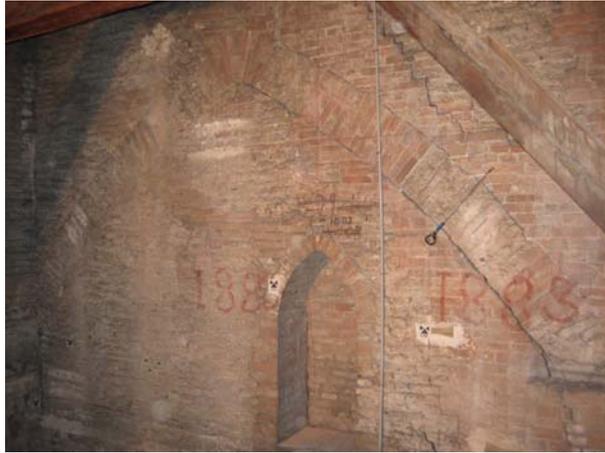
Figure 5-2: Relieving arch

More uncertain apparently was the formation of a relieving arch throughout the thickness of the wall (Figure 5-2), immediately above the arch; the internal elevation of the transept, completely without plaster, makes legible the presence of a relieving arch which certainly does not affect the entire thickness of the wall.

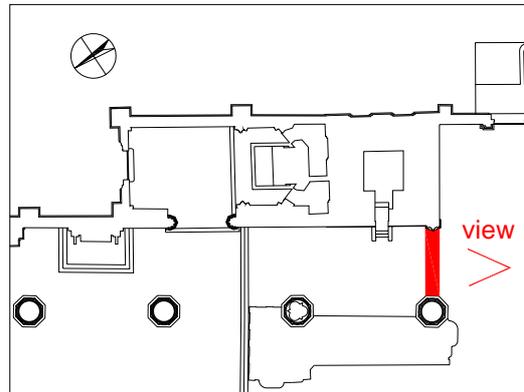
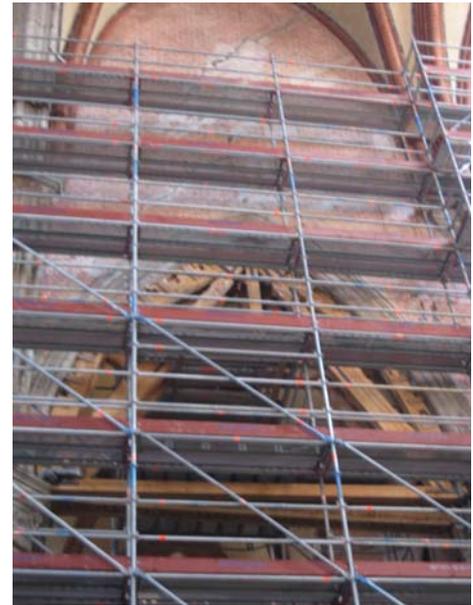
Figure 5-3: Propped stone arch: position and picture

Particularly the work carried out on the stone arch did not fulfill the expected goals, as the arch was propped again during the latest works in order to limit unpredictable damages on it. Its early reconstruction did not prevent it from further differential movements between its ashlar. The rash decision to demolish and reconstruct the arch during late XIX century was without a doubt a mistake and was most likely forced by the belief that there were no differential settlements between the tower and the Basilica, or that they were somehow being eliminated.

To avoid the occurrence of these two dangerous situations, three main devices were put in place. First: the already troubled stone arch was propped with a double timber truss. The same configuration was already used until 1881 and it seemed to be the best solution to adopt in order to avoid partial collapse of stone ashlars. The prop structure spans from the NW corner pillar of the bell tower to the last column of the main nave (Figure 5-3).

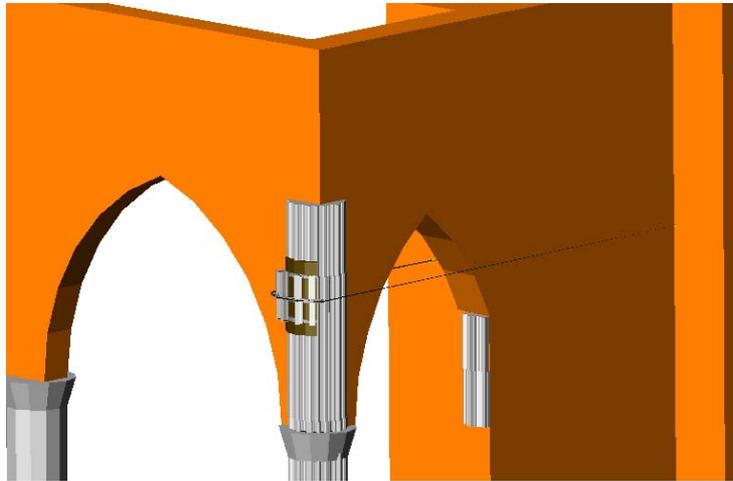
Third: to thwart and absorb the tower mass that would have leant towards *Campo dei Frari* a temporary steel tie rod was therefore designed. This proposal had the intent of minimal intervention on the structure by installing a device that would be totally removable without instauration of damages in the structure and with the goal of preventing further differential movements between the two structures. The \varnothing 24 mm steel cable was put in tension for this purpose and its location

was chosen in order to maximize the stabilizing effect on the column, which, as explained earlier, is a strong inflection towards the interior of the Basilica (Figure 5-5).

Figure 5-5: Provisional steel cable

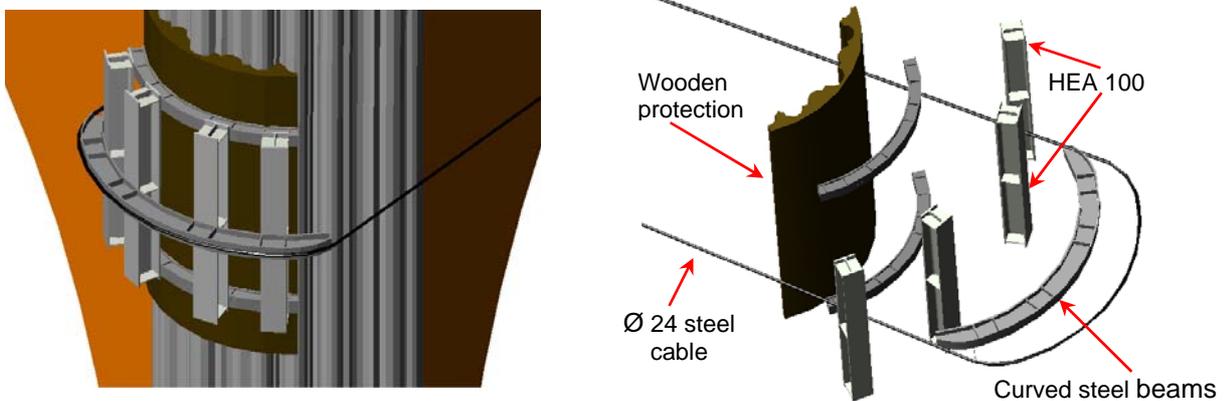
The metallic steel cable was housed in a curved steel beam that surrounds the column. Not to create local damage on the pillar by punching loads, a soft wooden protection has been placed between the metal structure and the stone column. Moreover, to uniform the distribution load, four HEA100 steel beams were placed vertically between the cable and the wooden protection (Figure 5-6).

Figure 5-6: Exploded drawing of the device at the column

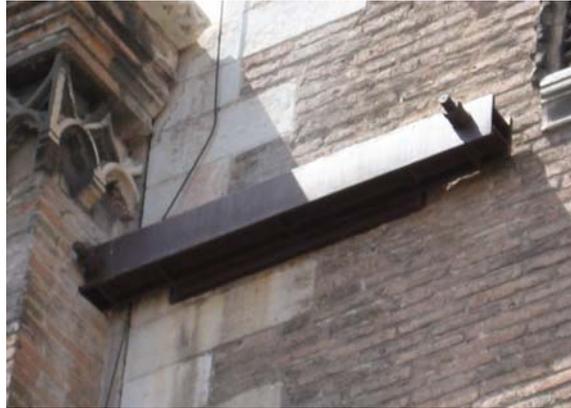
On the other side of the cable, on the SE wall of the tower, the removable tie plate was made by two UPN profiles stiffened with 10 mm gusset plates. As well the masonry wall was protected from local damages by a 2 cm thick steel plate that enlarged the load transmission area in order to stabilize the stress value around 1 MPa (Figure 5-7 and Figure 5-8).

Figure 5-7: Provisional tie plate on the tower

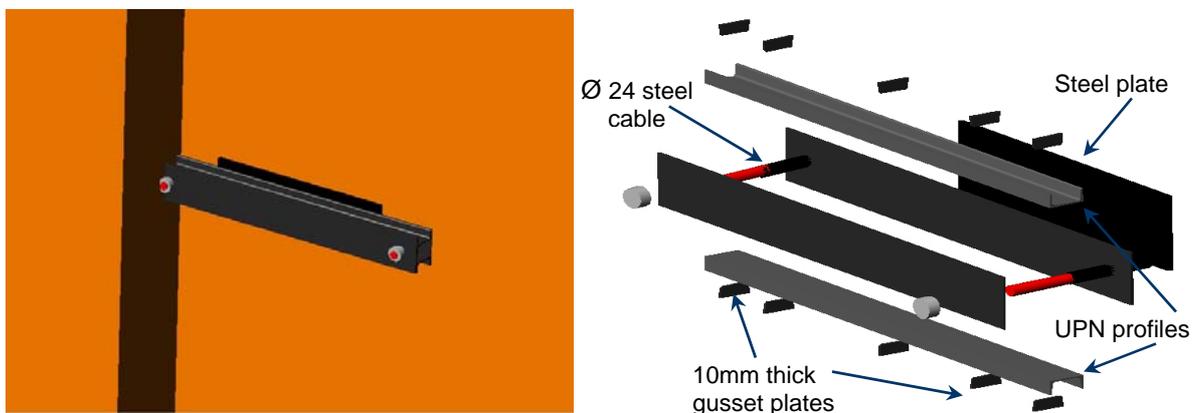
Figure 5-8: Exploded drawing of the tie plate at the tower wall

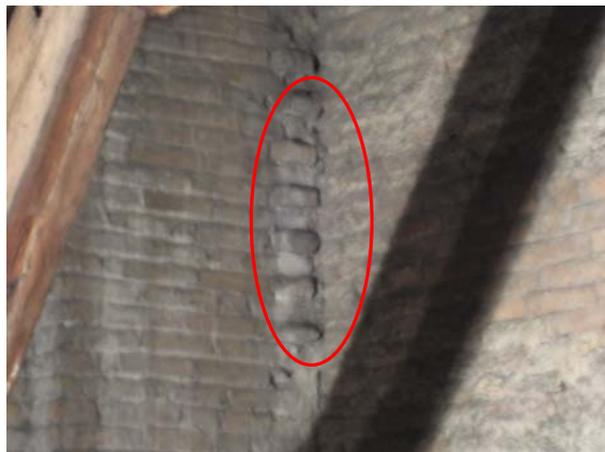
By removing the first two courses in a sample area of the inner corner side of the transept wall, evidence showed that the bell tower was only superficially connected; after removing a sample in the red highlighted zone of Figure 5-9 the proof was given.

Figure 5-9: Sample zone

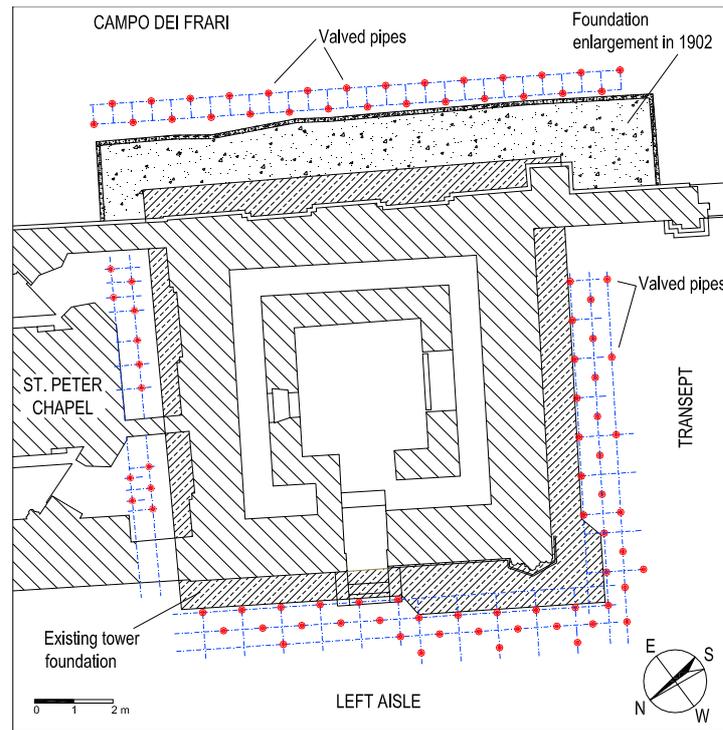
This technique has the great advantage of allowing the injections to be performed as gradually as necessary depending on the particular situation. In fact on the basis of a careful control, carried out continuously during all stages of processing, the soil-structure interaction, assigned to an adequate monitoring system, is continuously checked. The continuous monitoring action is important not only to check the quantity and the modality of the injections, but also to immediately stop the works if any unpredictable phenomenon would have occurred. This intervention, considered the most suitable for the work and the least invasive, is extremely flexible (Figure 5-10).

Figure 5-10: Soil-fracturing scheme

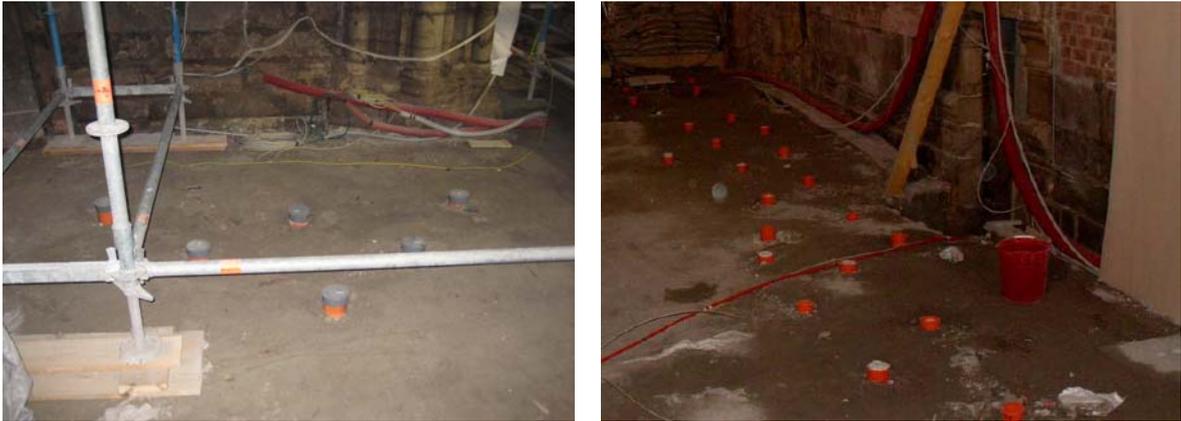
A picture representing a portion of the piles is depicted in Figure 5-11.

Figure 5-11: Valved piles of the soil-microfracturing technique

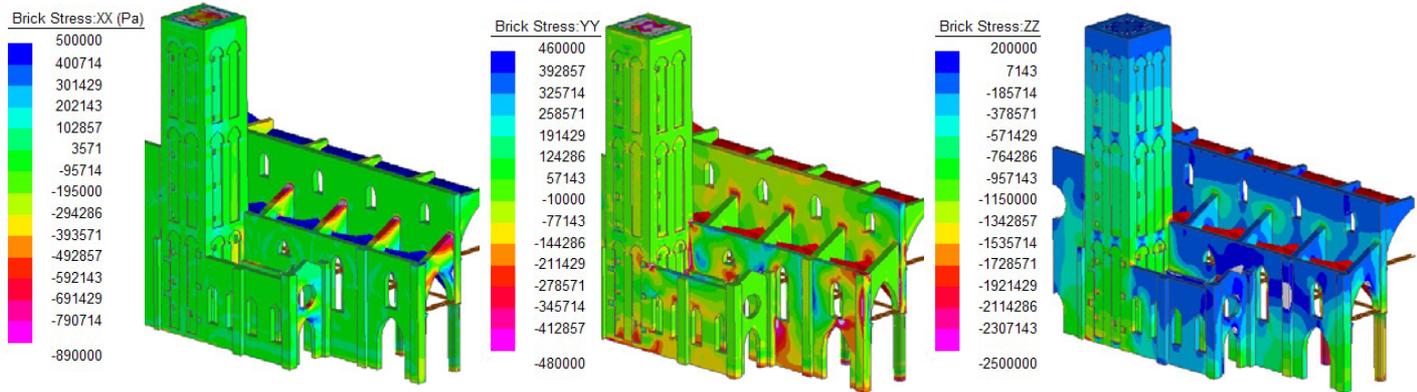
Figure 6-3 shows the stress patterns in the principal directions. The transversal direction considers the behavior of arches, vaults, walls and buttress warps in X direction and lying on the XZ plan of the model. In this direction we can see that all parts of the walls have a uniform distribution of tension. Different behavior can be noticed however in the transversal buttresses of the main nave comparing them with the same structures of the left aisle. This behavior can be traced back to the heavy thrust of the main nave arches. These thrusts are probably not properly referable to the tie rods; hence the partial flying arches give their contribution to the safety of the structure by transmitting the loads to the buttresses of the lateral walls.

Longitudinal behavior (Y direction) is not of particular interest for the sake of the arches which lie on the YZ plan: the horizontal thrust among a series of contiguous arches usually balances itself. Only the last arch on the 3rd bay shows an uneven behavior but this is due to the presence of the nearby restraints. Otherwise noteworthy is the behavior inspected from the longitudinal differential displacement along Y direction (Figure 6-4). The largest displacement, towards the transept, is surely the one in the upper stem of the last column of the Basilica. The thrust of the arch above this column is not counter act by another arch, and the tie rod placed between the two capitals seems not to be working properly.

Finally, regarding the vertical direction (Z direction), it can easily be noticed that most parts of the structure are subjected to compression. As predicted, the most stressed parts are the slender ones (columns) while the others, due to their considerable mass (tower and walls), show a lesser stress value. The columns, especially the one towards the transept, show an uneven compression state. The reason for that has already been explained in previous chapters.

Figure 6-3: Stress in XX, YY and ZZ direction

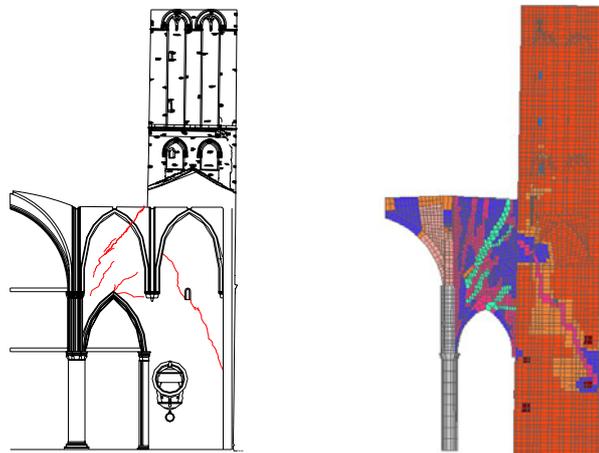
Lower values of Young's modulus indicate that those elements will be less stiff in the next analysis' step. This is done in order to redirect stresses towards other parts of the structure, knowing that those modified elements cannot contribute anymore to the normal behavior of the building (Figure 6-5).

Figure 6-5: Crack pattern (left) and different Young's modulus in the model (right)

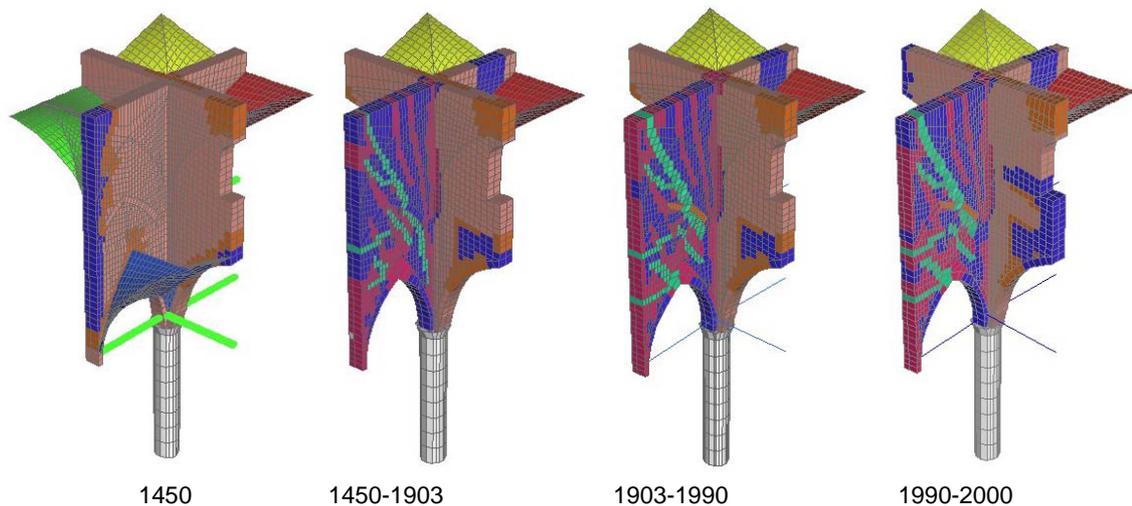
In Figure 6-6 iterative property changes in the four created models are depicted. These models show the walls of the transept and the left aisle, both seen from North direction. Cyan diagonal

elements depict the well known crack found from the damage survey in correspondence with the relieving arch above the masonry vault at the end of the left aisle. Pink brick elements are the ones that do not suffer damages and for which properties are defined since the first calibration procedures. After the first step analysis, with the support of the historical documents possessed by the Landscape and Architectural Heritage Office of Venice, accurate redefinition of the properties could have been performed.

Figure 6-6: Different properties among the finite element models

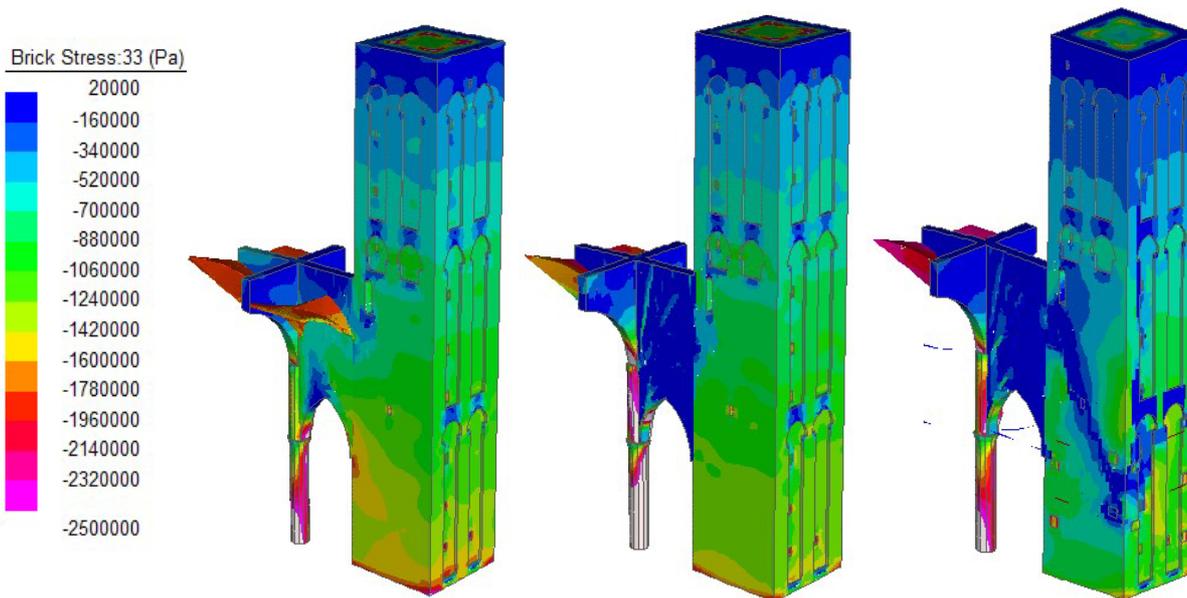
Figure 6-10 represents the principal compression stress for the most representative phases above mentioned, clearly showing the wide diagonal crack across the transept wall.

Figure 6-10: Principal minimum stress (3-3, compression)
