ADVANCED MASTERS IN STRUCTURAL ANALYSIS
OF MONUMENTS AND HISTORICAL CONSTRUCTIONS

Master's Thesis

THE GUARDIAN OF THE
PONTIFICAL STATE -
Structural Assessment of a
Damaged Coastal
Watchtower in South Lazio.

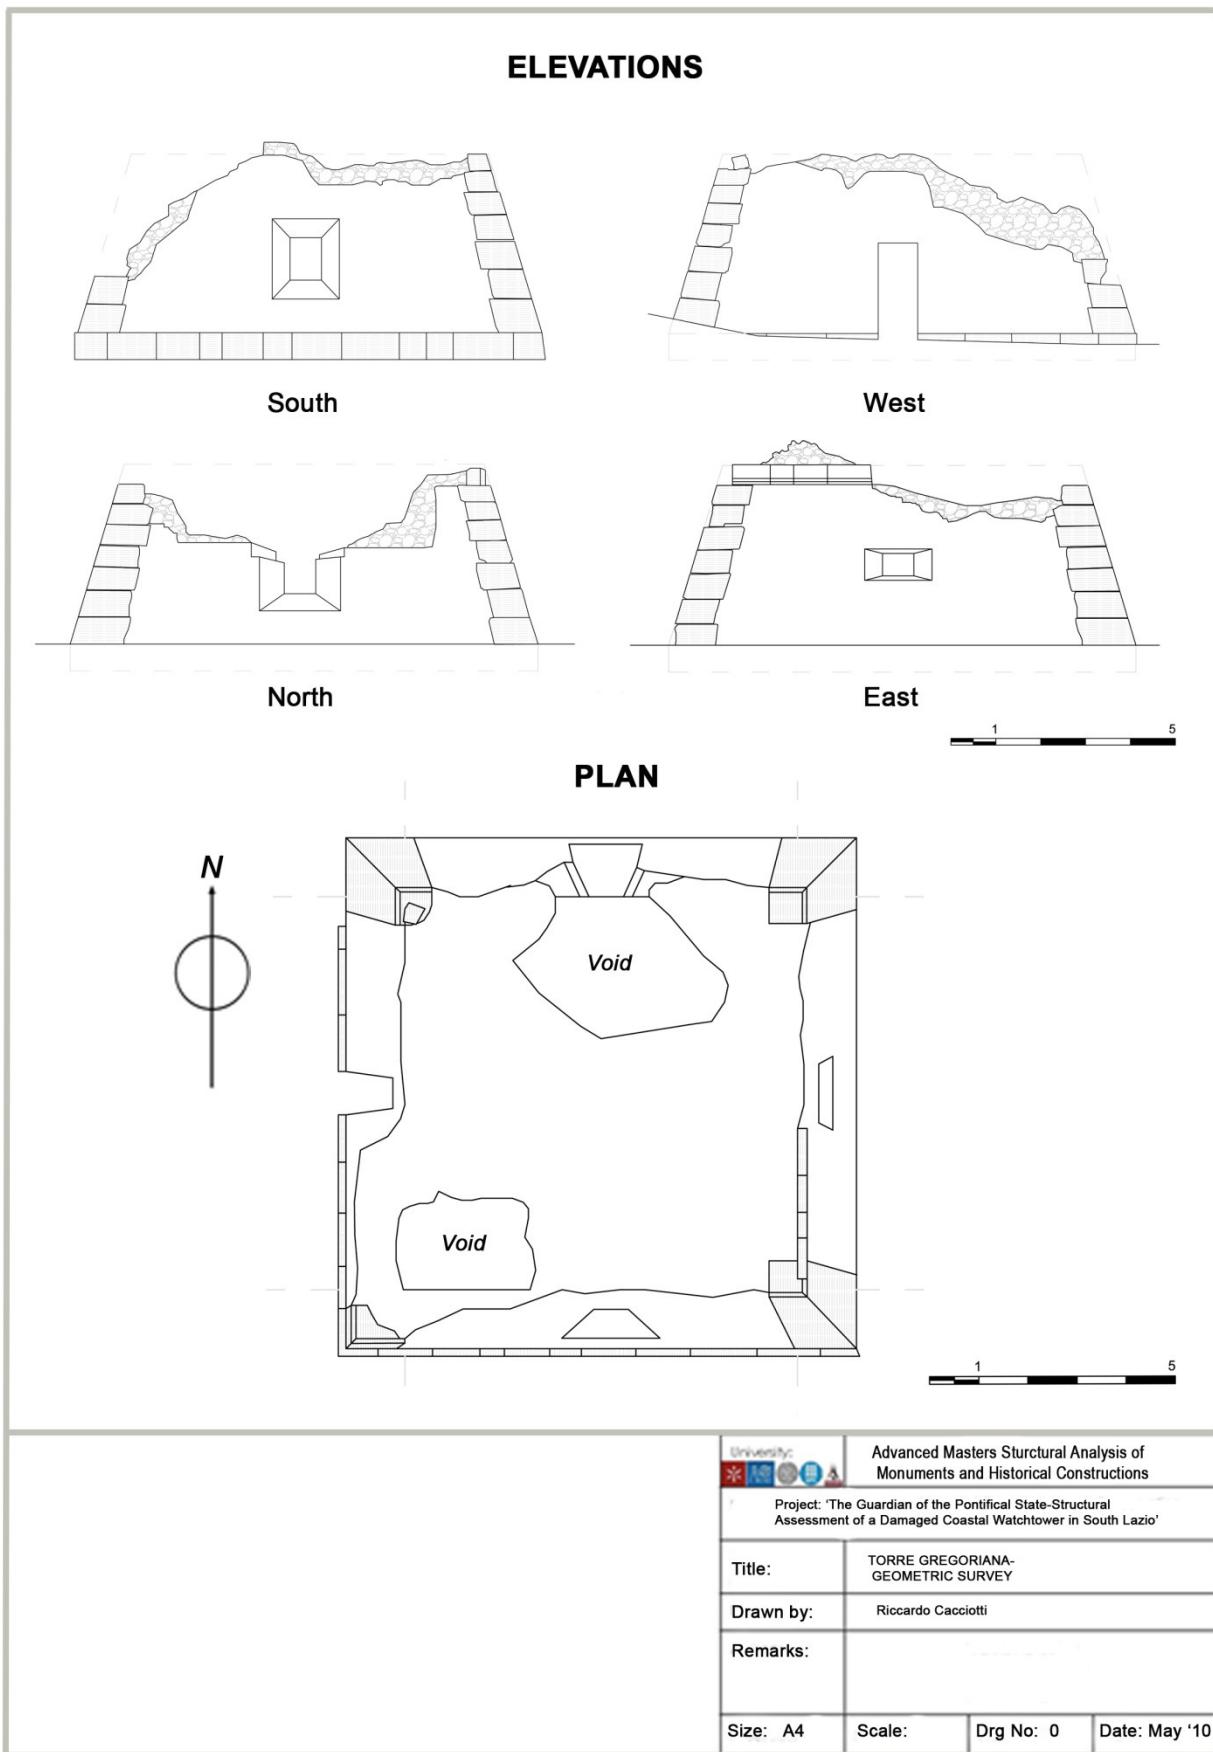
Figure 14.Torre Gregoriana- Geometric Survey

-The South elevation shows a 2 x 1,8 m opening in the middle of the façade which regresses inwards to an aperture of 1,5 x 0,7 m. The height of the elevation decreases considerably on the left-hand corner, where about 25 percent of the original dimension can be still observed. On the right-hand corner of the elevation the cornerstones reach almost the full original height. The top of the elevation between the corners is of irregular shape and quite variable in its dimensions.

-The plan of Torre Gregoriana has a square shape of 10,4 m side at the base, and of 8m side at the first floor level. The existent portion of floor slab on top of the tower is of 37,4 m² (about 50 percent of the 64 m² of the full plan area) and two considerable voids are visible in the plan as a consequence of the blast. The southwards void is located at the South-West corner of the base and has dimensions of 2,8 x 1,7 m. The second void, concentrated on the North side of the plan is of irregular shape and has rough dimensions of 4,3 x 2,8 m.

The actual geometry of the structure therefore is consistently reduced if compared to its original one. The raising body and the 20th century additions have been completely swept away. However the existing fabric still features the full structure of the base of the tower and, partially, the original extent of the vaulted system of the ground floor.

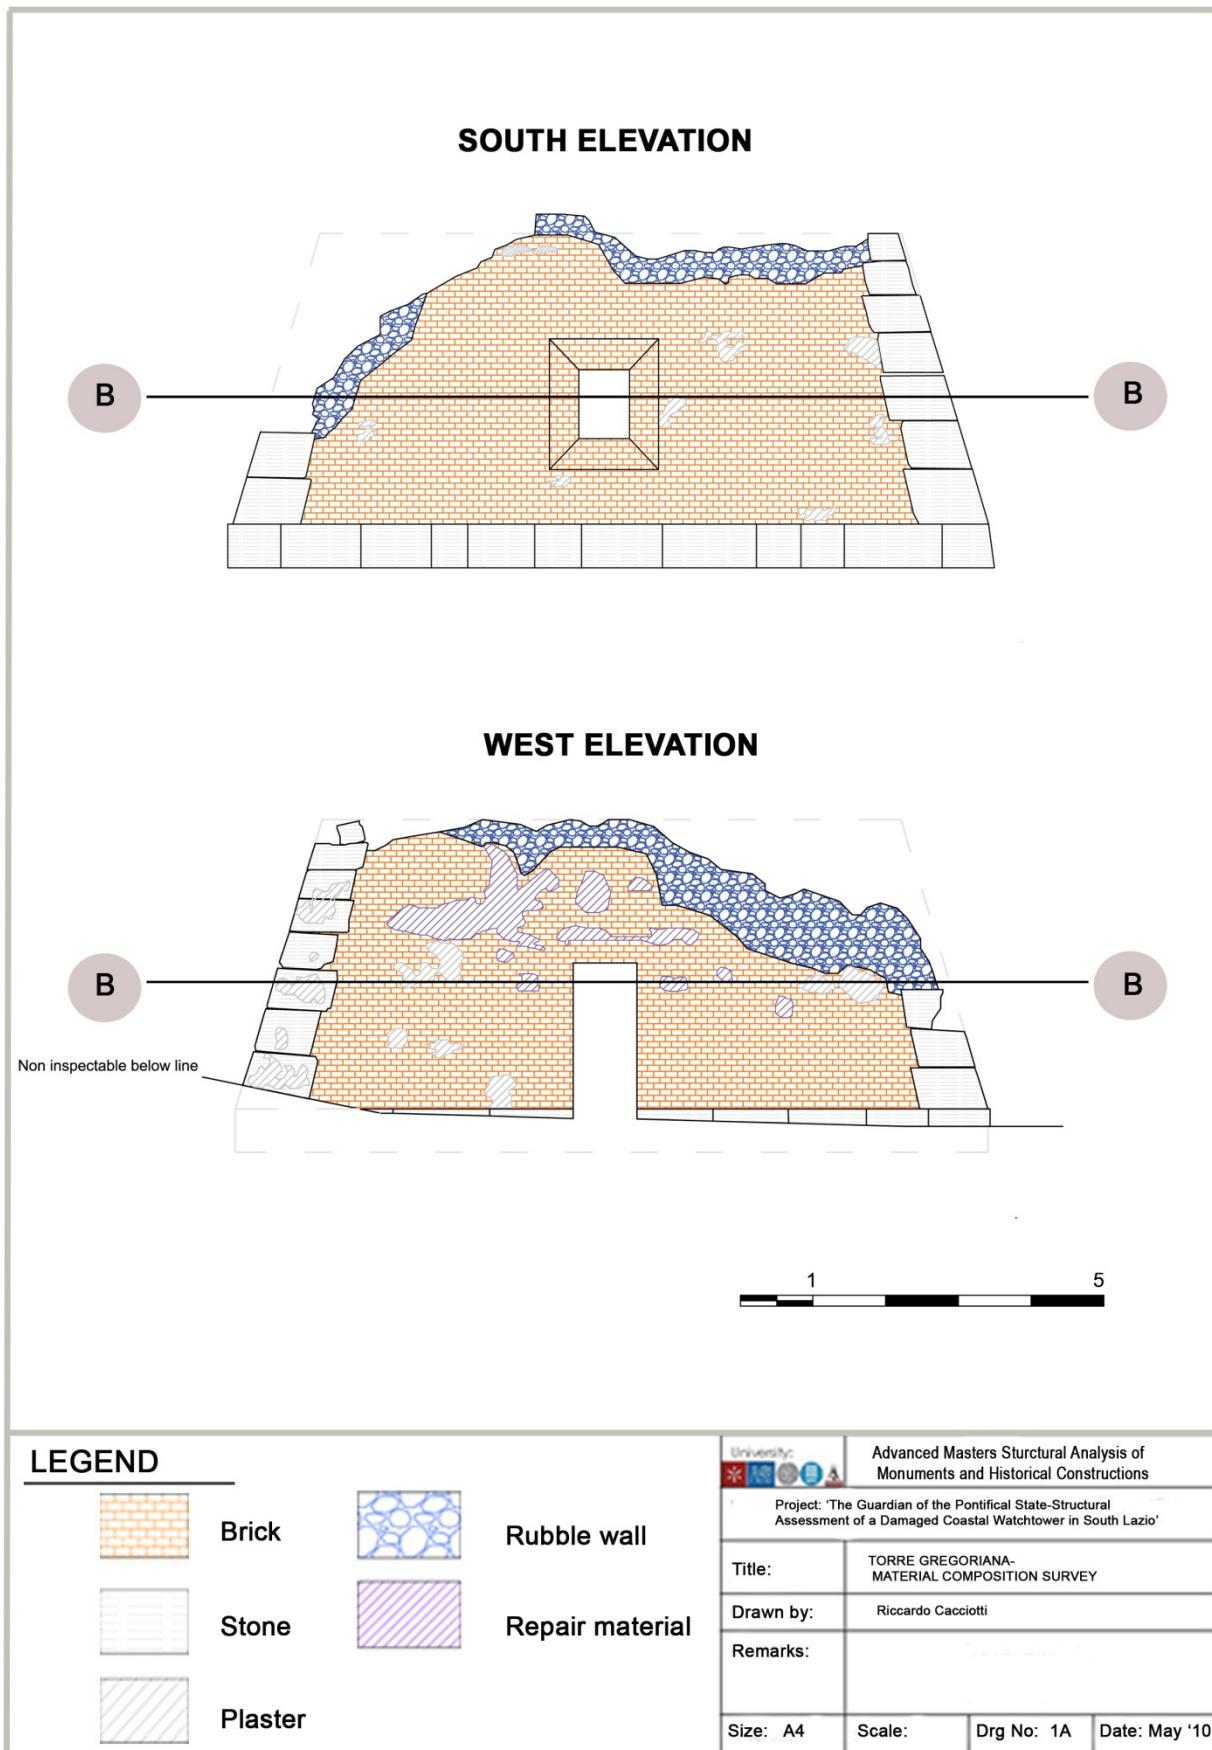
Figure 15. Torre Gregoriana- Material Composition S-W

The primary materials show a widespread distribution throughout the building. Stone is certainly the most common material and it is an essential component of the base, the walls and the vault of the tower. The type of stone observed in Torre Gregoriana is a local limestone, almost certainly coming from the opposite *S. Angelo Mountain*. The limestone is characterized by a dense and compact texture, with a minimal presence of quartz or clay impurities, ensuring a qualitative structural performance. The color of the stone varies between white and grey, depending also on the severity of exposition to weathering agents. Stone parallelepipeds of relevant size are present all around the tower, at the bottom of the base (*Figure 15*). The function is to transfer the compressive loading generated by the weight of the walls of the tower, into the foundations and the ground. The elevations and the plan of the fortification (*Figure 15, Figure 16 and Figure 17*) show the presence of limestone blocks, with two exposed faces inclined at 15° to the vertical, at the corners of the tower. These elements improve the connection between orthogonal walls, strengthening the resistance of the structure to a possible impact of gunfire. The East elevation of Torre Gregoriana (*Figure 16*) exhibits four remaining limestone units of the original ring ('cordonatura' see paragraph 3.1) topping the base of the structure. These elements contribute reinforcing the rigidity and solidity of the upper part of the base. Limestone units are also noticeable in the exposed parts of rubble wall, which constitutes the nucleus of the masonry of Torre Gregoriana. In fact, stone units of different shape and size can be found in the section of the walls and in the vault of the tower. Further details regarding the composition of the section of the tower will be discussed later in this paragraph.

If stone can be considered the most widespread structural material, brick certainly constitutes the one with the greatest visual impact. The façades of the base are covered with a layer of clay bricks. The dimensions of a unit are 4-5 cm thickness, 25 cm length and 15 cm width. The physical characteristics of the bricks range conspicuously: the color varies between light brown-yellow to orange-dark red, the texture is heterogeneous with voids and particles of different sizes. The heterogeneity of the bricks can be due to the different chemical and mineral contents of the raw materials in the bricks, to the localized repairing over time and substitution with new units, and to the different exposure of the four sides of the tower to weathering. The plan of the structure (*Figure 17*) shows that bricks are also used in the half-spiral stairs and for the shaft of the staircase itself. It should be underlined that a limited amount of bricks can be sporadically found in the vault and in the wall section, used more for constructive needs rather than for structural purposes.

The secondary materials have no clear participation in the structural performance of the building but contribute protecting the construction from external agents and repairing structural and non structural damages to the fabric. Plaster is present on almost all the façades of the building. However the portions of plaster still visible are limited and surely not older than one century. The plaster is composed by two layers: one underneath layer in contact with the façade and a finishing layer. The overall thickness is up to 2cm (the lower layer varies between 0,5-1cm, while the exposed layer is 1-1,5cm thick). The plaster is cement based and the color ranges from light to medium dark grey. The lower layer shows a coarse and medium size aggregate, while the texture of the upper layer presents homogeneous and fine constituents. In Figure 15, on the West façade, it is shown that also the cornerstones were plastered during an unspecified time period. It should be underlined that the type of plaster remaining is with high probability designed for rendering of interiors, as the base of the tower constituted the internal façades of the structural additions of the 20th century. The inadequacy of the plaster to the exterior might explain the reduced amount of plaster still conserved on the exposed façades of the tower.

Repaired areas are inspected on the West and North elevations of Torre Gregoriana. These are made with the use of mixed materials such as stone, bricks and mortar. The repair on the West façade features small size, angular stones and wedges of broken bricks bound by a lime based mortar. Stones are of different type and seem to be randomly selected. The material used on the North elevation is brick. The whole repaired section in *Figure 17* was reconstructed after being blown up during the WWII. New red solid bricks, whose dimensions are similar to the original ones, are employed for the external leaf of the wall, while a mix of reused material is used for the wall section (stone, brick, tuff and concrete). Further finishing materials can be individuated in the plan of the tower (*Figure 17*). Red and square floor tiles are used for finishing the first floor level. No information is available regarding the authenticity of these clay tiles. Under the floor tiles a layer of cement based material finishes the level of the top of the vault.

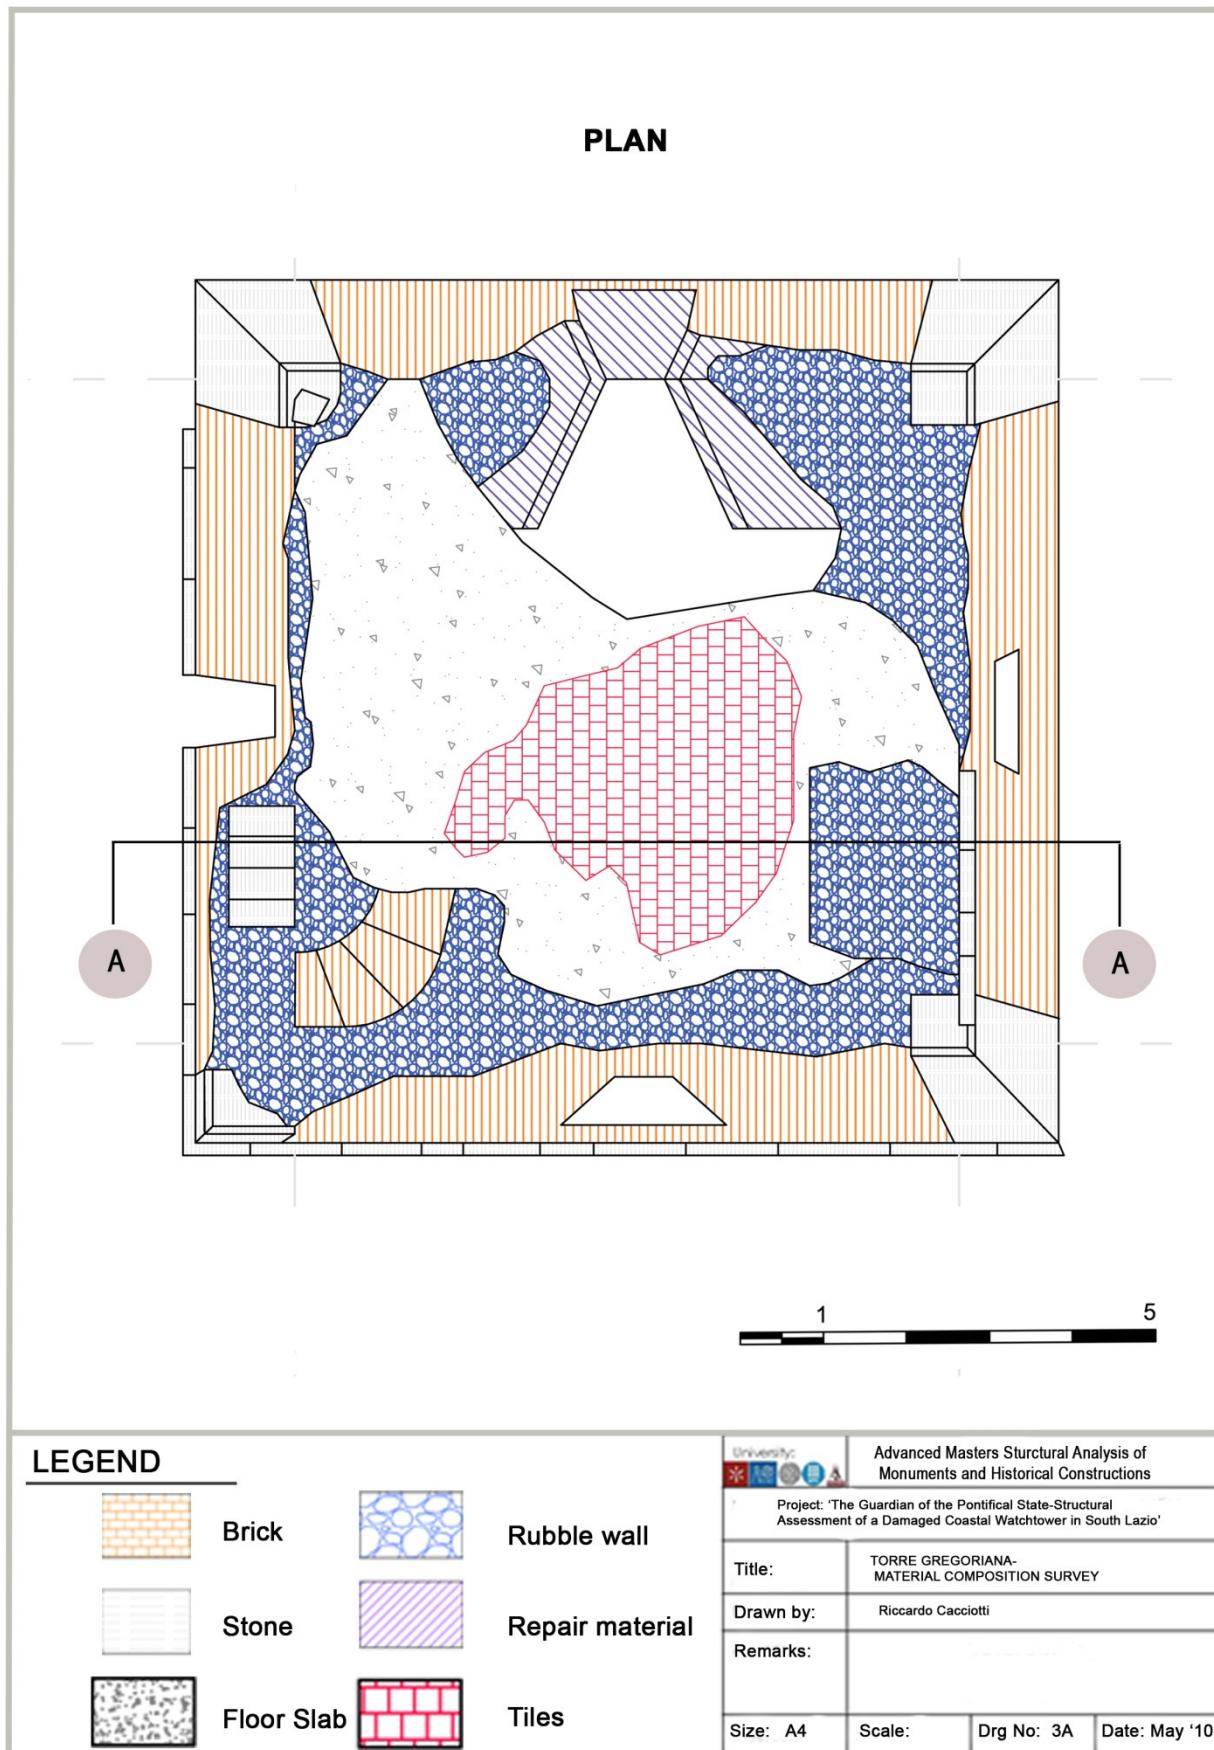
Figure 17. Torre Gregoriana- Material Composition Plan

Other types of stones should be included in this group of secondary materials, such as the marble slates used for finishing the second flight of stairs leading from the ground to the first floor (*Figure 17*).

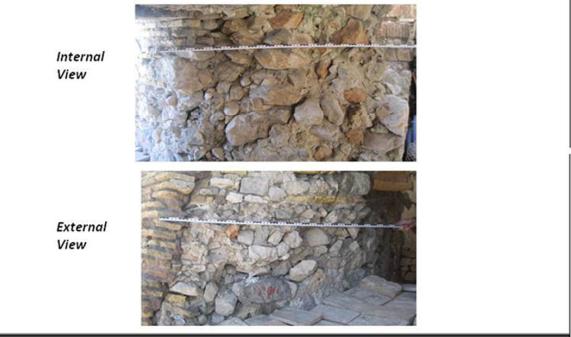
Figure 18. Cross Section Characterization Form. Source GNNT, 2006

The cross section typology is a three-leaf wall with good quality rubble infill. The total thickness of the wall at the bottom of the base is 3 m, of which 0,15 m is the width of the external leaf and 0,35 m the thickness of the internal one. The presence of internal voids in the rubble wall is not verified but limited spaces are observable from the outside of the base, running inwards deep into the masonry.

Bricks cover the external façades of the tower and constitute its external leaf. The conditions of the material vary depending on the exposure of the façade to weathering, however the state of conservation and consequently the quality of the brick units is expected to be poor. The mortar used to lay the units, although very eroded in localized spots, appears to be strong and compact. The binder is hydraulic lime and the aggregate is composed by poorly graded particles, of 4-7 mm angular shape and of different calcareous nature. The leaf layout is regular and features ordered horizontal courses of bricks with no break-course nor wedging between courses.

The internal leaf is predominantly composed by large limestone units (greater than 25 cm diagonal dimension), and with a random shape and finishing (rounded, angular and squared). The state of conservation of the leaf is discrete although some of the units are loose and badly bound to the texture of the wall. The mortar used for laying the stone units appears of loose consistency. The binder is hydraulic lime with well graded sand and silty soil as aggregate. The units are randomly located into irregular courses with the aid of stone wedging.

The rubble wall is composed mainly by limestone and mortar. The size and shape of the stone is very heterogeneous as it can vary considerably between 40 cm long angular units to 4-5 cm rounded or irregular particles. The units in the rubble wall are randomly arranged and no regularity can be observed. The mortar used to fill the voids between stones is generally in mildly loose conditions. The binder is hydraulic lime with a poorly graded mix composed by pebbles, crushed rocks and calcareous and basalt particles.

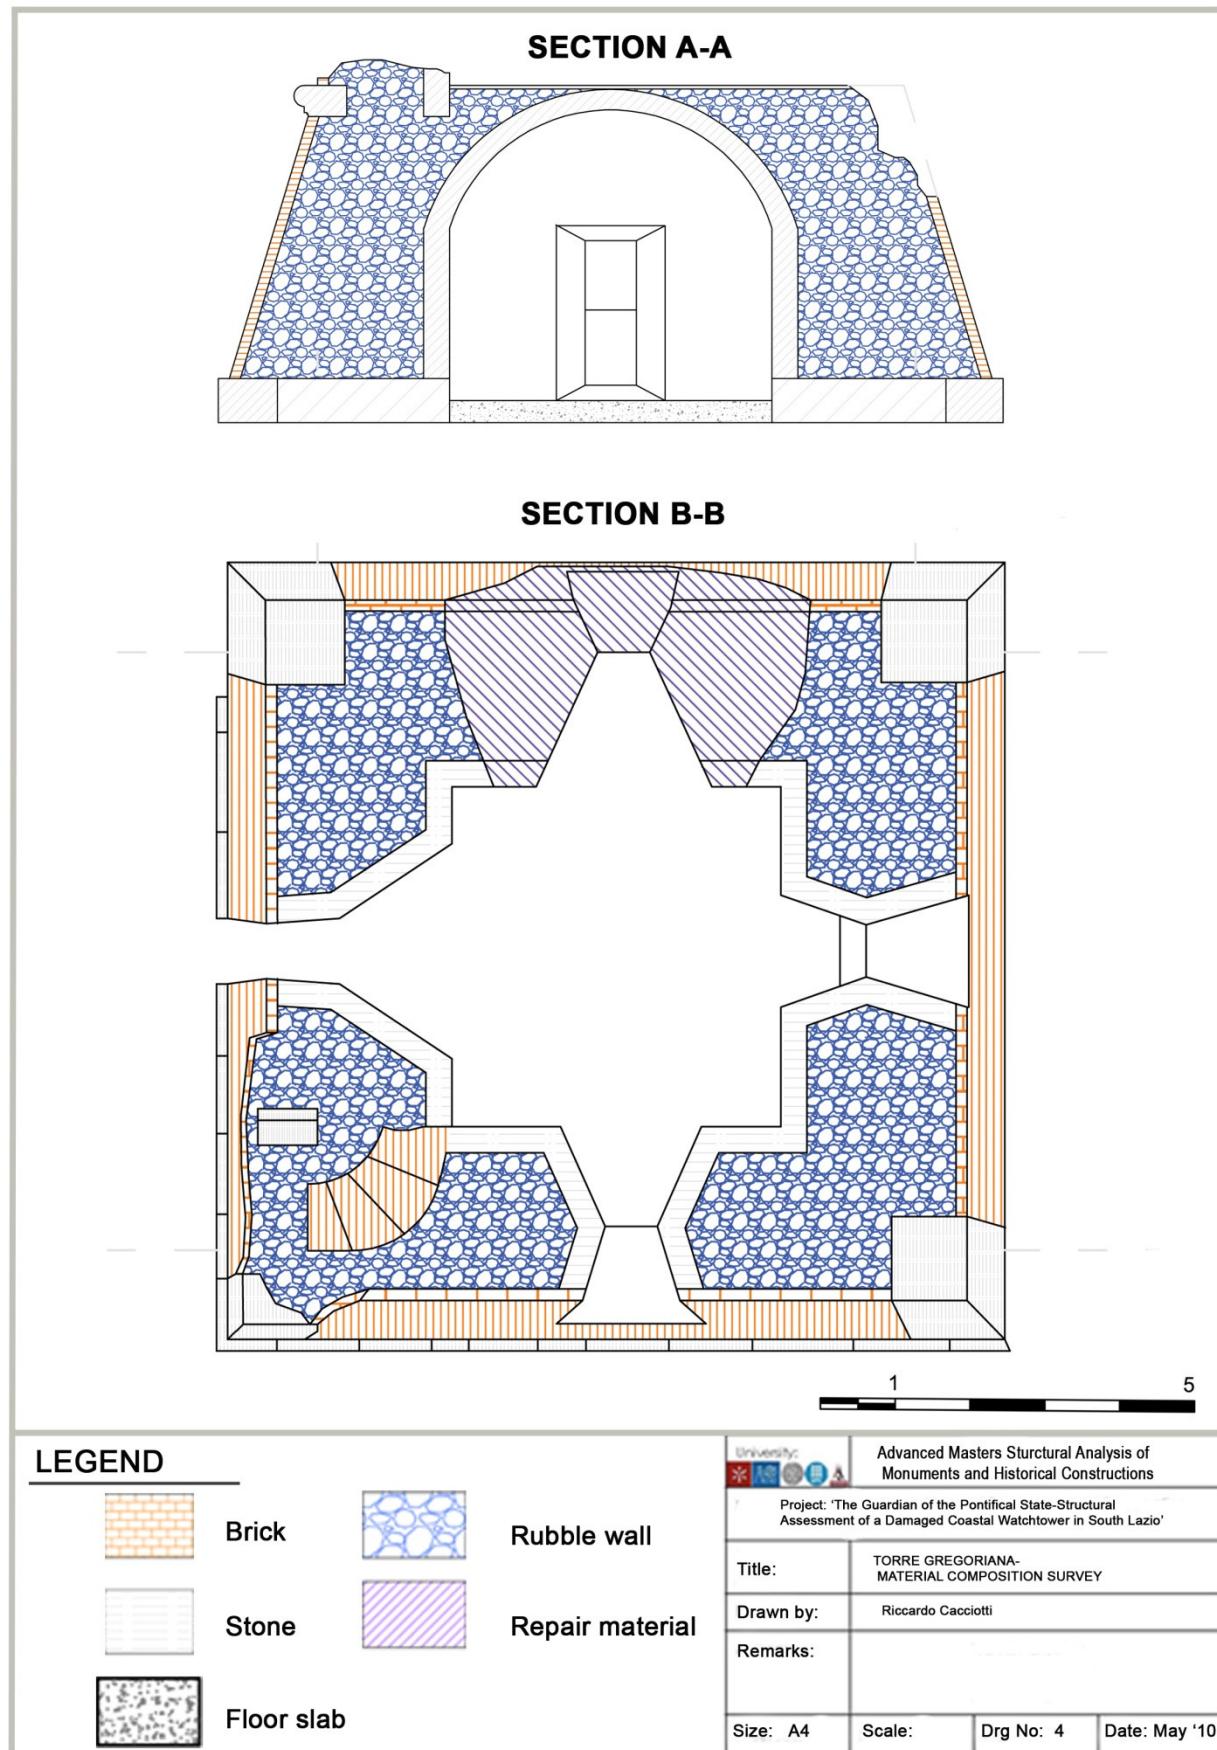
Figure 19. Torre Gregoriana- Material Composition Section A-A, B-B

The form shown below (*Figure 18*) summarizes the essential characteristics of the walls and of its composing materials. Sections A-A and B-B (*Figure 19*) show respectively a vertical and horizontal section of the base. The wall is composite and its internal nucleus, the rubble wall, constitutes a conspicuous part of the whole section.

It has to be noticed that the homogeneity and continuity of the above properties of the walls of Torre Gregoriana is not ensured.

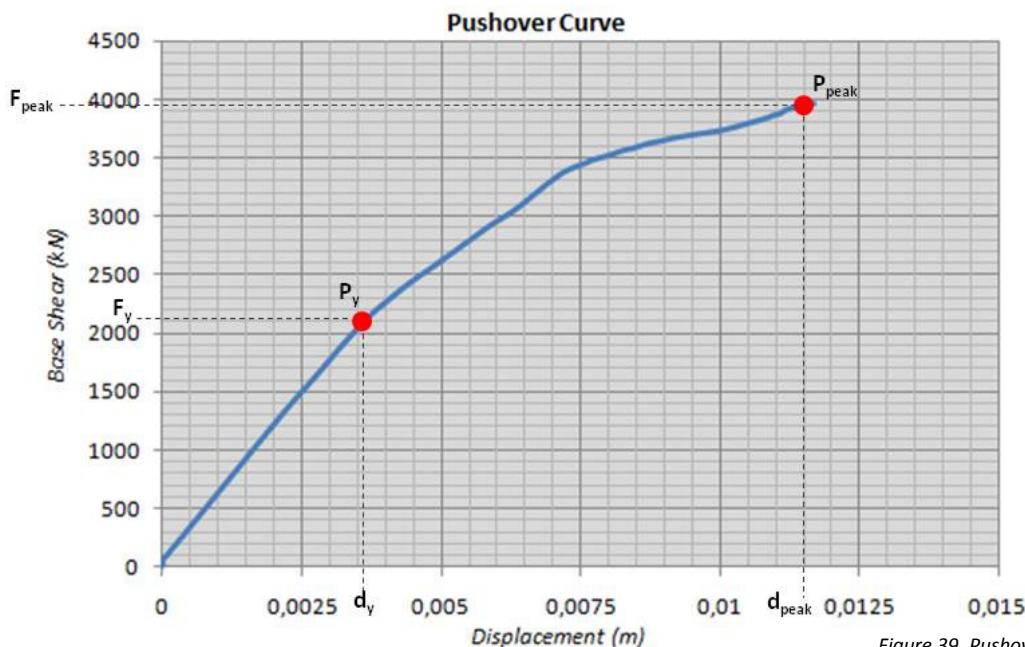
Figure 39. Pushover Curve

Figure 39 shows the relationship between the base shear and the displacement of the control point at the top of the tower (usually the node of maximum displacement). Two points are clearly identifiable on the plot. P_y is the yielding point of the building, at which the non-linear behavior begins. For a force of $P_y = 2100$ kN the control point is displaced by 0,0036 m and the first mechanism is expected to occur. The P_{peak} is achieved for a base shear of $F_{peak} = 4000$ kN, which corresponds to a displacement of 0,0115 m. At this point the maximum force is applied. Limitations due to the convergence requirements for the calculation of the FEM do not allow to go any further. After this point limit analysis of the mechanism could be used to achieve a final displacement and an approximation of the last section of the curve.

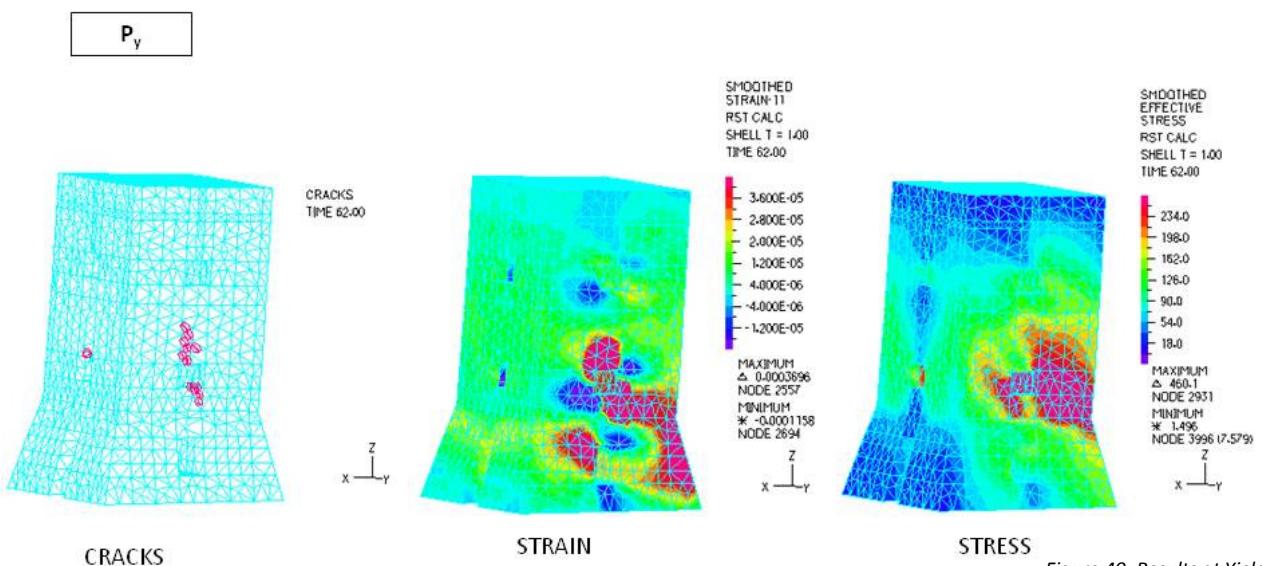
Figure 40. Results at Yield Point

The cracks, strain and stress at the yield point are shown in Figure 40. The cracks develop at the diagonally opposite corners of the opening and move outwards. At this point the significance of the damage is sensible and the structure enters the non-linear behavior. The principal strain at this stage is included between 0,0004 and -0,0001. The maximum strain distributes at the corner of the base of the tower running into the shear wall of the first floor, towards the openings. The maximum effective stress is 460 kPa, within the allowable for the base material of 800 kPa. The maximum compression occurs at the top of the base on the East façade, running towards the opening of the shear walls. The horizontal force multiplier necessary to activate this first mechanism is equal to the ratio of F_y over the total weight of the structure (8468 kN), that is $\alpha_1 = 0,248$.

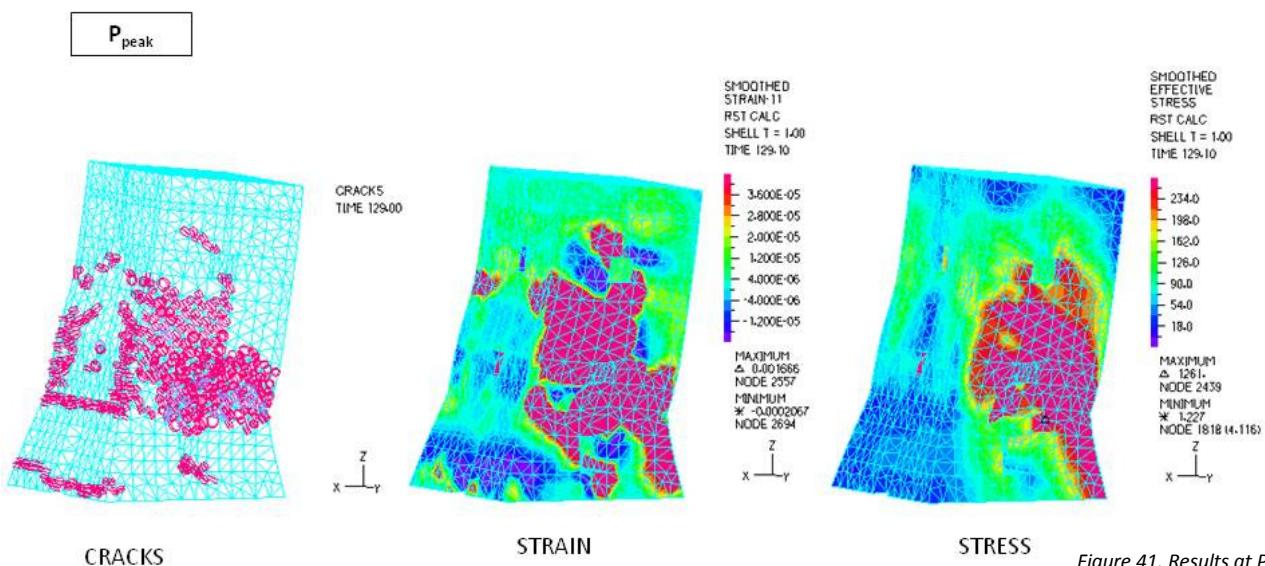
Figure 41. Results at Peak Point

The point P_{peak} represents the point after which the structure loses substantially its bearing capacity, dissipating increasingly applied energy and leading rapidly to collapse. Cracks, strain and stress for

this point are presented in Figure 41. The failure mechanism at this point seems mostly by shear, with some localized bending. The walls of the South and North façades show conspicuous cracking running diagonally from the top of the first floor to the top of the base. The collapse mechanism to consider would be therefore the shear failure of the body of the tower in the direction of the horizontal force applied. The strain observed for the peak of applied force is included between 0.0017 and -0.00021. The distribution of high strain involves mainly the diagonal running from the bottom of the base to the top of the first floor. The maximum effective stress at the peak point is 1261kPa which would induce the failure of the base material as it passes the limit of compressive stress of 800kPa . The conditions described above for the peak horizontal force are expected for a horizontal force multiplier $\alpha_2= 0.473$.

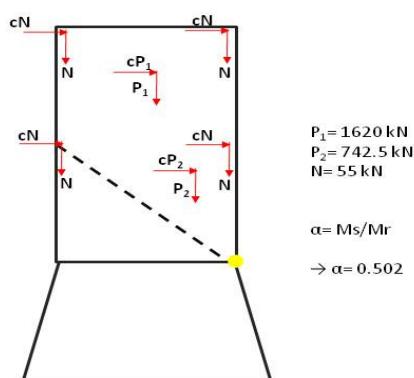
Figure 42. Safety Factor Verification

To verify the validity of the horizontal multiplier required to activate the failure mechanism, a new kinematic model is proposed (Figure 42). The value of α is calculated to be equal to 0.502, in a reasonable range with the value derived from the pushover curve. Note that this value is much lower than the one obtained in section 5.2 as it features a diagonal failure and less stabilizing mass is involved.
