ADVANCED MASTERS IN STRUCTURAL ANALYSIS
OF MONUMENTS AND HISTORICAL CONSTRUCTIONS

Master's Thesis

Moisture Problems in Irish
Tower Houses: Application to
Barryscourt Castle

Portugal | 2011

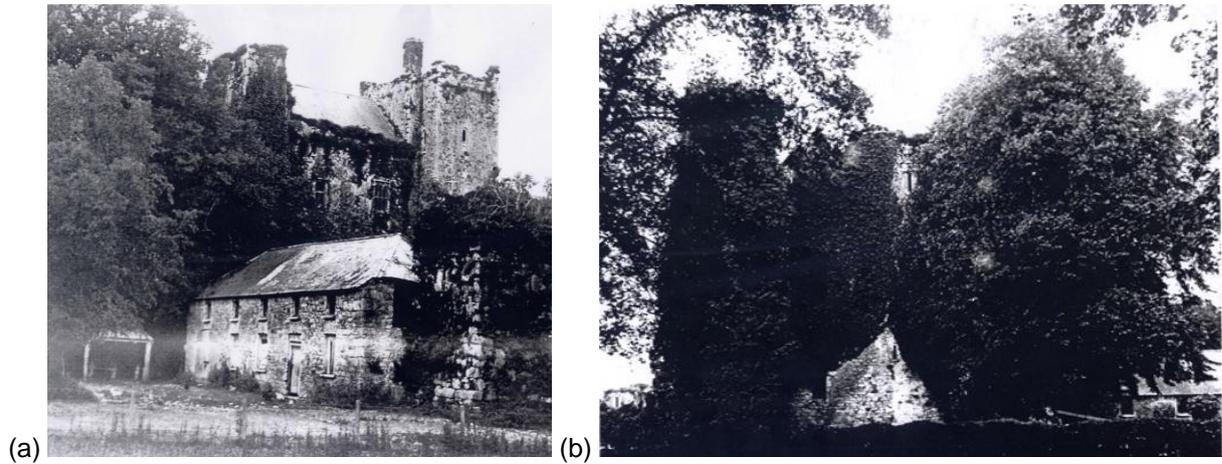
At the beginning of the project, the castle was in very poor condition; large scale water damage due to no roof protection had caused severe weathering of all main floors. Biological activity was thriving in the abandoned castle – vegetation such ivy and small plants had run riot on the walls, with strong roots rife in already vulnerable cracks in the both the interior and exterior (see Figure 18).

Figure 18: Photographs of Barryscourt from the southeast in 1914 – note the original roof still intact in this period (OPW Archives, 2011)

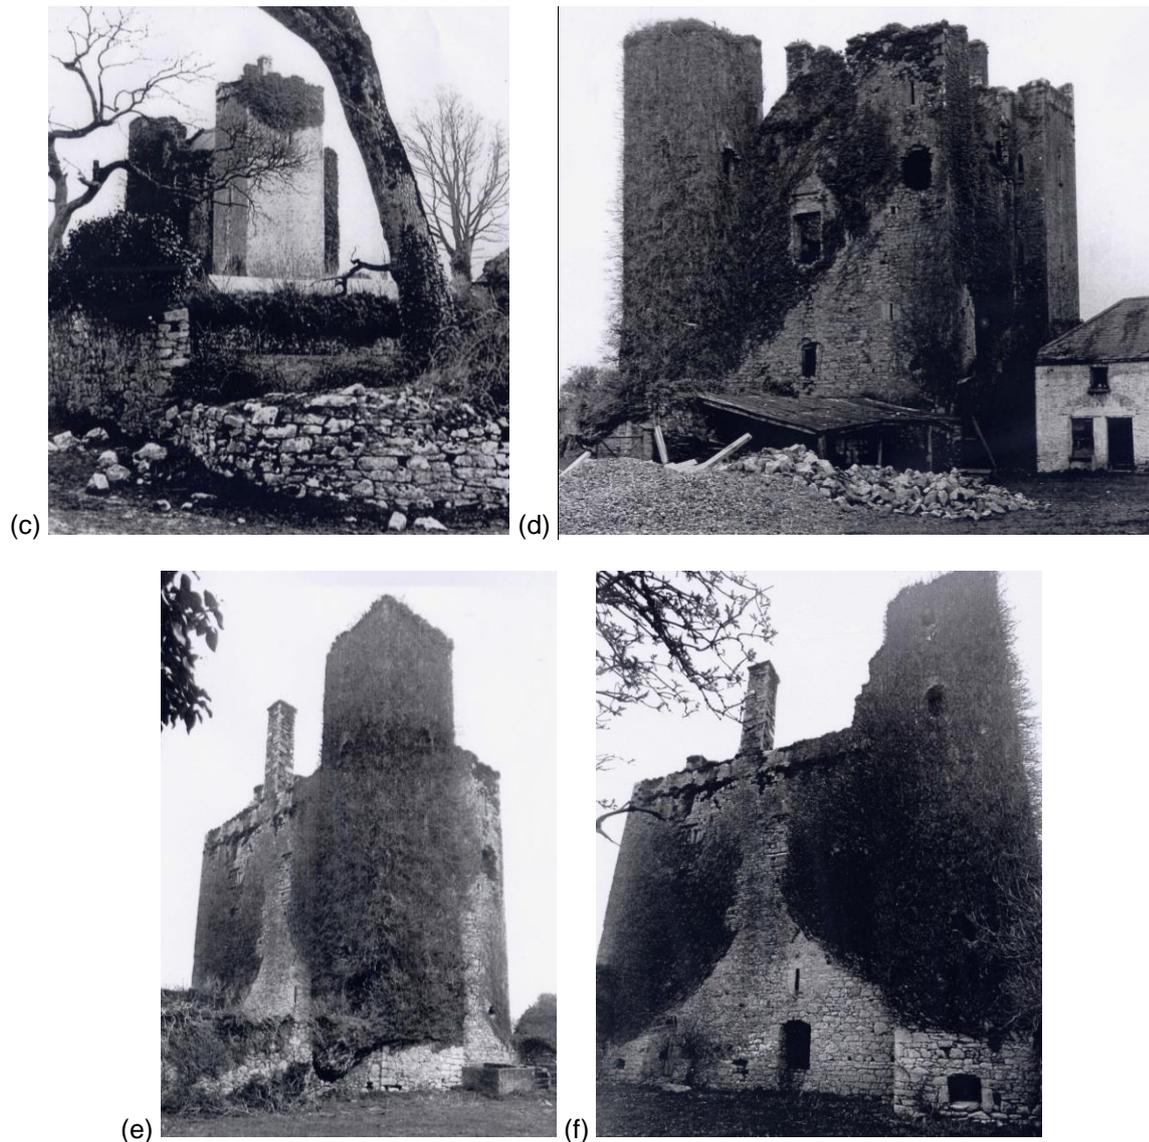
The lower sections of the castle walls had severe mortar loss, due to plant roots working their way into the lime mortar and rising damp was also evident from mortar loss and deterioration in areas where plant life was not so threatening. The ramparts had disintegrated and collapsed around the castle and many of the fallen masonry had been claimed by locals for walls and new buildings; there was extensive material loss as seen in the various historical photographs in Figure 19.

Figure 19: Photographs of the deterioration of Barryscourt through the 20th century: (a) View from northeast; (b) View from southeast; (c) View from southwest; and (d) View from west (All acquired from OPW Archives, 2011)

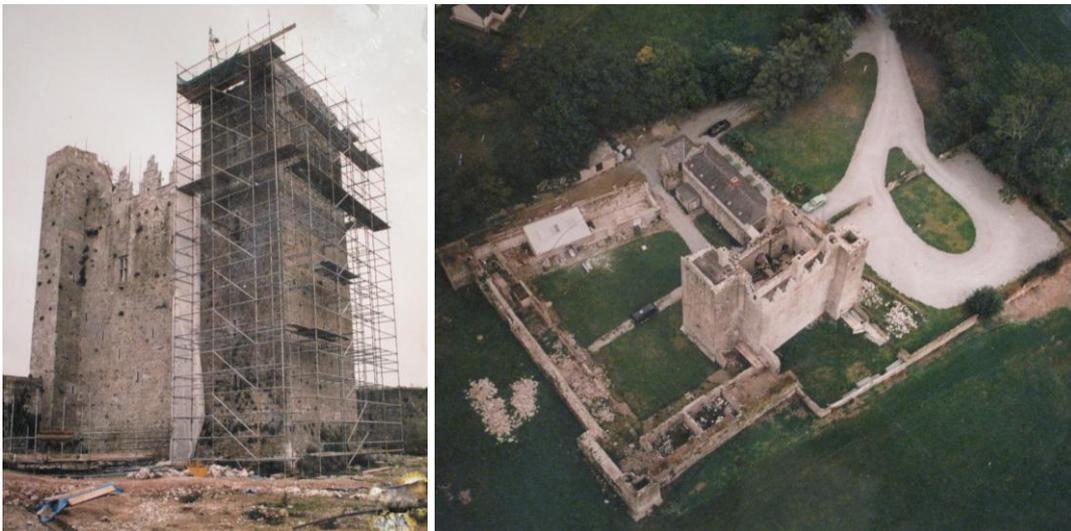
Figure 20: Barryscourt restoration in progress (OPW Archives, 2011)

The restoration began with the clearing of the site; detached masonry blocks, stones and disused material of no historical significance were all removed to landfill. Trees, bushes and various other damaging shrubs which had grown alongside the walls were removed to expose the hidden stone walls behind them. Their roots which had become embedded in the castles masonry were carefully cut or poisoned in order to minimise mortar damage and ensure the safe removal by not upsetting surrounding blocks.

Fallen material was gathered to provide suitable stones for the repair of wall holes and damaged parapets. Doors and window pieces such as the carved stone mullion window surrounds were remade and installed in their original positions. The oak, flagstone and rammed earth floors were redone adhering to historical evidence for the tower house's original typology. This respectful consideration for the historical architecture and original features of the castle is evident from the restoration efforts and achievements.

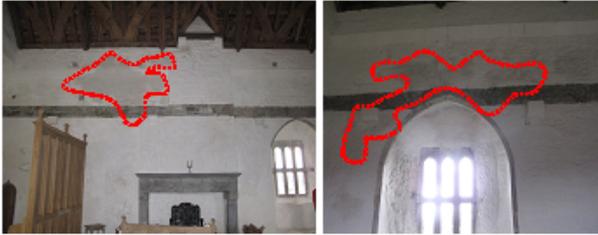
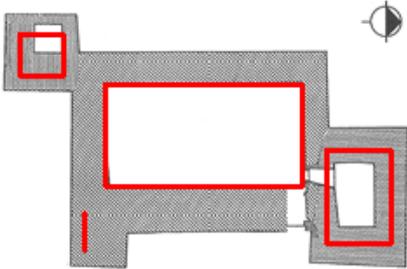
Barryscourt Tower House - Interior		PH_03
DAMAGE	Moisture induced staining and surface deterioration	Grading: Moderate
LOCATION	Global problem occurring on most interior walls of the tower house, especially noticeable in first floor hall, Great Chamber hall walls, northeast tower rooms exhibit many staining patches.	
CAUSES	Moisture causing staining - Number of contribution factors including faulty roof sealing joints, inadequate drainage. However, the moisture staining patches also occur in the middle of walls signifying porous masonry which is facilitating the ingress of moisture in times of rain and accelerating when accompanied by driving wind.	
MAIN MECHANISM	Water works through wall by differential pressure force and infiltrates to interior facades where it stays, causing staining of materials, namely lime wash and mortar joints, stone facing and timber. Constant moisture causes limewash to discolour to cream/yellow. Water combines with tannins in timber and stains walls when dripping or pouring. Water leaves staining lines and watermarks on naked stone.

Figure 22: An example of the formulated damage templates – Physical damage (weathering)

INTERVENTION PLAN	Roof sections should be repaired/ maintained. (See last template for intervention). Walls of castle should be repointed to repair mortar joints which are allowing moisture through. Rendering external plaster should be ideally reapplied using lime render to improve waterproofing whilst still allowing the walls to breathe in times of dry weather. Ventilation should be maximised to aerate the building during these times also and further the drying process.

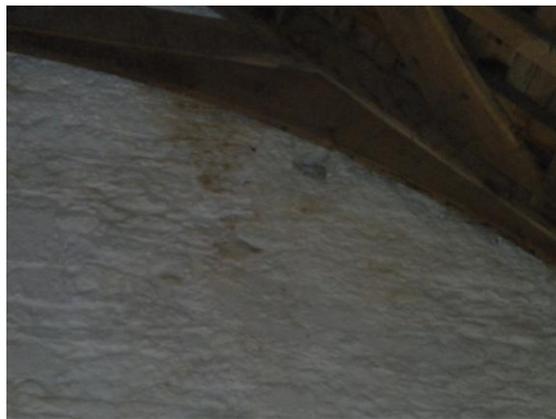
A different type of staining was found on the gable ends of the room (north and south). Here there is a different type of staining, where moisture appears to have infiltrated the timber and the resulting solution has run down the walls in times of long term rain. This staining is quite unsightly and occurs in both gables ends – the staining is brown in colour and indicates that the troublesome water is mixing with the tannin in the oak timber (see Figure 29).

Figure 29: Staining from water-oak tannin on gable walls of Great Chamber

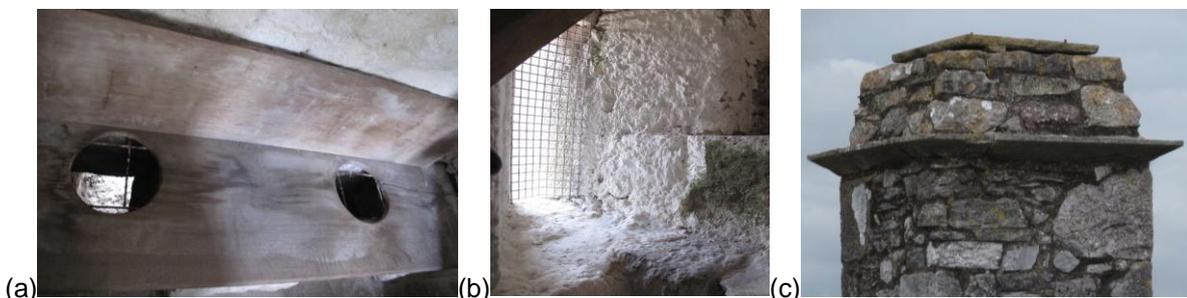
Additionally, the chimney has a capping stone which is not sealed at the top, allowing more air to move through the chimney shaft (see Figure 32b). In fact, many of the windows at Barryscourt, apart from the ground floor windows, possess the drainage outlets or opening frame sections which work in unison with the open chimney flues, waste exit shoots from latrines (see Figure 32c), arrow loops and door gaps, to allow fluent transportation of air through the building. With ample air flow, it is safe to say that Barryscourt does not have an issue with ventilation in the interior environment.

Figure 32: Examples of the abundant openings throughout Barryscourt which contribute to ventilation (a) Waste shoot from main garderobe of Great Hall (b) Open arrow loops of main staircase (c) Unsealed chimney capping

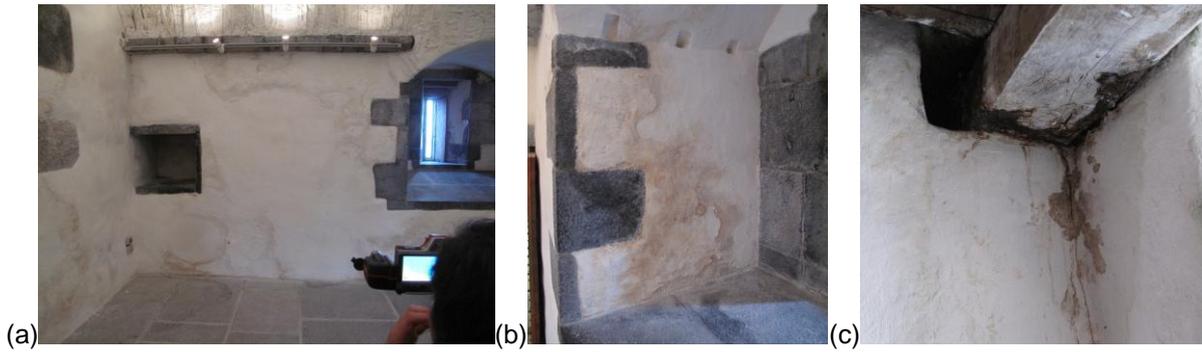
Various moisture-influenced damage evident in the castle include staining, rising damp, material deterioration, mortar loss, salt damage, material spalling, exfoliation and deteriorating timber structural elements (see Figure 35). Mould and fungus were running rife in the building also and just like Barryscourt, were affecting textiles and furnishings. Areas which could not be tended to by limewashing showed even worse damage, such as the chimney interior (see Figure 36a). The resulting thermography images are found and discussed in the following in section 5.1.1 of the results chapter.

Figure 35: (a) Moisture damage/staining in ground floor of Ross Castle; (b) Significant problems near window openings; (c) Decay of structural timber due to moisture presence

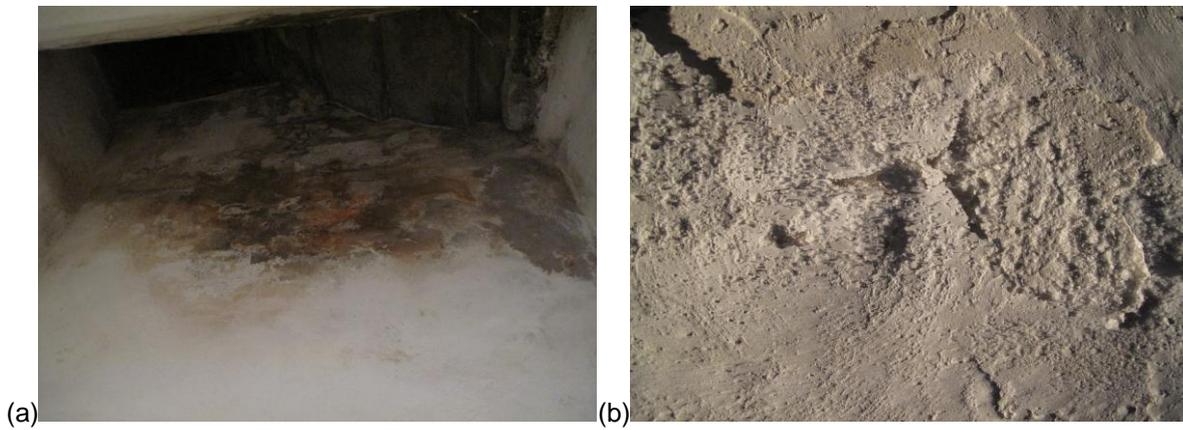
Figure 36: (a) Moisture damage in interior of Ross Castle chimney; (b) Abundance of salts and the associated material damage/exfoliation

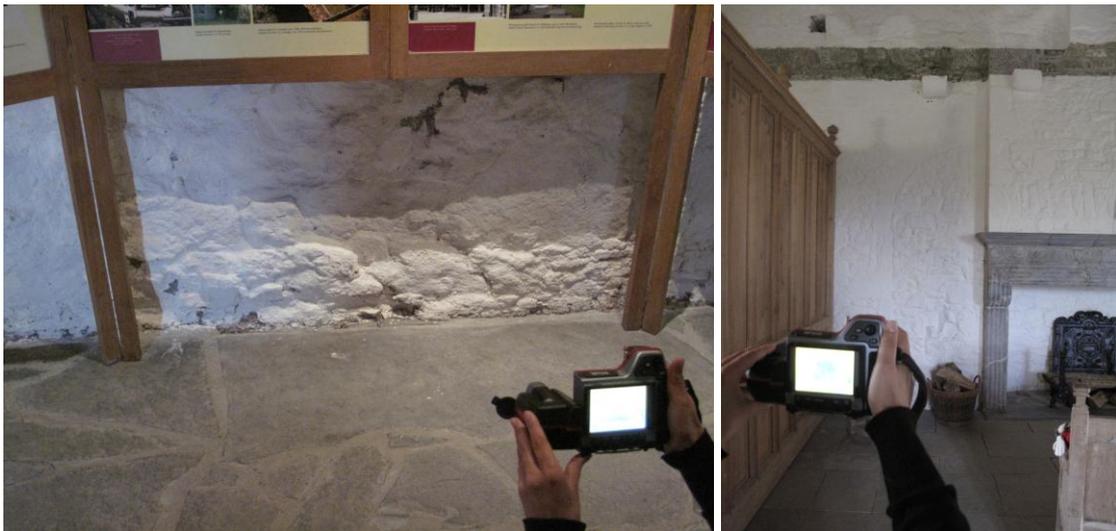
The analysis at Ross Castle was more successful due to the buildings underfloor heating. An additional test was conducted on Barryscourt on the same day. It had rained since the previous examination, the temperature was recorded as 11°C and the internal relative humidity was 85.4%, so conditions were more favourable. The testing was carried out in exactly the same way as the Ross castle analysis, with the updated emissivity and humidity settings. All rooms of all floors were re-examined and on this occasion the analysis was far more sensitive and illustrative of the moisture presence. Each section of damage which was observed and recorded in the preliminary visual inspection was tested using the camera. The thermography findings generated suspicions about the roof performance in some rooms, particularly in the master bedchamber. This provoked the need for a further rooftop/wall-walk inspection, which is outlined in the next section 4.3. A selection of the most important resulting images and their corresponding discussion of the findings are found in section 5.1.2 of the following results chapter.

Figure 37: Thermography analysis of Barryscourt tower house using handheld ThemaCAM T400 camera

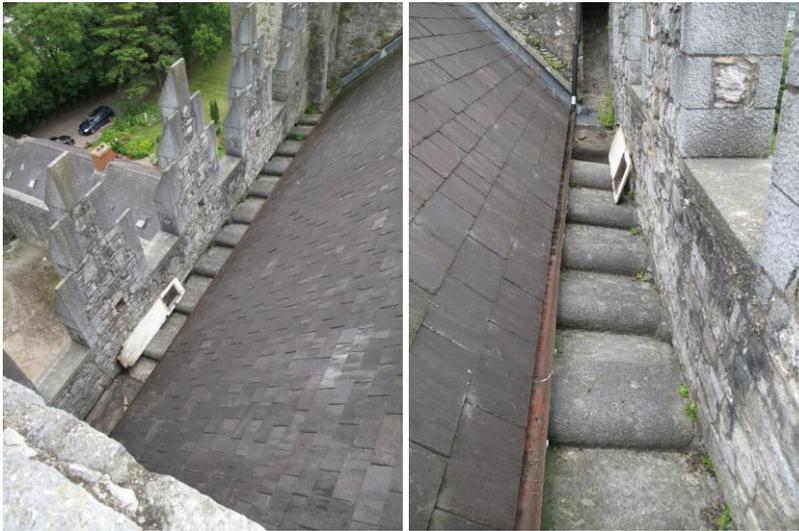
Figure 41: East roof surface and waterstone drainage arrangement

The roof surface appears to be in good condition, with no observed broken slates or displaced courses. Under the first course of slate (moving from bottom to top) lies a thick blanket of lead flashing which runs down and under the waterstones and saddle stones (see Figure 42). This lead is overlapped and counter flashed with well moulded joints and appears to be in good condition. The waterstones are arranged alongside each other with a capping “saddle” stone which overlies the joint of the two waterstones. These are joined using more of the restoration mortar. The cast iron gutter is held up by cast iron support brackets which are screwed in through the lead flashing into the underlying support structure. The saddle stones do not appear to be sealed very well and the quality of the bonding mortar is in very poor condition in multiple regions, which can allow moisture to penetrate quite easily. The gutter size and position is also questionable since the roof has such a steeply pitched angle and the catch gutter sits well under the eave of the final course of slates. In times of heavy rain, the momentum of the rainfall runoff would appear to be so great as to even overshoot the gutter and land on the waterstones.

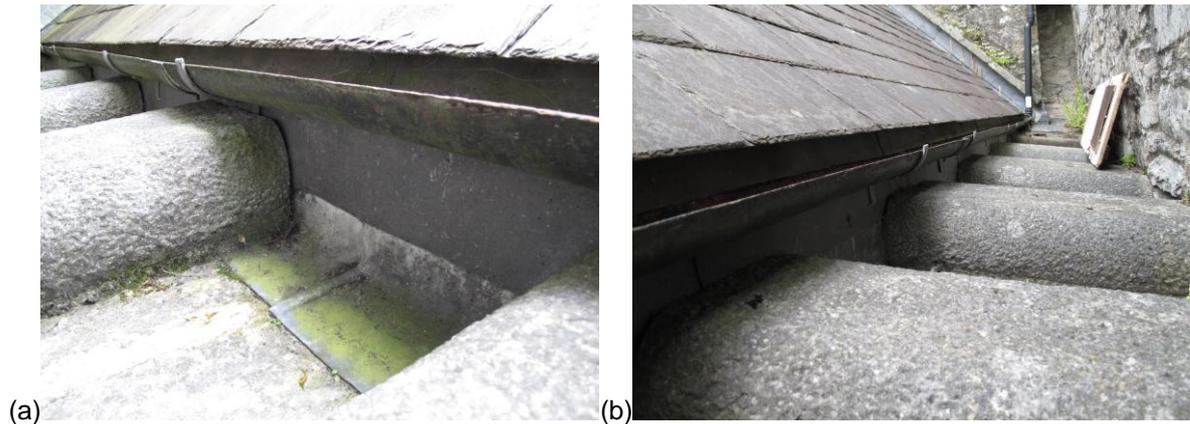
The waterstones themselves have only a slight inclination towards the outlet dripstones, a slope so small that water must take quite a while to evacuate the surface, time enough to soak into the

surrounding mortar and in the presence of high winds, work its way under the stones and lead flashing. Their surface is also very flat, so the evacuating water is not channelled away from the edges but can rather flow over the whole surface. The outlets along the wall walk, where the dripstones are located, funnel significant air flow when the wind blows against the building and this convection would seem to drive additional water back towards the building if the wind blows against the direction of the outlet, slowing water evacuation and pushing the water back towards the building.

Figure 42: Close up views of drainage gutter, lead flashing and counter flashing, waterstones and capping saddle stones

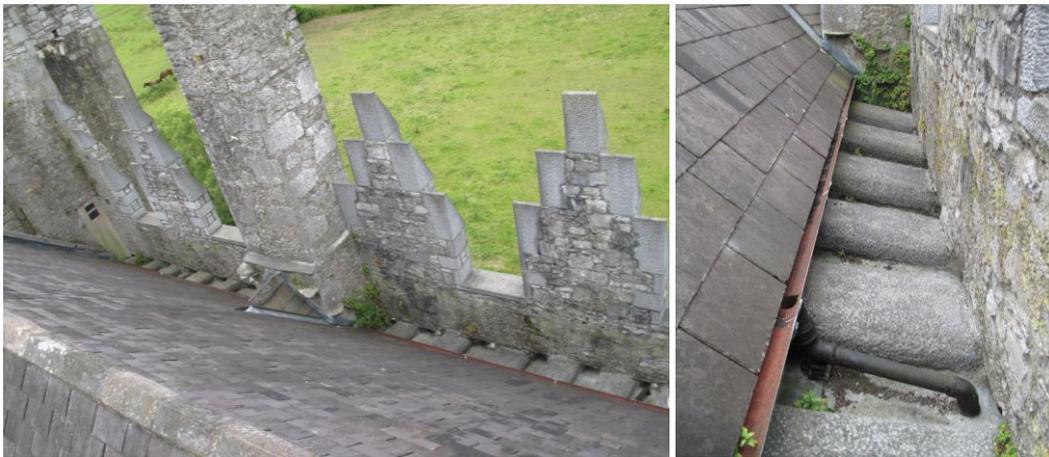
Figure 46: (a) West side of main roof with main chimney stack (b) Drainage channel with inbuilt downpipes on either side of the chimney

On this side, the flashing appears to be in good condition, as is the roof surface with no broken slates or obvious damages. Damage is very similar to what was observed on the east side, vegetation appears to be the most problematic agent on this side with plants and weeds in abundance and associated mortar loss and damp mortar. The gutter, just like the eastern gutter, is set well in under the

As detailed in a previous section, the west sides gutter is drained via two built in downpipes which run inside the external wall. The gutter on this side should be replaced with the half-round deep-flow gutter pipe also in order to efficiently catch the runoff rooftop rainwater, and the two existing downpipes should be adequate for water evacuation.

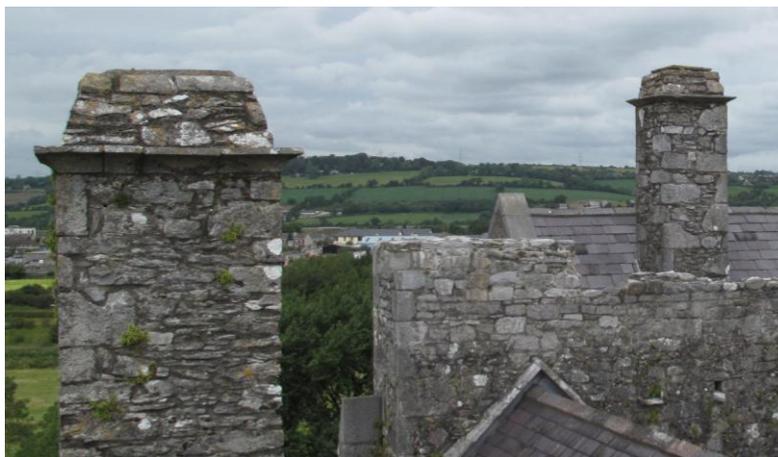
Figure 47: Capped/sealed main chimney and capped/unsealed bedroom chimney

eaves of the roof but has the benefit of the two draining downpipes. There is no such downpipe visible on the eastern roof section. The chimney is capped with a limestone flagstone just like the chimney on the northeast turret; however the capping stone on the west side chimney is apparently sealed around the edges with mortar, unlike the northeast chimney (see Figure 47). Even though the chimney is sealed with mortar, as observed during the primary site inspection, the interior of the chimney stack had incurred serious damage from moisture infiltration, and since the top is sealed, it illustrates that that water is infiltration through the masonry.

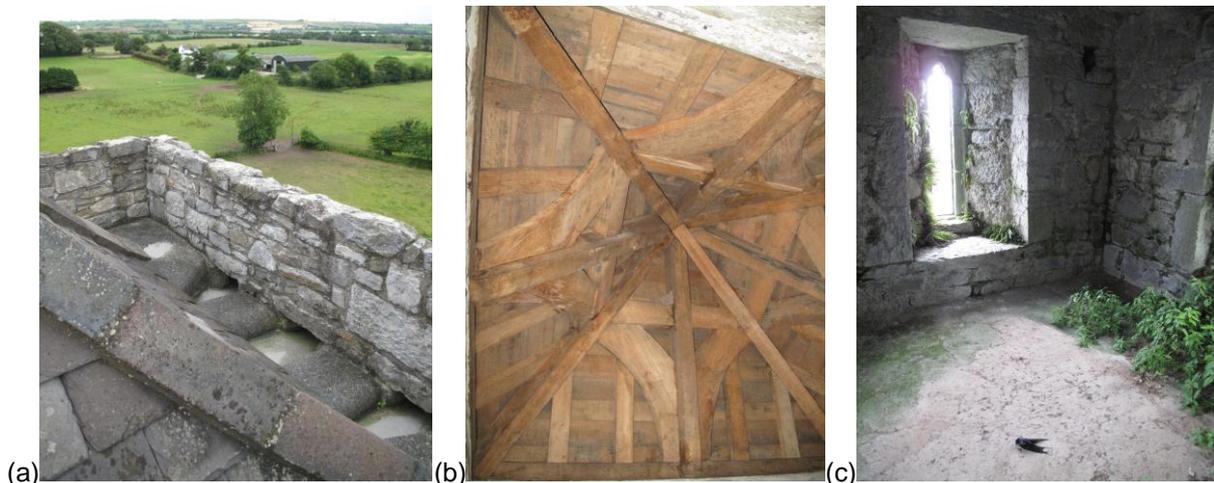
Accessed through a small door at the top of the spiral staircase in the south-western turret (refer to Figure 40), it opens out onto a wall walk which runs around a pyramidal shaped slate roof which is built on an oak timber trussed frame (see Figure 48a). This roof was replaced during the restoration project and the surrounding water/dripstones were repaired / replaced. There is no gutter drainage system and wall rainfall runoff water runs straight onto the waterstones and vacates via the dripstone outlets which surround the turret. This roof appears to be working quite well, as the underlying timber structure was free from staining (see Figure 48b) with vegetation seeming to be the only obvious problem. The upper two rooms of this turret were not restored, limewashed or repointed during the restoration project and they are in a state of complete disrepair with massive mortar loss, peeling walls, large spalling sections and copious vegetation growth (see Figure 48c). These unrestored rooms, give a view of what the building condition is when unattended and what may have been the case in most rooms prior to the restorative project.

Figure 48: (a) Pyramid roof with waterstone wall walk; (b) Timber roof structure; (c) Unrestored top room of south-eastern turret

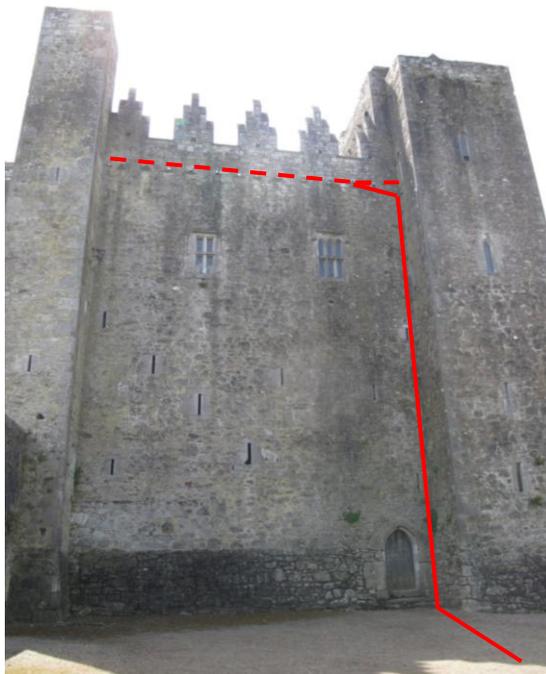
Figure 81: Proposed new gutter position with corner downpipe which evacuates through northern most dripstone

vegetation, voids, cracks and poor sealing joints. These features must first be tended to along with the underlying lead flashing. Then a painted cast iron half-round deep-flow gutter pipe should be fitted using corresponding painted cast iron fascia brackets to affix the gutter to the lead facing that underlies the roof eaves. The brackets should be screwed directly into the lead facings and sealed using plastic/rubber capping plugs. The gutter affixed on the east side of the castle should fall/slope from south to north, with a draining downpipe connection at the northern end. This drainpipe can run down alongside the northern most saddle stone to the first dripstone. The pipe can then be run out through this exit and down the corner between the main block and the northeast tower (see Figure 81).

The guttering would also benefit from a fitted strip of anti-pigeon spikes (galvanised steel) which can be fitted to the bottom of the gutter to deter birds from nesting in the gutter systems, case which was observed during the visual inspection.

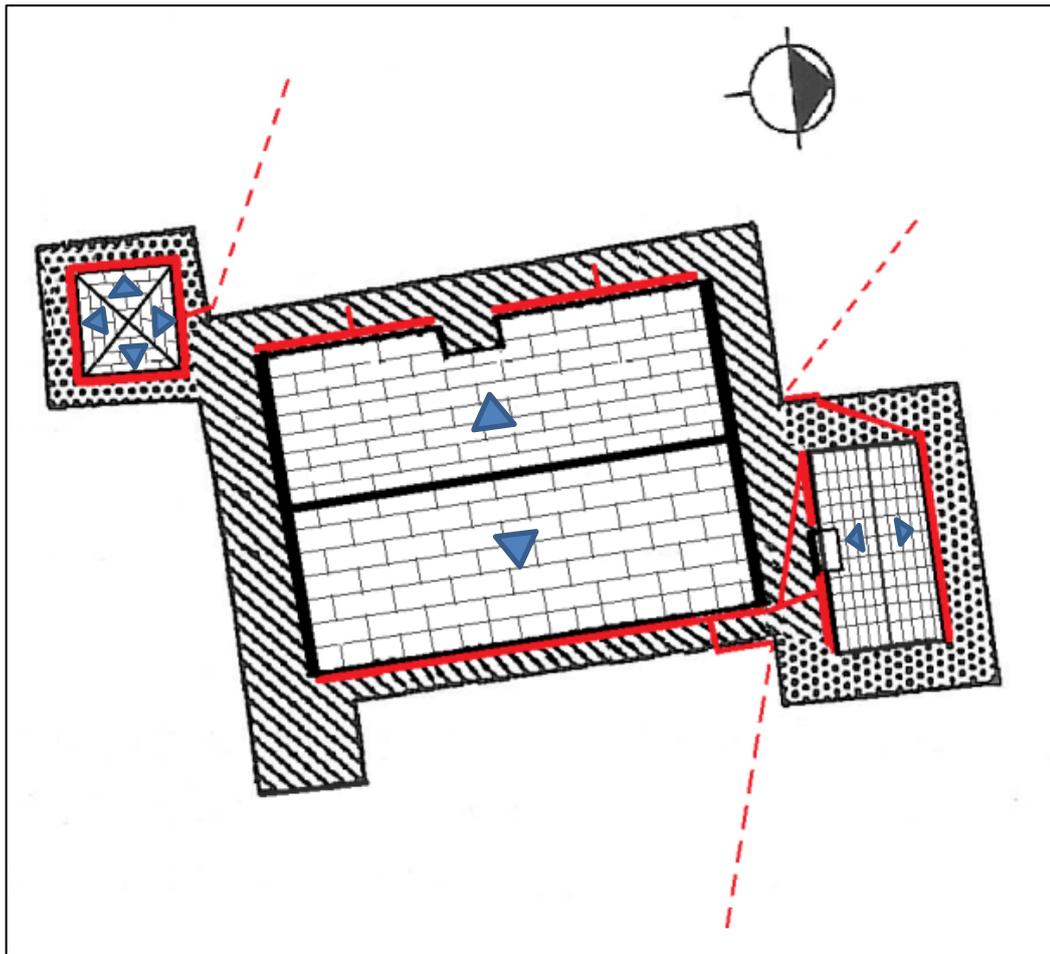
Figure 82: Rough plan view layout and schematic of new gutter/drainage system

The seals around the waterstones and saddle stones must be address, examined and repointed if necessary including all joints where lead leaves were woven into the lime mortar. Cracks, voids and openings must be raked and cleaned out with the careful removal of any loose or crumbled debris. All sections must then be repointed and sealed against water intrusion. The most obvious and necessary alteration that must be introduced to this tower and also in the case of the southwest tower is a new active cast iron gutter. A standard cast iron gutter (with corresponding fascia brackets) should be positioned along the north roof ending and either side of the chimney on the south side of the roof (The roof pitch is not as steep at the buildings main roof and the roof catch area is significantly smaller also). The gutter on the north side should be positioned to slope from east to west along under the last course of slate, and a collecting downpipe should run the evacuated water out the southernmost dripstone of the west façade (see Figure 82).

The downpipe should then run down the corner between the northeast tower and the west wall and out away from the structure to a region of suitable drainage. The gutter fitted under the eastern section of the south roof should be drained out through the easternmost dripstone of the south façade and should run down into the downpipe of the eastern main roof section. Therefore only one downpipe is required on this side and it is connected into the eastern evacuation downpipe. The water drained from the small section of gutter on the western side of the bedchamber chimney can be connected to the eastern sections evacuation downpipe.

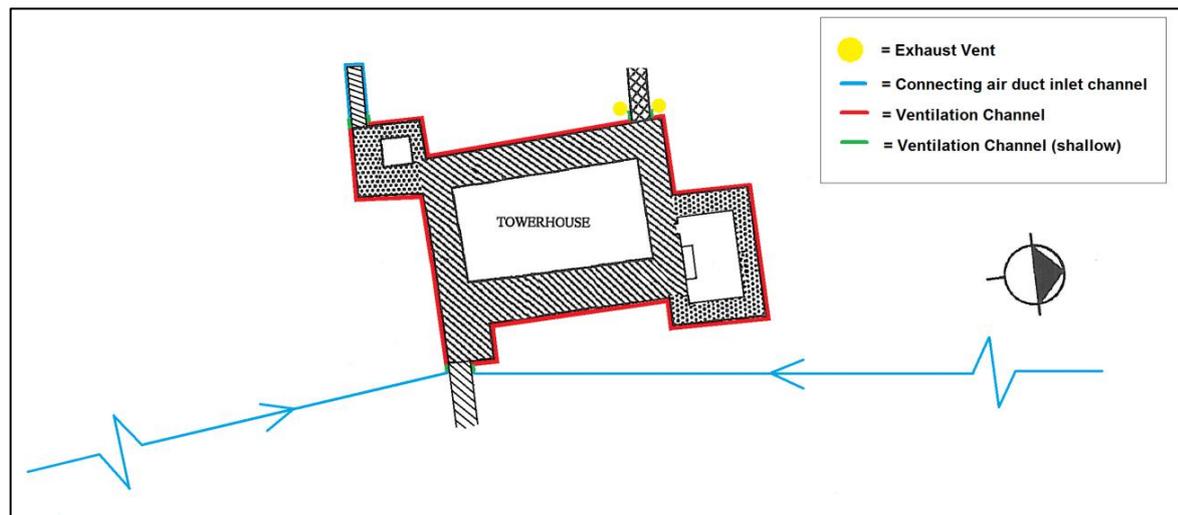
Figure 83: Ventilation channel layout plan view and inlet air channels

The highest (or most elevated) end of the ventilation channel should be fitted with an upright exhaust chimney to provide the necessary air movement through the channel, starting the drying process, whilst the lowest section is fitted to a sealed PVC pipe which is set into the ground and should run to an area of lower elevation (at least 1 metre lower than the exhaust level). By forcing a elevation differential and a sealed passageway, the air naturally moves through the channel beginning the "drawing process". The first stage of the process will be passive; if the flow of air does not begin automatically, it should be induced using a connecting fan which would start the air flow (see Figure 83).

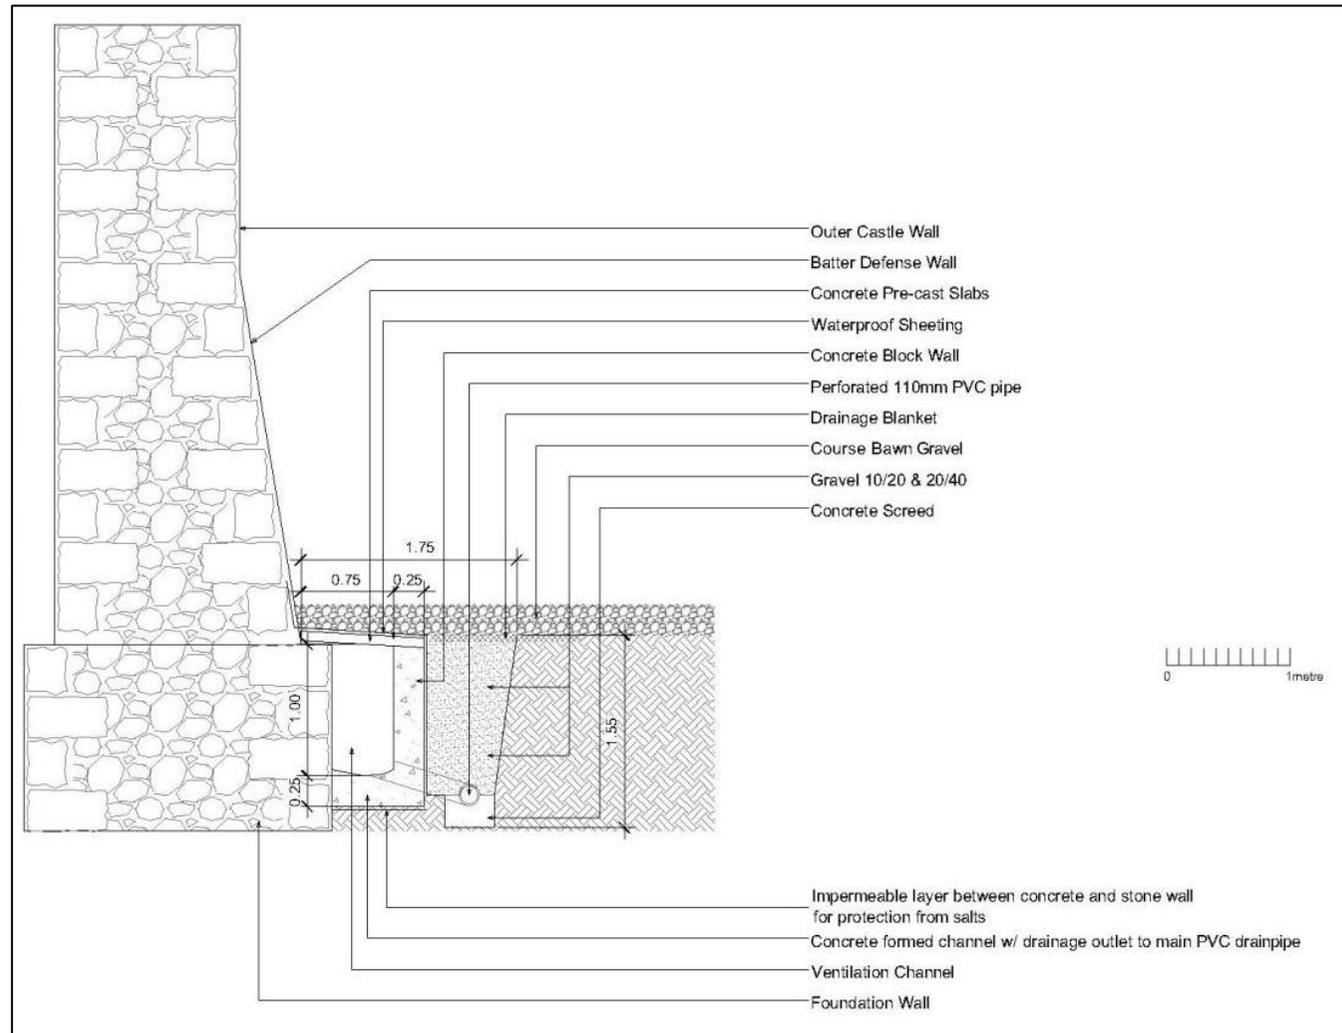
Figure 84: Detailed cross section of ventilation channel and design components

After the trial holes have been completed it is then possible to construct the channel alongside the foundation. A detailed cross section of the proposed intervention is shown in Figure 84 and the corresponding implementation procedure for the construction of the ventilation channel is as follows:

When set in place, this ventilation system should draw significant amounts of moisture from the castles foundation and help to restrict the damaging effects of wet-dry cycles on the lower walls of the tower house, help protect the batter wall which had been suffering due to water retention and hinder the transportation of soluble salts through the wall via capillary action. It is worth noting that this system would have been advised for inside the corresponding opposite side of the foundation walls at the

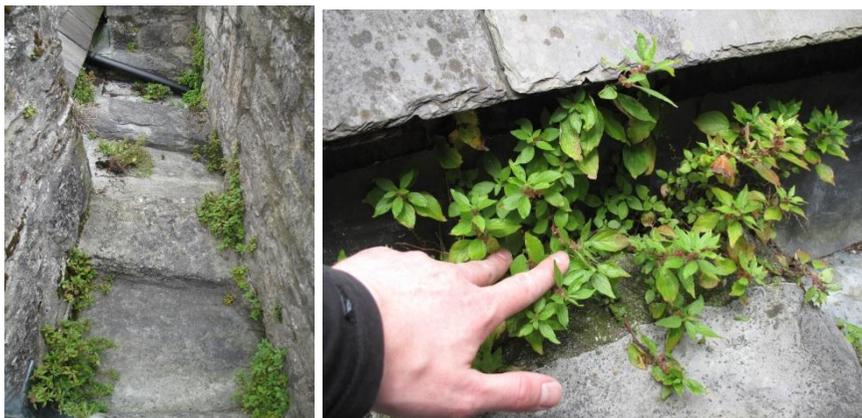
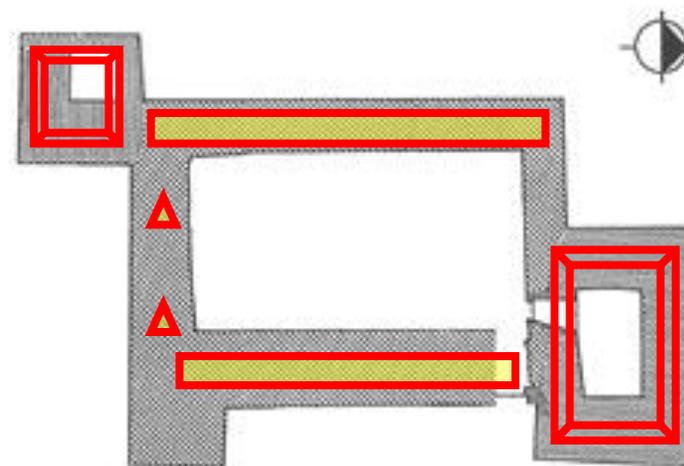
Barryscourt Tower House - Exterior		BIO_02
DAMAGE	Biological activity; Vegetation growth	Grading: Severe
LOCATION	Wall walks and roof sections where waterstones and saddles are situated. Gutters and downpipes also affected	
CAUSES	Ideal conditions for vegetation growth where water is remaining stationary on the roof surfaces. Small cracks in sealing mortar already present provide shelter and moisture encouraging mosses, fungi and more concerning plants, which in turn are rooting and allowing extra moisture in to underlying walls. Ample shelter and moisture under eaves and earthen debris ideal for growth. No maintenance of wall walk regions is in place.	
MAIN MECHANISM	Small size plants and mosses thrive in the cracks between stone and mortar. This growth causes further damage as roots weave into mortar and stone cracks expanding and forcing cracks to widen, allowing moisture into underlying walls

INTERVENTION PLAN	Removal of vegetation must be undertaken with great caution. The plants and shrubs can be poisoned and cut out but caution must be taken when removing roots which have become woven into mortar and masonry – sometimes removing these roots and cause masonry to become unstable and cause further cracking. If roots are removed from joints then the void must be replaced with a suitable lime mortar as detailed in intervention chapter. Monthly maintenance attention must be adopted.

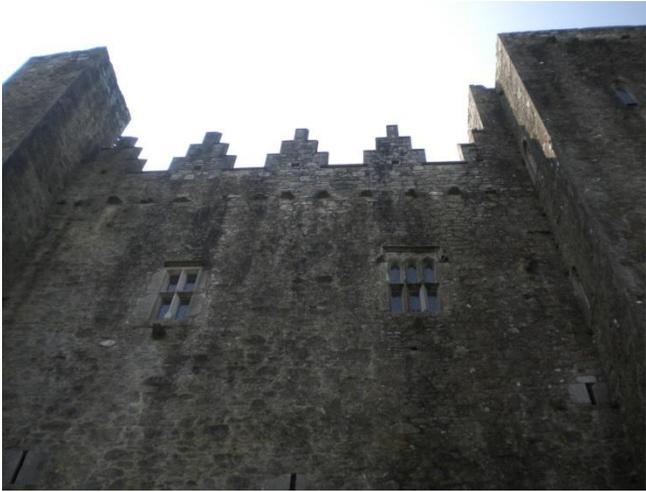
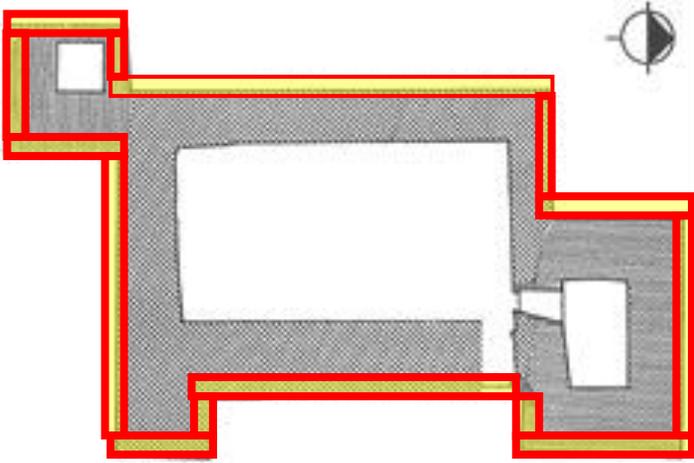
Barrycourt Tower House - Exterior		BIO_03
DAMAGE	Attack on stone/mortar due to biological growth; Black staining due to lichens/moulds	Grading: Non Serious
LOCATION	Tower House External Walls – All external façades are affected but east façade & north façade display large scale staining. The global staining occurs under dripstones and along batter wall	
CAUSES	Ireland's climate & the naturally occurring limestone's chemical composition give ideal conditions for the development for black lichens, seemingly in this case, <i>Placynthium nigrum</i> . Other patches of white lichens, perhaps of the Verrucariaceae species are also evident. Areas where water drips down wall from dripstones and sheltered façades provide ideal conditions.	
MAIN MECHANISM	Formation of black (and small patches of white) lichens affecting appearance and surface texture of stones	
INTERVENTION PLAN	To be absolutely certain of the lichen or fungi in question it would be advised to take a small sample and have it analysed by an expert. The staining does cover large areas of the castle façade and gives a dirty look to sections of the building. If an intervention plan for sealing the building was decided upon, in order to correctly and efficiently attach the new render to the surface of the castle, the lichen would first need to be removed. Removal is conducted by washing the surface using a mild anti-parasitic agent such as <i>dichlorophen</i> mixed with water, and scrubbed using nylon brushes.

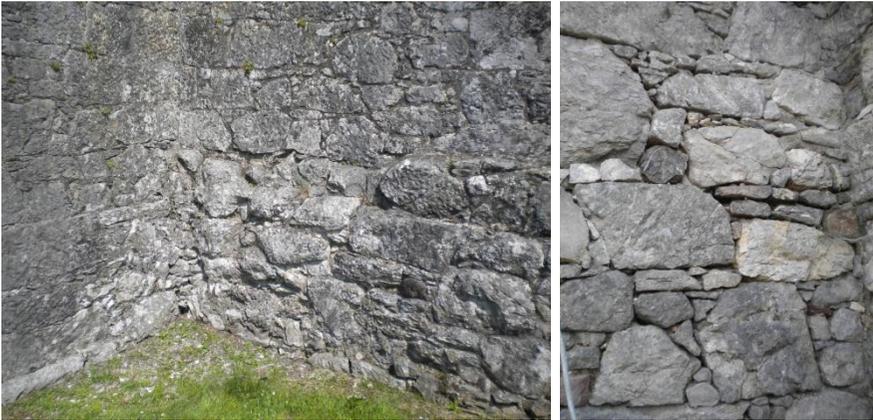
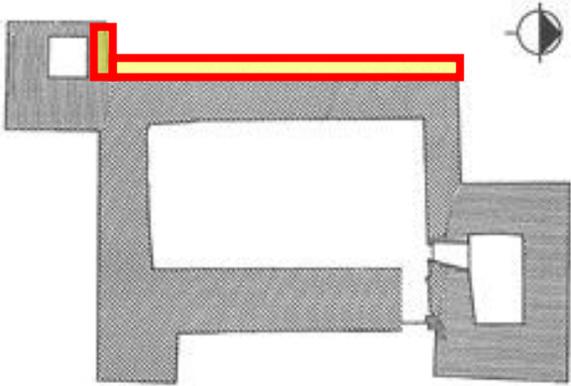
Barryscourt Tower House - Exterior		PH_01
DAMAGE	Physical decay; General weathering/Mortar loss	Grading: Severe/Moderate
LOCATION	Lower sections of the castles walls, most predominantly on the western façade especially on the batter wall section	
CAUSES	Cyclic weathering due to climatic conditions of rain and wind – absorptive mortar deteriorates over long periods of time. Rising damp due to lack of damp proofing under support walls – wall soaks moisture via capillary action. Greater accelerated damage in times of frost/ sub-zero conditions due to freeze thaw action that induces fatigue in stone and especially mortar.	
MAIN MECHANISM	Continued precipitous conditions weather the surface and infiltrate the pores of the permeable stone and mortar. Wetting and drying process induces stresses which over time cause fatigue and material loss (disintegration and spalling) in the stonework and mortared joints.

INTERVENTION PLAN	First rising damp must be taken care of to some extent. Ventilation channel surrounding outer foundations can be introduced to draw moisture from the low lying walls (detailed in interventions chapter). Areas which are subjected to mortar loss must have joints raked and repointed with new lime based mortar. Walls should be additionally rendered with a lime render to assist water proofing.

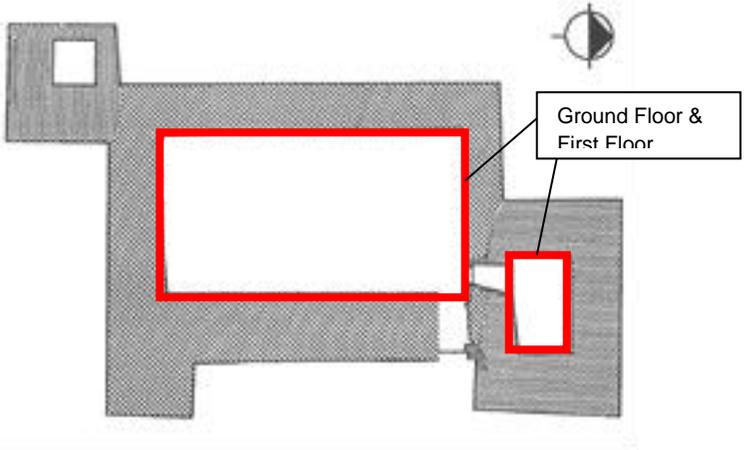
Barryscourt Tower House - Interior		CH_02
DAMAGE	Chemical attack; Efflorescence salts decay	Grading: Moderate
LOCATION	Evident during dry spells in ground floor main room, first floor halls and kitchen (most predominant near regions surrounding windows) but probably extends beyond these regions also. High humidity makes it difficult to pinpoint exact points of presence.	
CAUSES	Due to moisture presence in castle walls, soluble salts migrate from restoration mortars into surrounding masonry sections. The salt content may originate from the ordinary portland cement ingredient of the restoration mortar or from sand used in the mortar mix.	
MAIN MECHANISM	Salts become soluble in water and migrate through walls during wetting and drying. This cyclic crystallisation of the salts induce stress and eventual fatigue on the surface materials (named the limewash and surface mortar) causing eventual spalling, disintegration and mortar loss/surface exfoliation.

INTERVENTION PLAN	Take samples of both mortar and stone and analyze in laboratory which exact salts are present. Removal of damaging mortar is not ideal since salts are already contained in the stone and these can migrate back into new mortar in the presence of moisture. By conducting laboratory tests, we can identify salts and devise counter measures to neutralize their effect. This can be done along with mortar removal and with the replacement with a lime based traditional mortar which has similar properties and appearance – (properties can be determined in lab tests – MDT, drill and analyze powder).

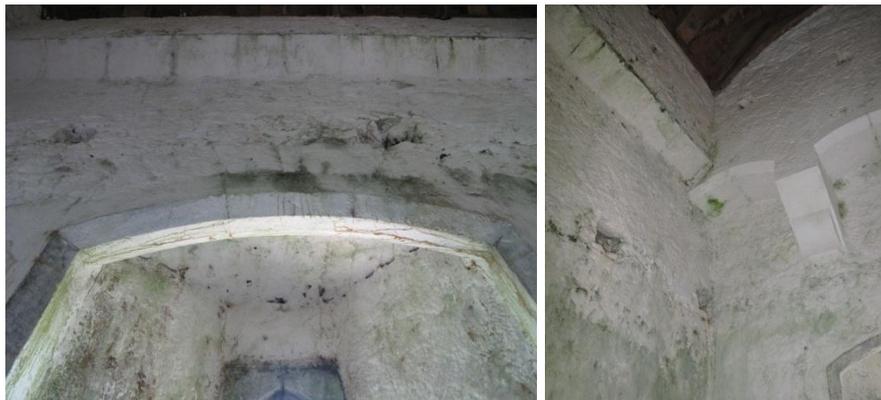
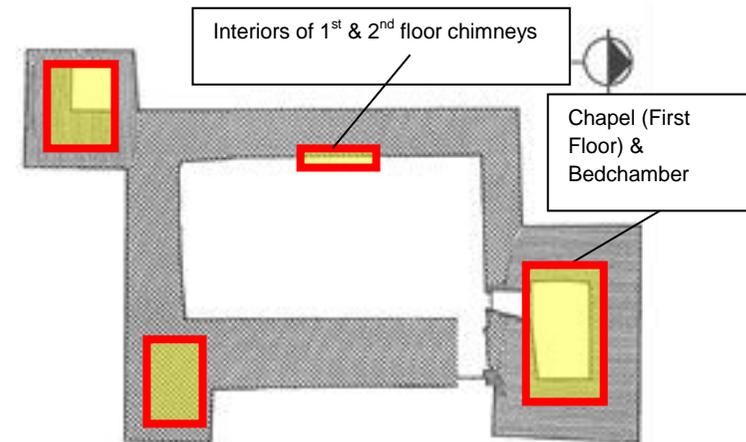
Barryscourt Tower House - Interior		BIO_04
DAMAGE	Biological Activity - Moulds/Fungi	Grading: Moderate
LOCATION	Master bedchamber most affected with large scale mould patterns and wall fungi on all walls, also surrounding chimney interior in bedroom and main chimney of Great Hall. Windows surrounds in all towers also exhibit activity. Chapel also badly affected but examination not conducted due to restricted access during ultra violet treatment.	
CAUSES	Abundant presence of moisture in the sheltered environment provides ideal conditions of biological activity, feeding from limewash organic content.	
MAIN MECHANISM	During the thermography analysis of the bedchamber, the roof was shown to be leaking in the corners of the room, especially where the bedroom chimney meets the roof. Water ingress is occurring and percolating through wall to provide necessary moisture for the moulds and fungi to flourish. Fungi spores attach to surface and multiply rapidly under correct conditions.

INTERVENTION PLAN	Roof platforms and sealing must be radically improved with new guttering. Chimneys must be resealed and repointed (optionally rendering of outside), External walls would ideally be repointed and have a rendering plaster applied to somewhat deter moisture ingress. Interior walls would need to be washed with a mild water/bleach mix to kill spores of fungi, then re-limewashed after outer walls have been tended to.

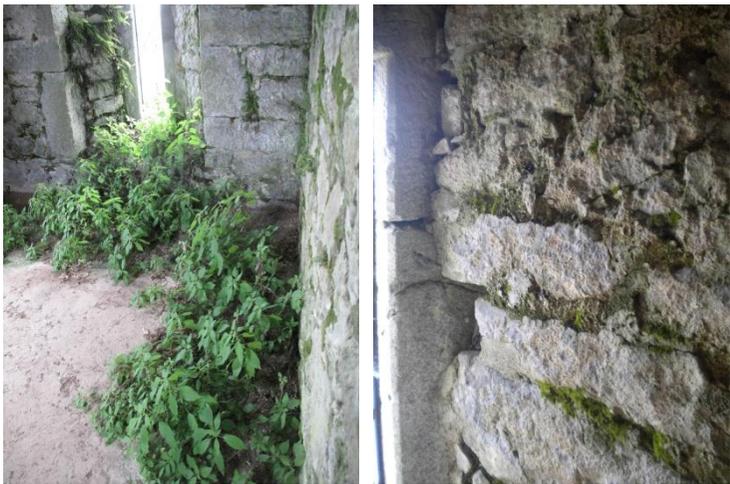
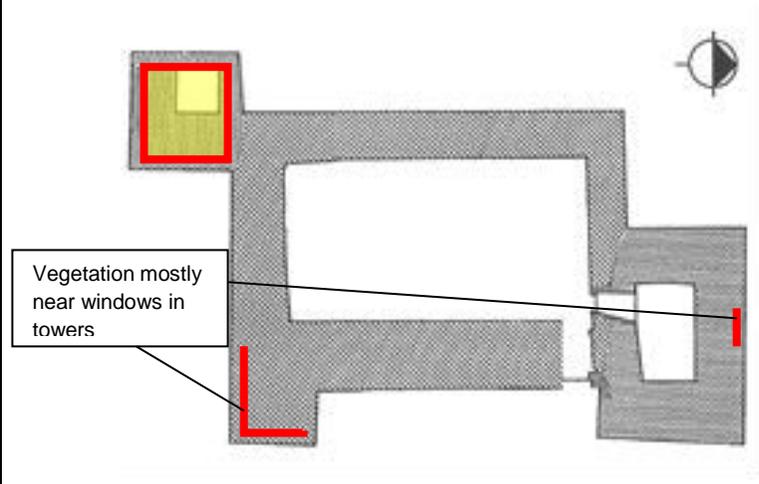
Barryscourt Tower House - Interior		BIO_05
DAMAGE	Biological Activity – Vegetation (Plants/Mosses)	Grading: Moderate
LOCATION	Southwest tower most affected with minor presence in southeast tower also (mostly inside window sections). Southwest tower has vegetation on ceilings, windows and floors.	
CAUSES	Vegetation works its roots into mortar joints causing damage such as mortar loss, degradation, cracking, disintegration of surface and constituents materials of walls and ceilings. Generate voids which allow further moisture and vegetation to take hold and flourish. Causes staining of surrounding areas when in contact with slow moving water. Very little/ no maintenance in effect, southwest tower is left unopened, section totally neglected because its closed to public.	
MAIN MECHANISM	Abundant presence of moisture in the sheltered environment provides ideal conditions of biological activity, feeding from limewash organic content.

INTERVENTION PLAN	The plants/mosses can be poisoned and cut out but caution must be taken when removing roots which have become woven into mortar and masonry – sometimes removing these roots and cause masonry to become unstable and cause further cracking. If roots are removed from joints then the void must be replaced with a suitable lime mortar as detailed in intervention chapter. Source of moisture must be sealed/ removed with inspection of roof areas and window surrounds. Monthly maintenance attention must be adopted. Affected joints should be repointed with appropriate mortar (see interventions)

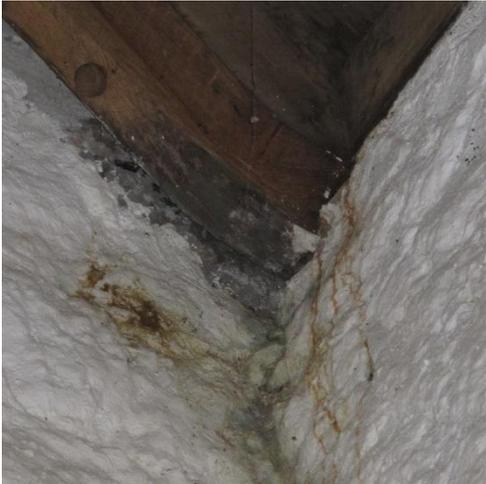
Barryscourt Tower House - Interior		PH_02
DAMAGE	Timber staining – early stage decay	Grading: Moderate
LOCATION	Staining on timber upper roof structure of main block of castle – believed to be from lack of covering/protection during rain storm during construction period. Lower corner sections show additional staining, suspected roof leakage. Master bedchamber with definite moisture damage in corners of timber roof where the support beams meet wall plate – especially near chimney and roof meeting point.	
CAUSES	Water infiltration through poor seals, or seals which have been broken due to vegetation roofs or deterioration of silicone filling. No existing guttering in place over master bedchamber allowing water time to remain on roof surface and infiltrate mortar.	
MAIN MECHANISM	Over time and due to lack of maintenance, vegetation has taken hold and opened seals in lead and mortar joints allowing water to percolate down onto wall plate and into interior walls. Timber elements soak water via capillary action and retain moisture causing staining, and in extended periods of time, rotting and deterioration of structural ability.

INTERVENTION PLAN	Since the roof is the main source of the damaging moisture, guttering must be tended to, or introduced in areas where it doesn't exist. Mortar sealing joints of waterstones and saddles must be freed from vegetation and repointed. Lead flashing must be investigated by a trained roof technician and countered to avoid dripping inside the roof sections. All traces of silicone should be removed and seal should be woven into mortar joint or ran up under slating to rule out infiltration.
