ADVANCED MASTERS IN STRUCTURAL ANALYSIS
OF MONUMENTS AND HISTORICAL CONSTRUCTIONS

Master's Thesis

Moisture Problems in Irish
Tower Houses: Application to
Barryscourt Castle

Portugal | 2011

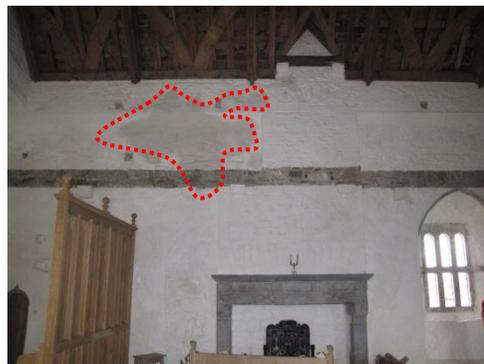
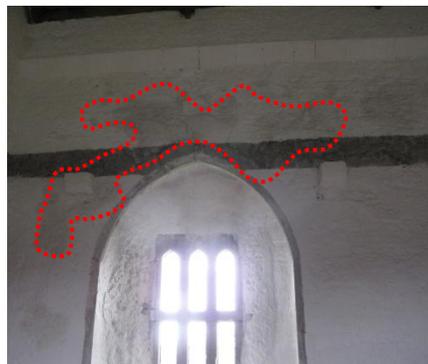
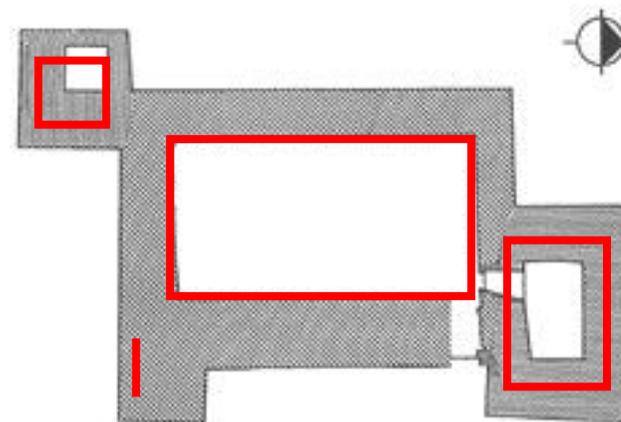
Barryscourt Tower House - Interior		PH_03
DAMAGE	Moisture induced staining and surface deterioration	Grading: Moderate
LOCATION	Global problem occurring on most interior walls of the tower house, especially noticeable in first floor hall, Great Chamber hall walls, northeast tower rooms exhibit many staining patches.	
CAUSES	Moisture causing staining - Number of contribution factors including faulty roof sealing joints, inadequate drainage. However, the moisture staining patches also occur in the middle of walls signifying porous masonry which is facilitating the ingress of moisture in times of rain and accelerating when accompanied by driving wind.	
MAIN MECHANISM	Water works through wall by differential pressure force and infiltrates to interior facades where it stays, causing staining of materials, namely lime wash and mortar joints, stone facing and timber. Constant moisture causes limewash to discolour to cream/yellow. Water combines with tannins in timber and stains walls when dripping or pouring. Water leaves staining lines and watermarks on naked stone.

INTERVENTION PLAN	Roof sections should be repaired/ maintained. (See last template for intervention). Walls of castle should be repointed to repair mortar joints which are allowing moisture through. Rendering external plaster should be ideally reapplied using lime render to improve waterproofing whilst still allowing the walls to breathe in times of dry weather. Ventilation should be maximised to aerate the building during these times also and further the drying process.

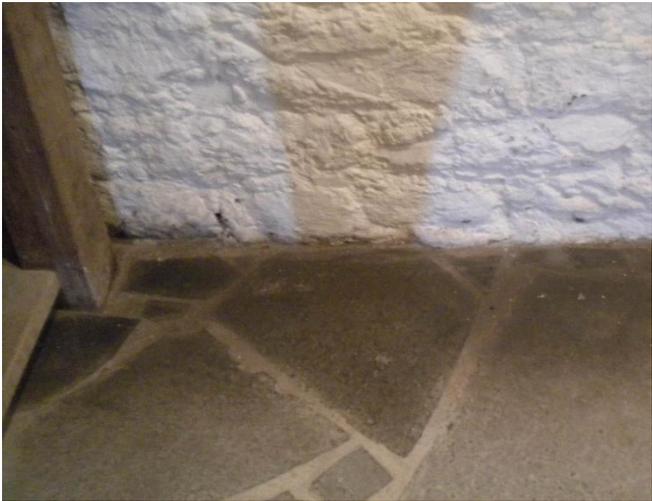
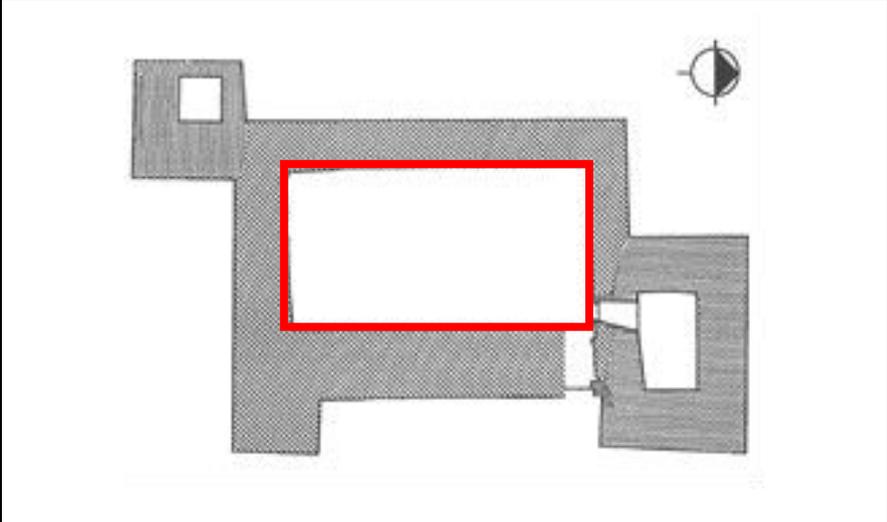
Barryscourt Tower House - Interior		PH_04
DAMAGE	Moisture staining/dampness on ground floors	Grading: Non Serious
LOCATION	Ground floor flagstones and lower sections of ground floor walls	
CAUSES	Rising damp originating from surrounding walls – extensive moisture presence for long periods of time causes staining and damage to wall surfaces especially in lower sections. Semi-impermeable flooring due to cement content in mortar surrounding floor flagstones.	
MAIN MECHANISM	Water rises through stones and mortar or foundations and load bearing support walls via capillary action. Water remains in periods of prolonged rain, causing staining. Wetting and drying of mortar and surface materials induces forces on materials who over extended periods, become fatigued and disintegrate/spall leading to mortar loss and surface damage. Water cannot evaporate through flooring also due to suspected use of ordinary portland cement in flooring mortar surrounding flagstones.

INTERVENTION PLAN	External ventilation channel surrounding outer foundations can be introduced to draw moisture from the low lying walls (detailed in interventions chapter). Floor paving must be analysed for composition – if ordinary portland cement was used in the mix, then the floor must be re-laid with a more permeable flooring mortar around flagstones to allow moisture vapour to escape and facilitate drying.
